Replace 3rd Row Seatbacks

Classification	Recall Bulletin	Section/Group	13 - Seats	Country/Region	United States
Year	2016	Model	Model X	Version	All

This Service Bulletin supersedes SB-16-13-003 R1, dated 22-Apr-16. Each content change is marked by a vertical line in the left margin. Discard the previous version and replace it with this one.

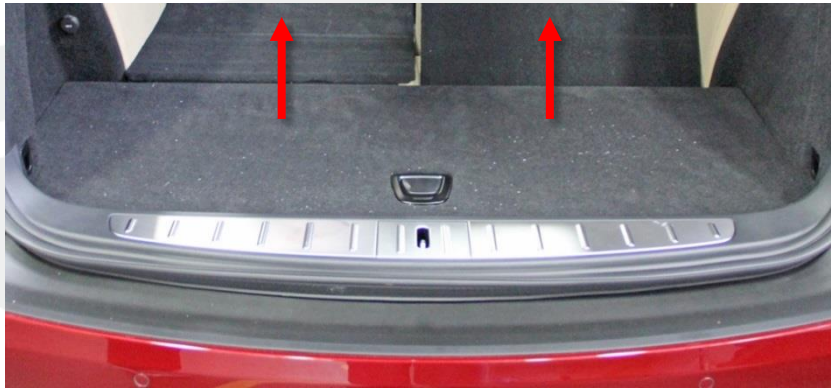
Figure 1

1. Fold down both 3rd row seats.
2. Lift the front portion of the liftgate load floor and remove the load floor from the vehicle (Figure 1).

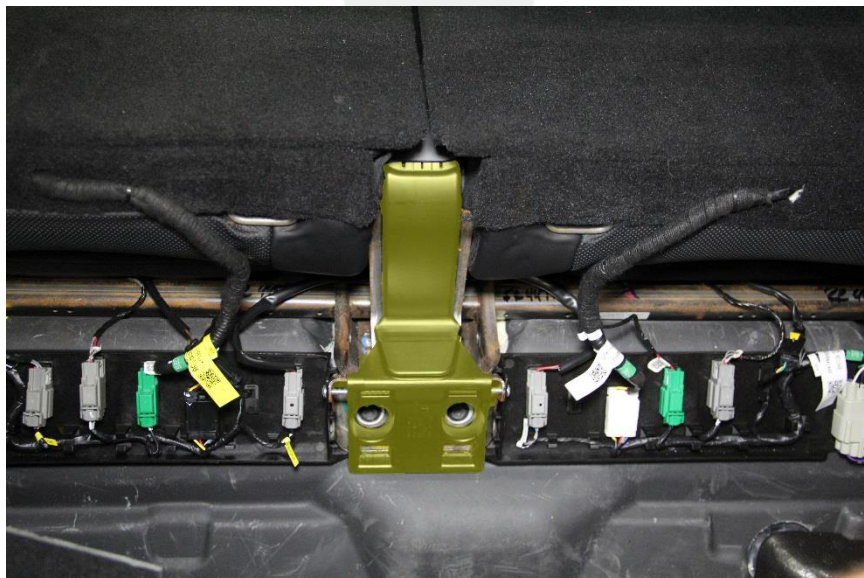
Figure 2 (Seat bracket cover highlighted)

3. Pull the trunk floor carpet towards the rear of the vehicle to gain access to the hardware on the rear of the 3rd row seats.
4. Carefully release the seat bracket cover and remove it from the 3rd row seat assembly (Figure 2).

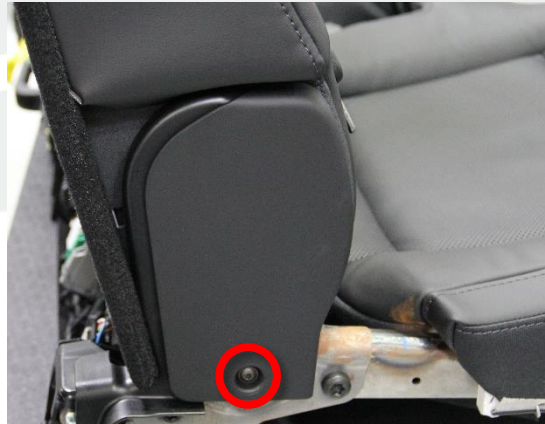
Figure 3 (LH outer recliner cover shown)

5. Remove the 3rd row seat assembly (refer to Service Manual procedure 13060102).
6. Disconnect the lower cushion wiring harness connectors.
7. Remove the lower cushion from the 3rd row seat assembly.
8. On the LH and RH sides of the 3rd row seat assembly, remove the bolt that secures the outer recliner cover to the seat (Figure 3). Remove the outer recliner cover.

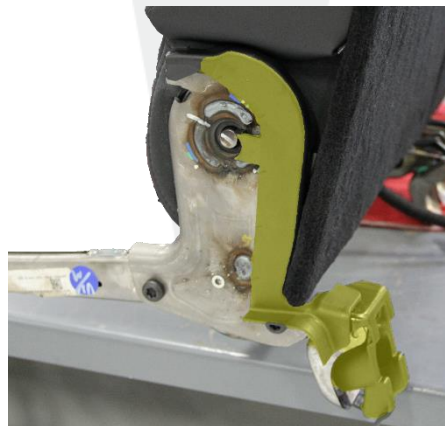
Figure 4 (RH inner recliner cover highlighted)

9. Remove the LH and RH inner recliner covers (Figure 4).

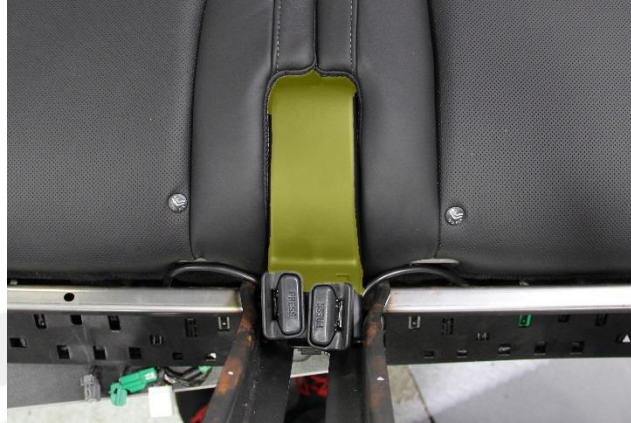
Figure 5 (Center recliner cover highlighted)

10. Remove the center recliner cover (Figure 5).

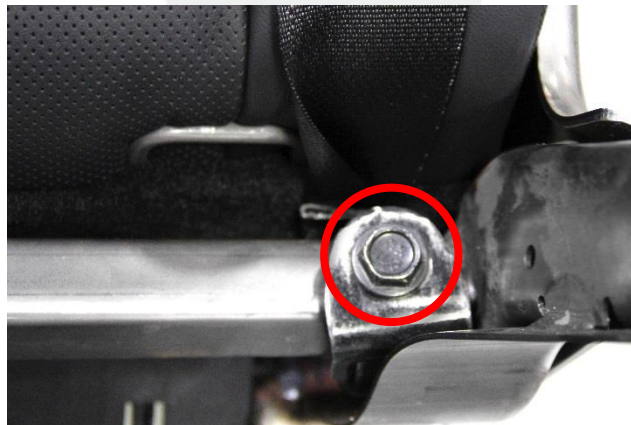
Figure 6

11. Remove the bolts that secure the LH and RH seat belt lower mount brackets to the seat frame (Figure 6).

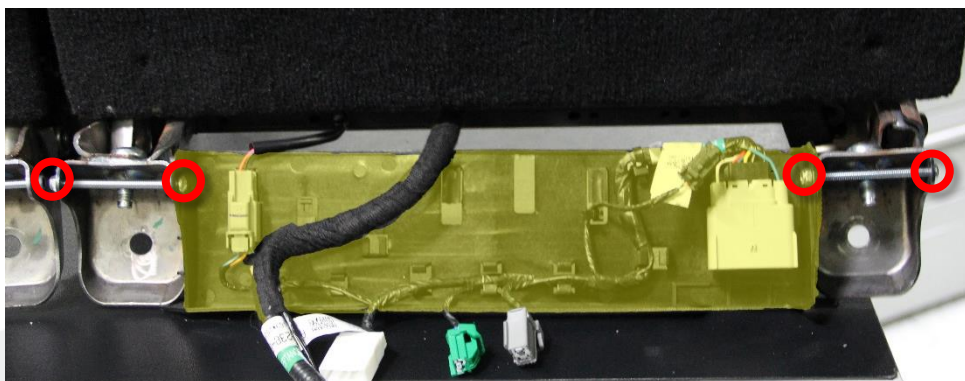
Figure 7 (RH cable tray assembly highlighted)

13. Remove the 2 screws and 2 nuts that secure the RH seat cable tray assembly to the seat frame. Repeat this step on the LH seat. Discard the screws and nuts (Figure 7).

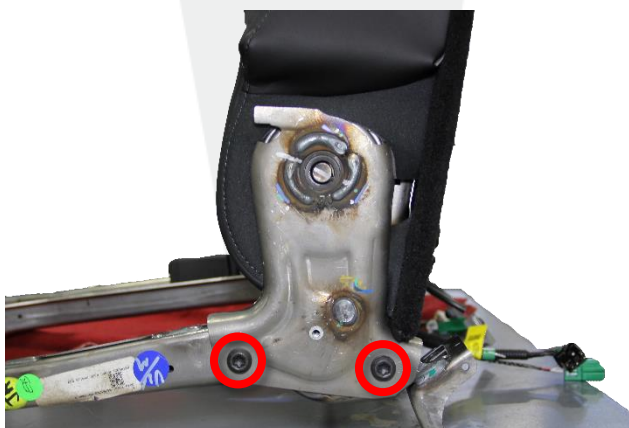
Figure 8

15. Remove and discard the 2 outer bolts that secure the LH seatback to the seat frame (Figure 8).

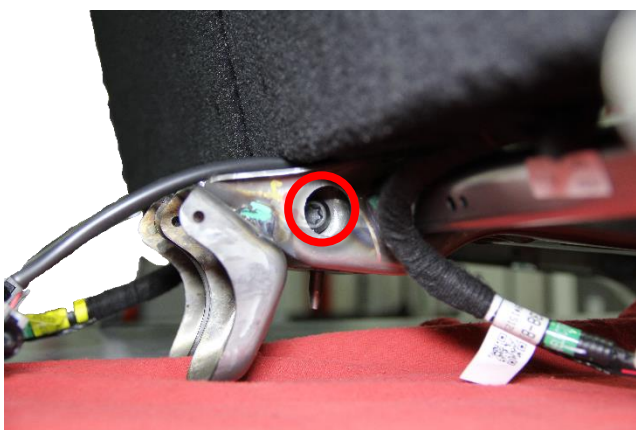
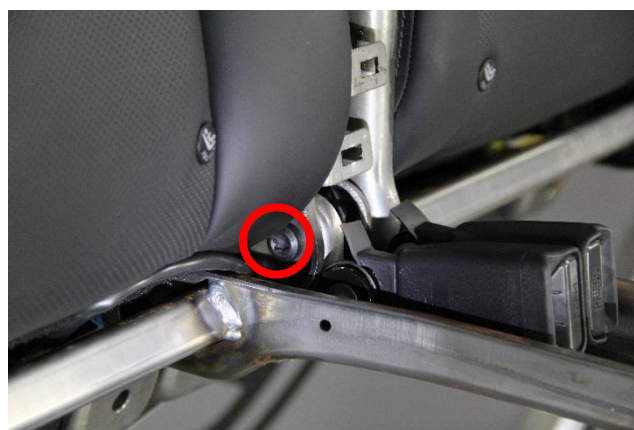
16. Remove and discard the 2 inner bolts that secure the LH seatback to the seat frame (Figures 9 and 10).

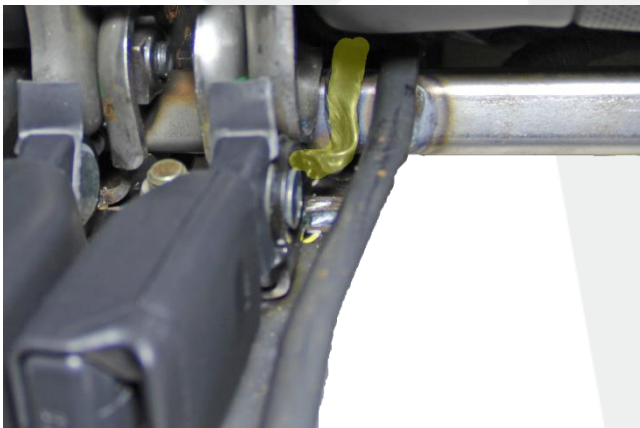
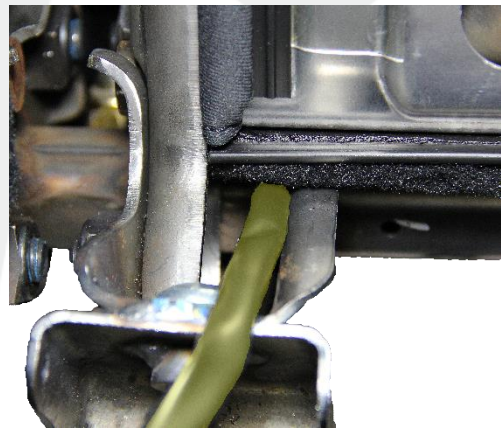
1. Place the new LH seatback in position onto the seat frame. Route the seat belt between the seatback and the seat frame without pinching the seatbelt buckle harness (Figures 11 and 12)

✓ Figure 11 (Correct; front shown)

✓ Figure 12 (Correct; rear shown)

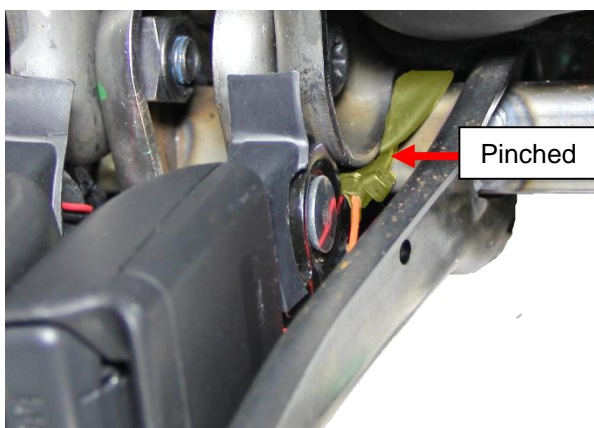
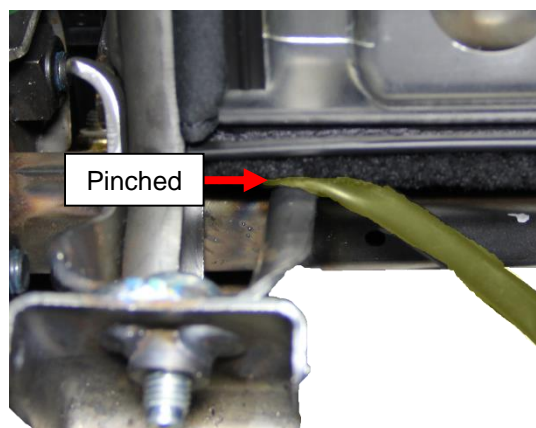
⚠ WARNING: Before installing the seatback onto the seat frame, make sure that the seatbelt buckle harness is not pinched (Figures 13 and 14).

✗ Figure 13 (Incorrect; front shown)

✗ Figure 14 (Incorrect; rear shown)

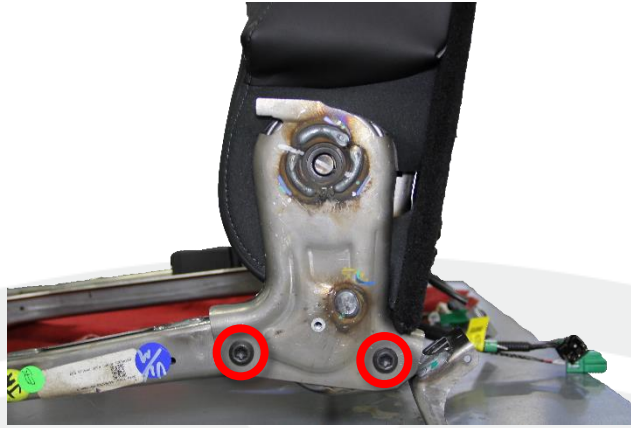
Figure 15

2. Loosely install the 2 new outer bolts that secure the LH seatback to the seat frame (Figure 15). Do not fully torque the bolts at this time.

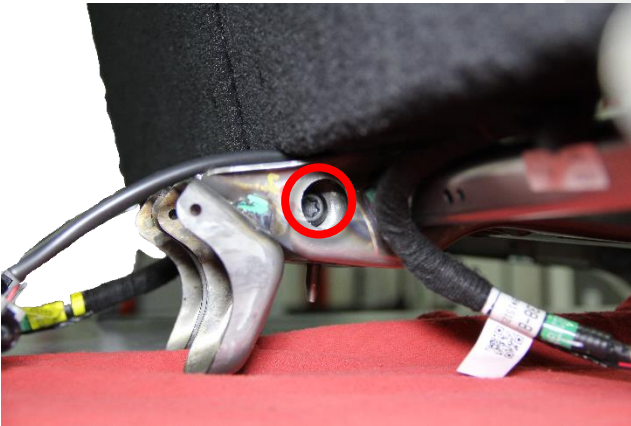
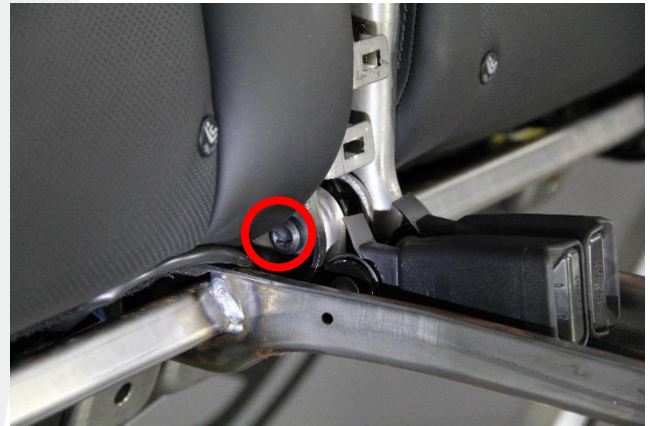
3. Loosely install the 2 new inner bolts that secure the LH seatback to the seat frame (Figures 16 and 17). Do not fully torque the bolts at this time.

⚠ CAUTION: Do not use any tools to force the seatbacks to align with the holes on the seat frame. All 4 seatback bolt holes must align with the holes on the seat frame without applying excessive force. If any seatback bolt holes do not easily align with the seat frame, remove the seatback and repeat steps 1–3 with a new seatback.

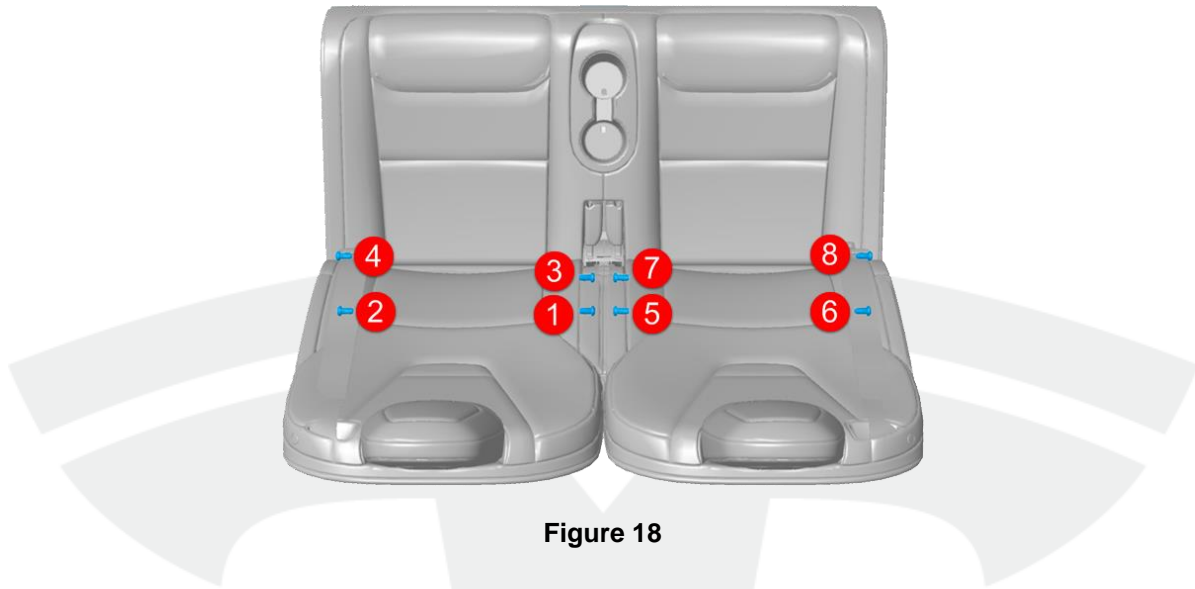
Figure 18

5. Tighten the inner and outer bolts that secure the LH and RH seatbacks to the seat frame in the sequence shown (torque 40 Nm) (Figure 18). Mark the bolts with an orange paint pen.

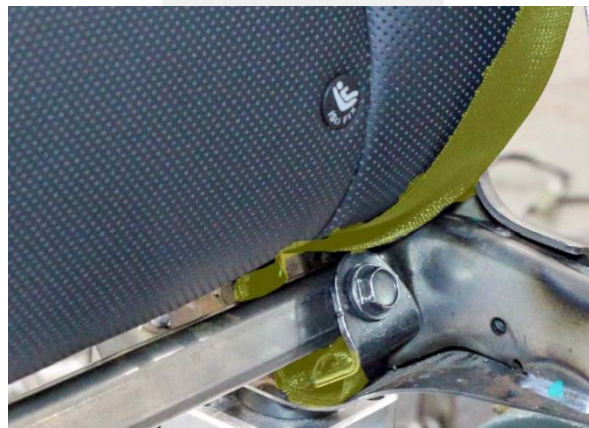
Figure 19 (Seat belt highlighted)

6. Wrap the LH seat belt around the lower seat frame (Figure 19).

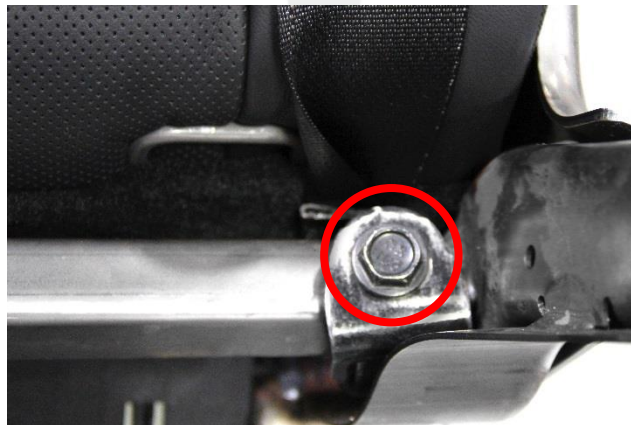
Figure 20

7. Secure the seat belt lower mount bracket to the seat frame with a new bolt (torque 45 Nm) (Figure 20). Mark the bolt with an orange paint pen.

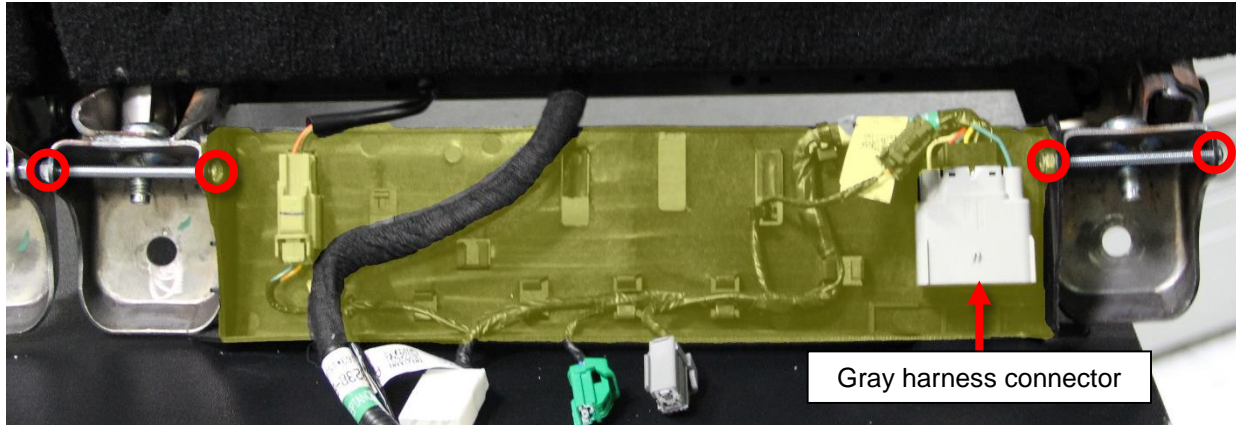
Figure 21 (RH cable tray assembly highlighted)

8. Repeat steps 6 and 7 for the RH seat belt.
9. Install new LH and RH cable tray assemblies (Figure 21). Secure each cable tray assembly with 2 new screws and nuts.

NOTE: The LH cable tray has a black harness connector and the RH cable tray has a gray harness connector.

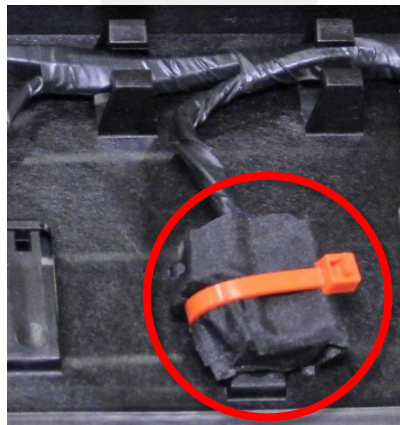
Figure 22

NOTE: For vehicles without heated rear seats, wrap the unused wiring harness connectors with electrical tapes, then secure the heated seat connectors to the cable tray assembly with cable ties (Figure 22). Remove any excess cable tie.

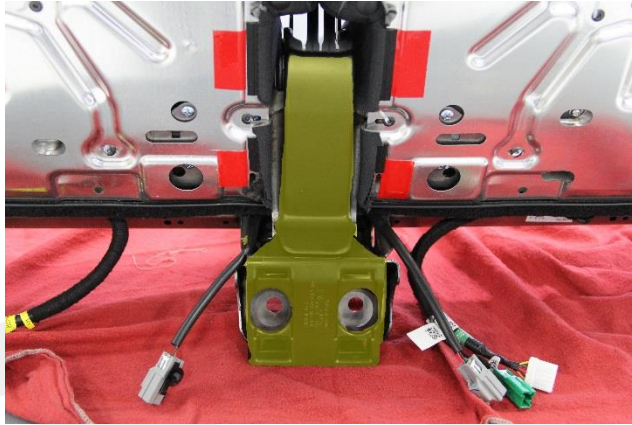
Figure 23 (Seat bracket cover highlighted)

11. Install the seat bracket cover (Figure 23).

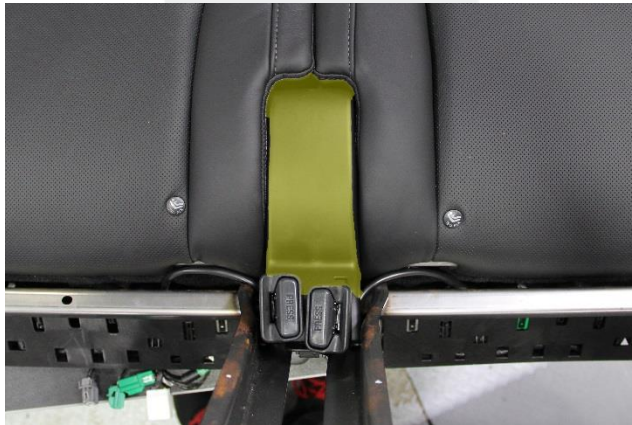
Figure 24 (Center recliner cover highlighted)

12. Install the center recliner cover (Figure 24).

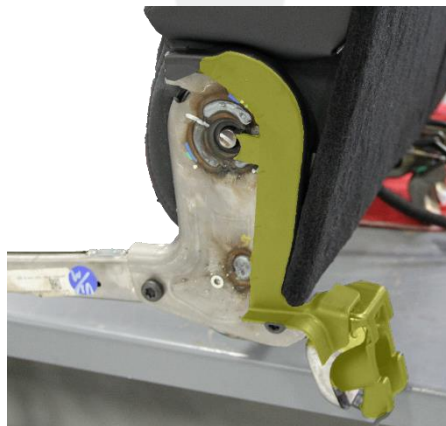
Figure 25 (Inner recliner cover highlighted, RH shown)

13. Install the LH and RH inner recliner covers (Figure 25).

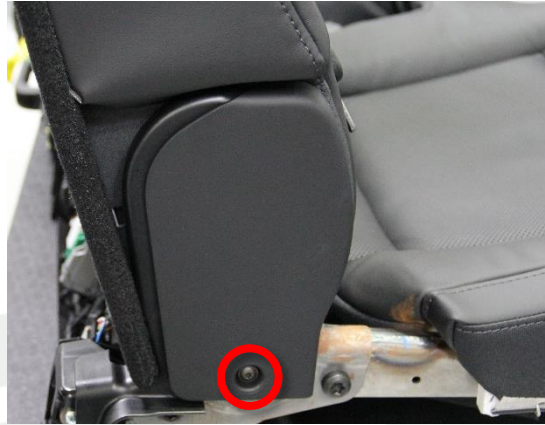
Figure 26 (LH outer recliner cover shown)

14. Install the outer LH and RH recliner covers. Secure each cover with a bolt (torque 2.5 Nm) (Figure 26).

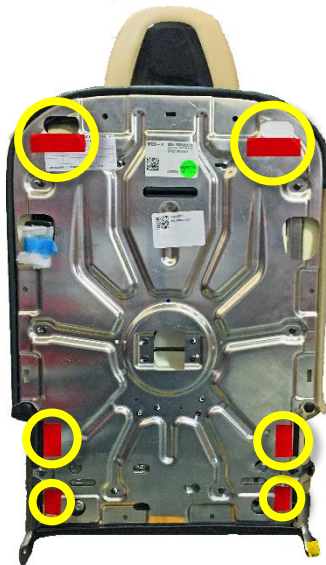
Figure 27

19. Peel off the backing film to expose the 6 adhesive strips (Figure 27).

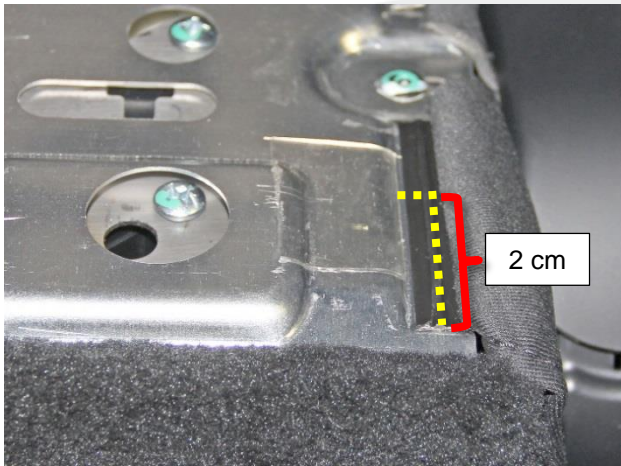
Figure 28

21. On the RH base of the seat, cut off the lower 2 cm of the plastic retainer that secures the flap on the side trim to the seat frame, if necessary (Figure 28).

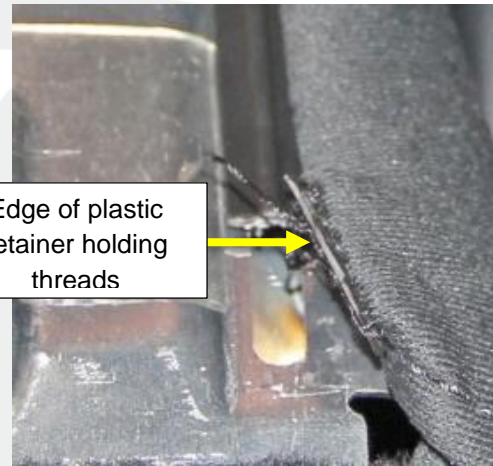
Figure 29

⚠ CAUTION: To prevent fraying of the side trim flap, leave a small section of the plastic retainer attached to the threads on the flap (Figure 29).

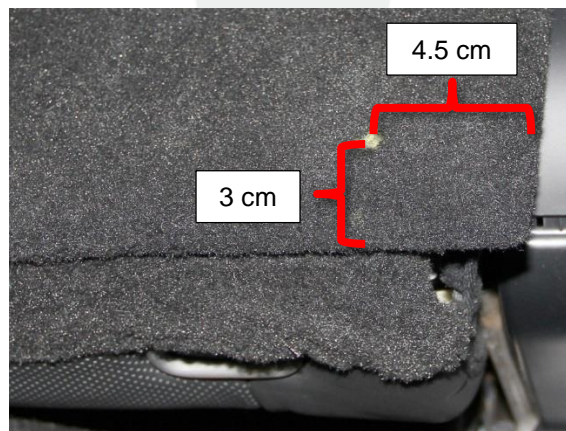
Figure 30

22. Mark the location for a drill hole 3 cm up and 4.5 cm inboard from the lower corner of the seat (Figure 30).

23. Use a 11/64 in (4.5 mm) drill bit to drill a hole through the seat backing.

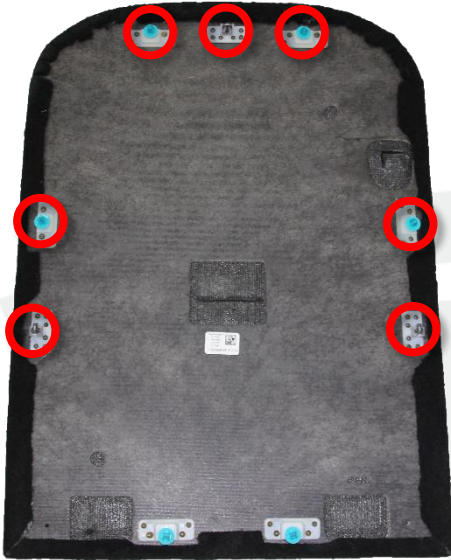
Figure 31

25. Partially install the LH seat backing by securing the 7 upper clips to the LH seatback (Figure 31). Do not attach the 2 lower clips at this time.

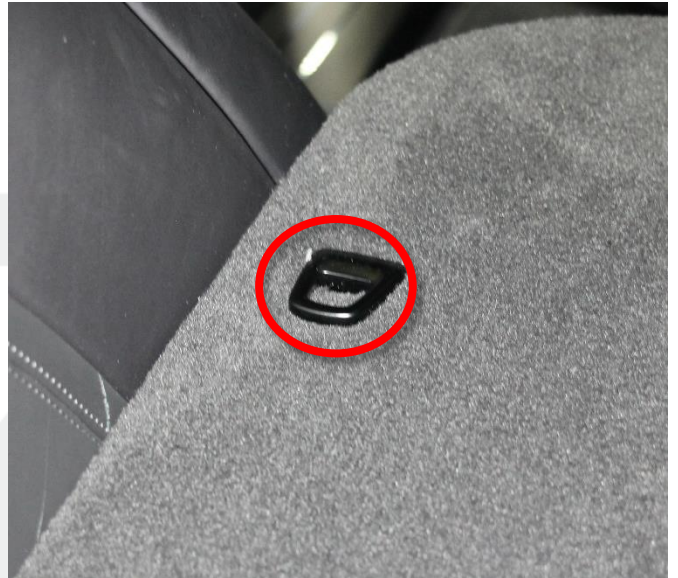
Figure 32

NOTE: Insert the cargo hook through the carpet backing during installation (Figure 32).

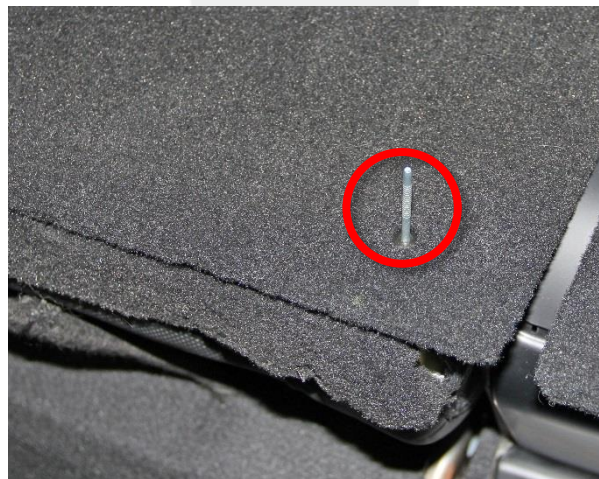
26. Insert a rivet into the hole located near the lower RH corner of the carpet backing (Figure 33).

Figure 33 (Rivet shown at bottom RH corner of LH seatback)

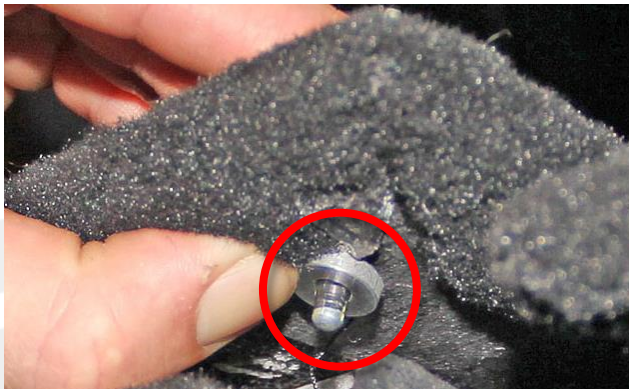
Figure 34

27. While holding the rivet in place, lift up the seat backing. Install a washer onto the shank (Figure 34). While holding the washer in place, lower the seat backing.

NOTE: Ensure that the washer remains installed on the mandrel.

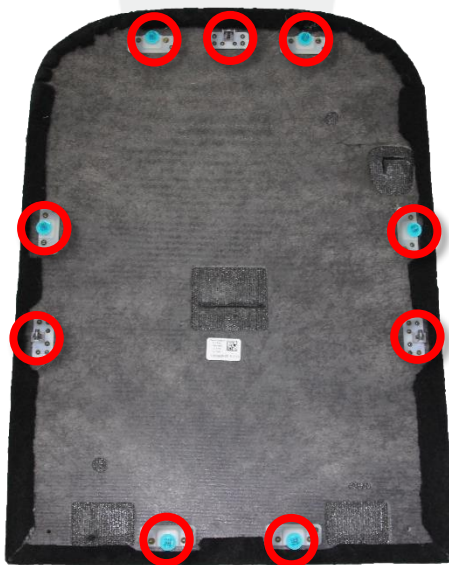
Figure 35

30. Verify that the 9 clips on the carpet backing are securely attached to the seatback (Figure 35).

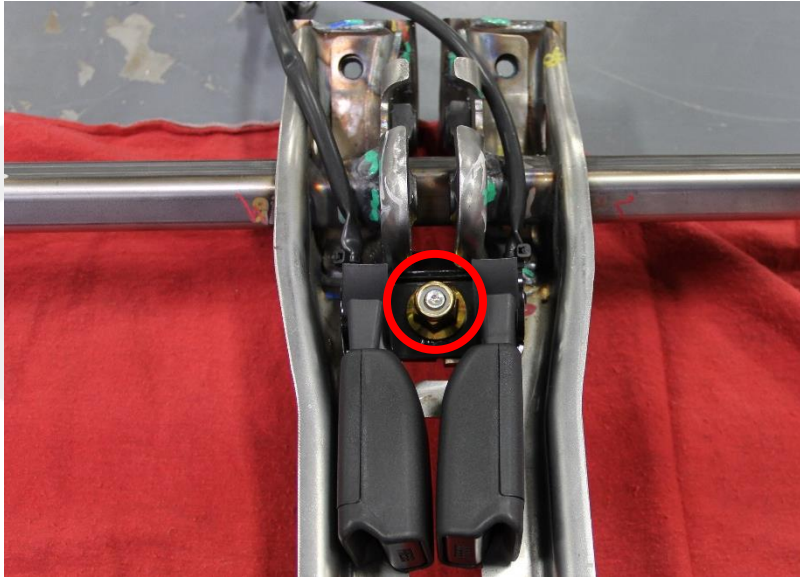
Figure 36

1. Repeat the “Seatback Removal” section of this document.
2. Remove and discard the bolt and nut that secure the seat belt buckle assembly to the seat frame (Figure 36).

3. Transfer the seat belt buckle assembly to the new seat frame and secure it with a new bolt and nut (torque 45 Nm). Mark the bolt with an orange paint pen.
4. Repeat the “Seatback Installation” section of this document.
