# Replace Rear Drive Unit HV Header and Positive Contactor Bolts

<b>Classification</b>	Campaign Bulletin	<b>Section/Group</b>	16 - HV Battery System	<b>Country/Region</b>	United States, Canada
<b>Year</b>	2018	<b>Model</b>	Model 3	<b>Version</b>	All

On certain Model 3 vehicles, the rear drive unit HV header bolts and the positive contactor bolt within the High Voltage (HV) battery penthouse were insufficiently torqued to internal specifications during manufacturing.

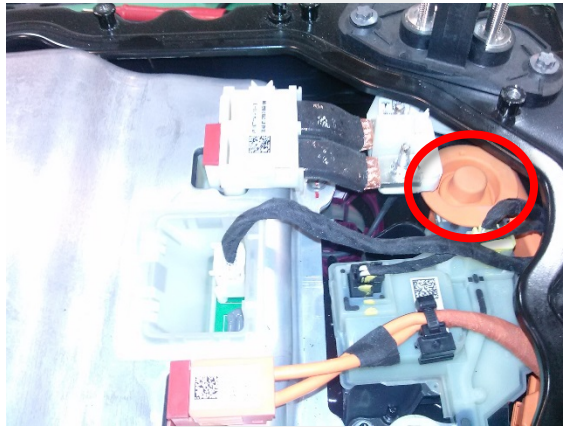
Figure 1

1. Remove the pyrotechnic battery disconnect (refer to Service Manual procedure 16300200).
2. Remove the insulator cap from the HV battery positive contactor output terminal bolt (Figure 1).

6. Install the insulator cap onto the HV battery positive contactor output terminal bolt (Figure 1).
7. Raise the high voltage controller vertically, release the clips that attach the fuse access insulator to the penthouse, and then remove the insulator from the penthouse (Figure 4).

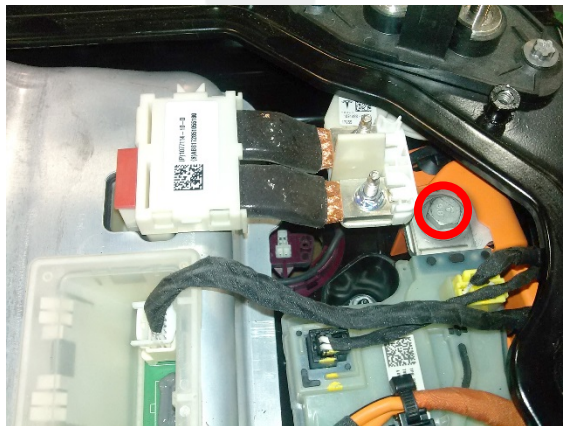
Figure 2

3. Remove and discard the bolt that attaches the HV battery positive contactor to the positive busbar (Figure 2).

4. Install a new bolt to attach the HV battery positive contactor onto the positive busbar, and then mark the bolt with a paint pen after it is torqued (torque 5 Nm +60°) (Figure 2).

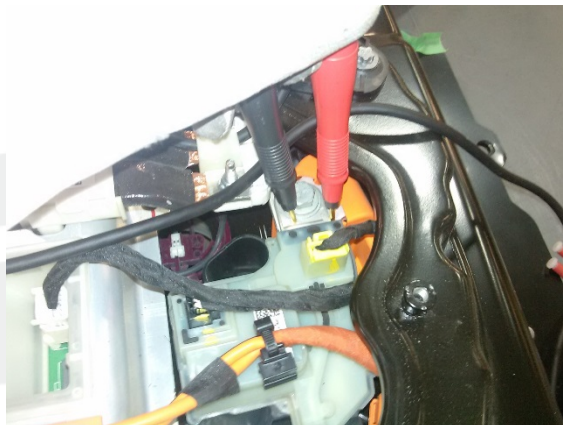
**Figure 3**

5. Use the Hioki resistance meter to measure the resistance at the HV joint between the HV battery positive contactor and the positive busbar (Figure 3).

**NOTE:** The maximum acceptable resistance is 0.060 mΩ (60 μΩ). If the resistance is above this value, escalate a Toolbox session, as appropriate.

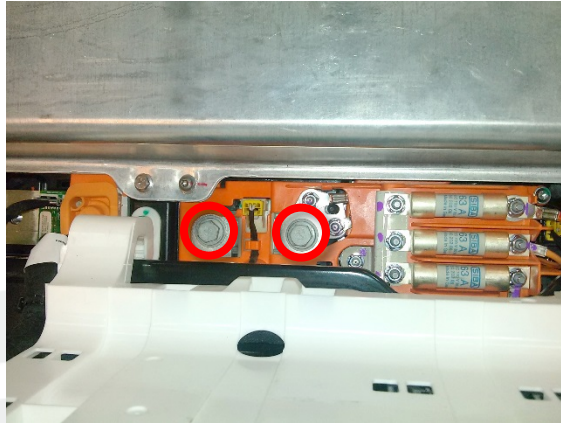
**Figure 5**

- Remove and discard the bolts that attach the positive and negative busbars to the rear drive unit HV header (Figure 5).

- Install new bolts to attach the positive and negative busbars to the rear drive unit HV header, and then mark the bolts with a paint pen after they are torqued (torque 5 Nm +60°) (Figure 5).
- Use the Hioki resistance meter to measure the resistance at the HV joint between the rear drive unit HV header and the busbar at each bolt (Figure 6).

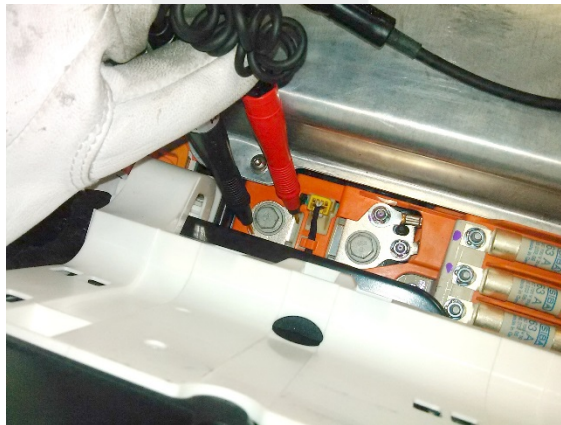
**Figure 6**

**NOTE:** The maximum acceptable resistance is 0.070 mΩ (70 μΩ). If the resistance is above this value, escalate a Toolbox session, as appropriate.
