Tesla, Inc. Service Bulletin		<h2>Remove Front Door Outer Belt Seal Stuffers</h2>	
SB-19-11-006 December 2, 2019			
Classification		Section/Group	Mobile Service
Repair Bulletin		11 - Closures	Can Perform (where permitted)
Model Year	Model	Country/Region	Version
2016 - 2018	Model X	All	All
<small>The model(s) and model year(s) listed are a general approximation of the affected VIN list. Refer to the VIN/Bulletin Tracker or Customer/Vehicle profile to determine applicability of this bulletin for a particular vehicle.</small>

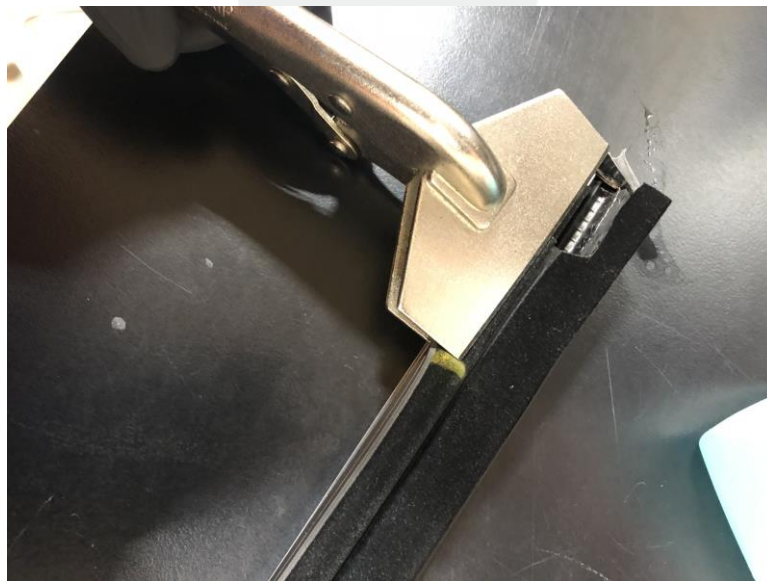
Figure 2

3. Carefully clamp the front end (Figure 1) of the outer belt seal so that an airtight seal is formed (Figure 2).

CAUTION: Do not clamp the stuffer; clamp only the rubber seal.

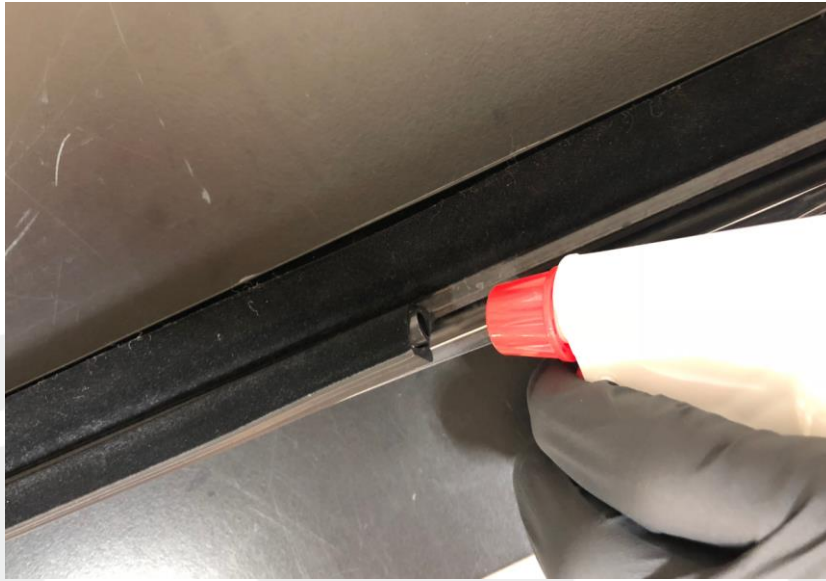
Figure 3

- Using a spray bottle, apply approximately 7 pumps of soapy water in the short stuffer at the rear end (Figure 1) of the front door outer belt seal (Figure 3).

**NOTE:** Combine Miracle Bubbles and water to create the soapy water solution.

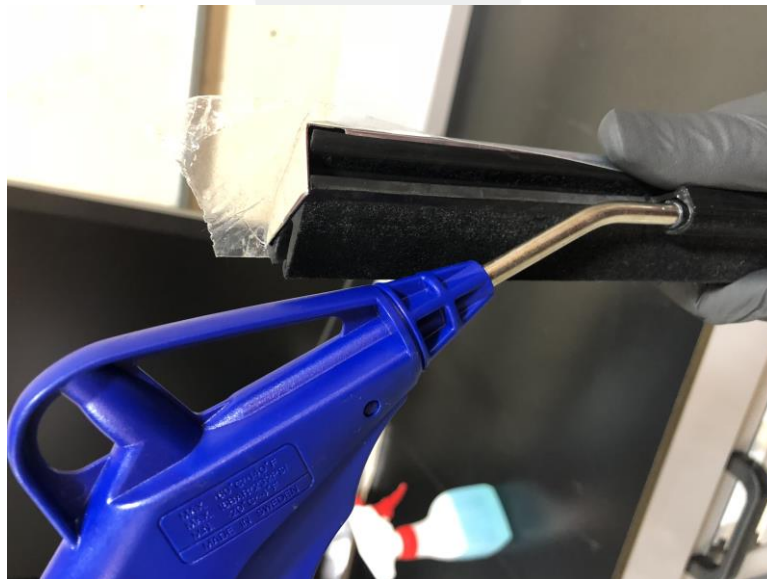
Figure 4

- Insert and wedge the tip of a shop air blowgun in the short stuffer opening (Figure 4).

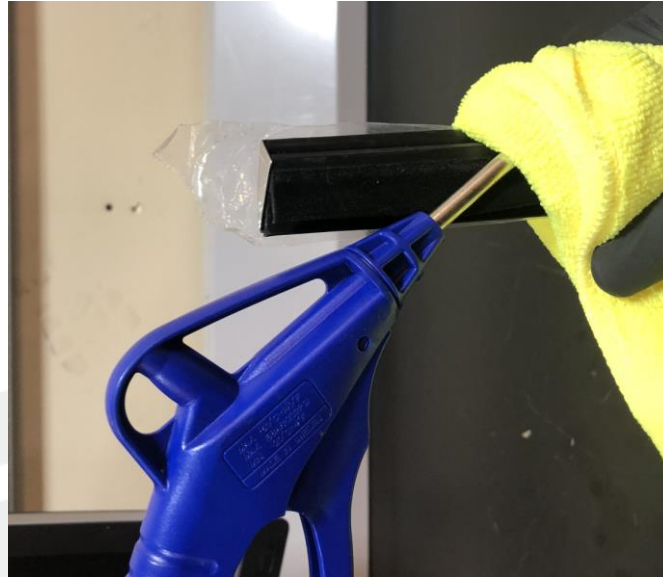
Figure 5

- Loosely wrap a shop towel around the blowgun tip to catch fluid blowback when the next step is performed (Figure 5).

- While carefully blowing shop air into the short stuffer, pull on the blowgun to remove the stuffer from the outer belt seal.

⚠ CAUTION: Do not apply maximum air pressure to the stuffer, as this might damage the outer belt seal. Carefully modulate the blowgun trigger until the stuffer can be removed.

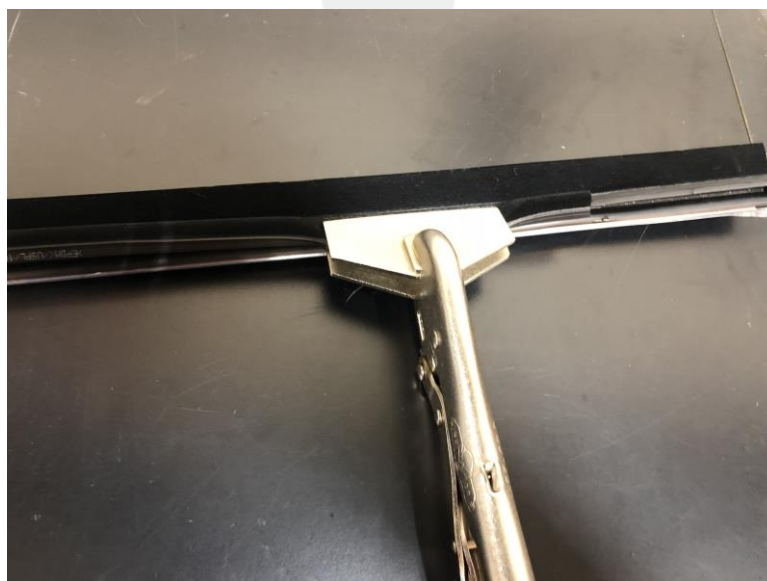
Figure 6

- Remove the stuffer from the blowgun.
- Remove the clamp from the outer belt seal.
- Carefully clamp the rear end (Figure 1) of the outer belt seal so that an airtight seal is formed (Figure 6).

- Repeat steps 4-9 on the long stuffer located at the front end (Figure 1) of the outer belt seal.
- Remove any excess fluid from the outer belt seal with a clean shop towel.
