Tesla, Inc.
Service Bulletin

Replace Tow Hitch Label

SB-19-19-006
September 13,
2019

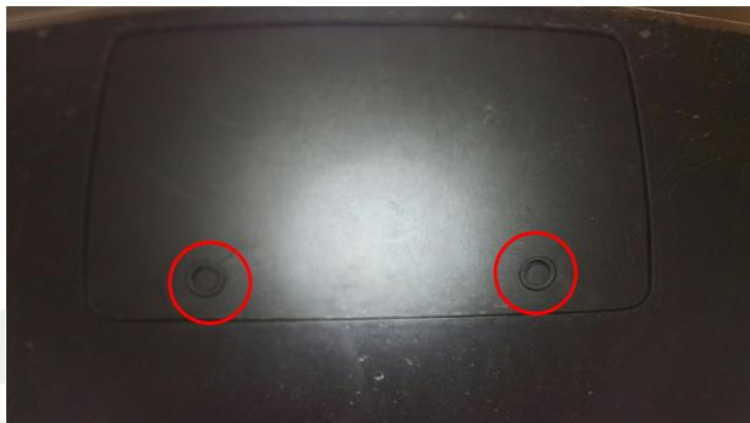
Figure 1

1. Raise the vehicle to a comfortable working height.
2. Use a clip prytool to remove the clips (x2) that attach the tow hitch cover to the rear fascia (Figure 1).

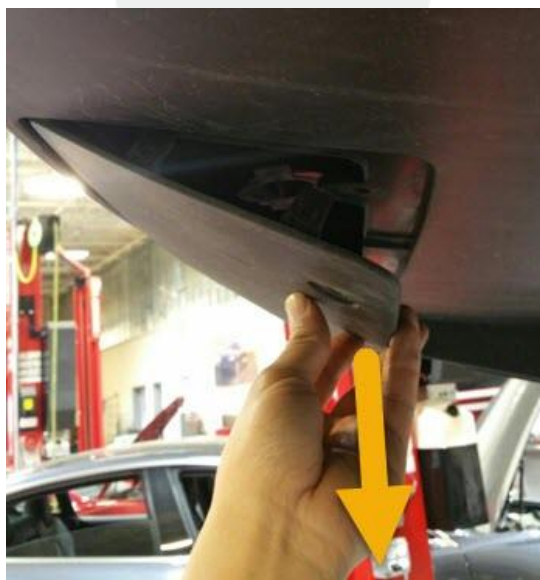
Figure 2

3. Remove the tow hitch cover from the rear fascia (Figure 2).
