| V | esla, Inc.<br>ervice Bulletin | | Replace Front Aft Links And Rear Upper<br>Links, China | | | |
| SB-20-31-007 R1 | | R1 | | | | |
| September 18, 2021 | | | | | | |

Certain Model S vehicles in China have experienced front aft link and rear upper link failures at low speeds due to a unique driving environment that causes vehicles to negotiate a severe load or repeated severe loads (e.g., hard curb impact, deep pothole strike) with greater frequency.

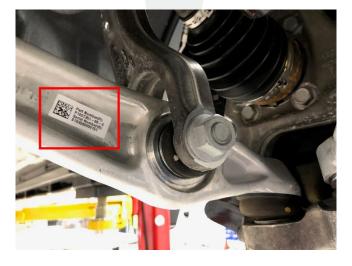
- 1. Raise the vehicle (refer to Service Manual procedure 10000205).
- 2. Inspect the part number (PN) on the LH and RH front aft links (Figure 1):

Figure 1 – LH shown, RH similar

- If a front aft link PN matches one of the following PNs, do not replace that front aft link. Take note and then continue to step 3:
  - 1027351-00-C or later
  - 1048951-00-C or later
- 3. Inspect the PN on the LH and RH rear upper links (Figure 2):

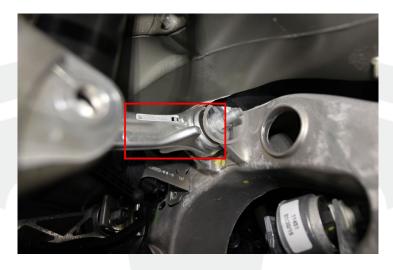
NOTE: The PN sticker might be on the upward-facing surface of the rear upper link. Use a video scope if the PN is not easily readable.

Figure 2 - LH shown, RH similar

- If a rear upper link PN is one of the following, do not replace that rear upper link. Take note and then continue to step 4:
  - 1027426-00-A or later
  - 1027421-00-C or later
  - NOTE: End this procedure if all front aft links and rear upper links do not need replacement.
- 4. If replacing at least one front aft link, continue to step 5. If not replacing any front aft links, continue to step 12.

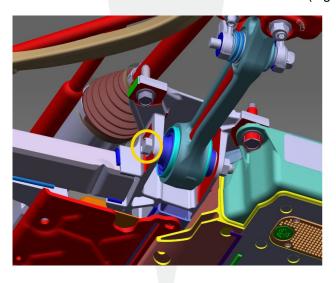
5. Inspect the bolts that attach the LH and RH front aft links to the front subframe (Figure 3).

Figure 3 – Bolt head facing away from the HV battery (LH shown, RH similar)

- If **both** bolt heads are facing away from the HV battery (Figure 3), continue to step 12.
- If only one aft link needs replacement, and the bolt head attached to that aft link is facing away from the HV battery, continue to step 12.

- If a bolt head is facing toward the HV battery, and the front aft link attached to that bolt needs replacement, continue to step 6.
  - NOTE: As an alternative to performing steps 6–11, the bolt can be cut off with an angle grinder. After all affected bolts have been cut and removed, continue to step 12.

- 17. Replace the LH and/or RH front aft links (refer to Service manual procedure 31013602).
  - NOTE: Make sure the new front aft link to subframe bolt(s) are installed with the bolt head facing away from the HV battery.
