Tesla, Inc. Service Bulletin		<i>Install 1st Row Floor Butyl Patches Due to Flexing Noise</i>	
SB-20-45-001 February 14, 2020			
Classification		Section/Group	Mobile Service
Repair Bulletin		45 - Noise, Vibration & Harshness	Can Perform (where permitted)
Model Year	Model	Country/Region	Version
2019	Model 3	United States, Canada	All
<small>The model(s) and model year(s) listed are a general approximation of the affected VIN list. Refer to the VIN/Bulletin Tracker or Customer/Vehicle profile to determine applicability of this bulletin for a particular vehicle.</small>

Condition

Some Model 3 vehicles were built without butyl patches on the LH and RH front 1st row floor panels. Consequently, the sound of normal body flexing is heard and is not dampened.

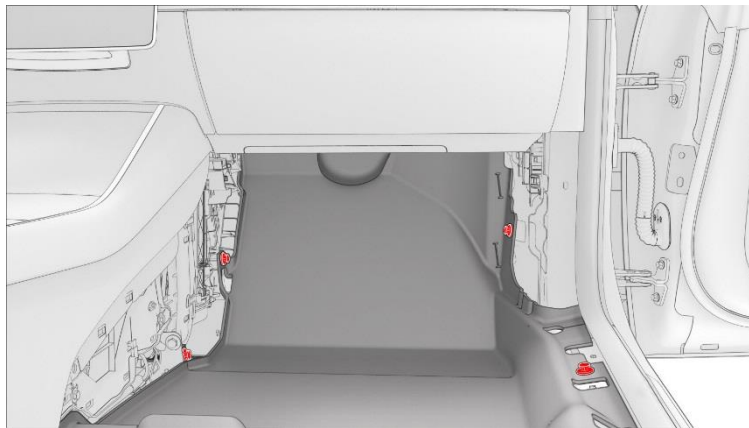
Figure 1

9. Remove the clips (x4) that attach the RH front carpet to the vehicle (Figure 1).

17. Unfold the RH front main carpet back to its original position, and then secure the seat electrical harness with clips (Figure 2).
18. Install the clips (x4) that attach the RH front carpet to the vehicle (Figure 1).

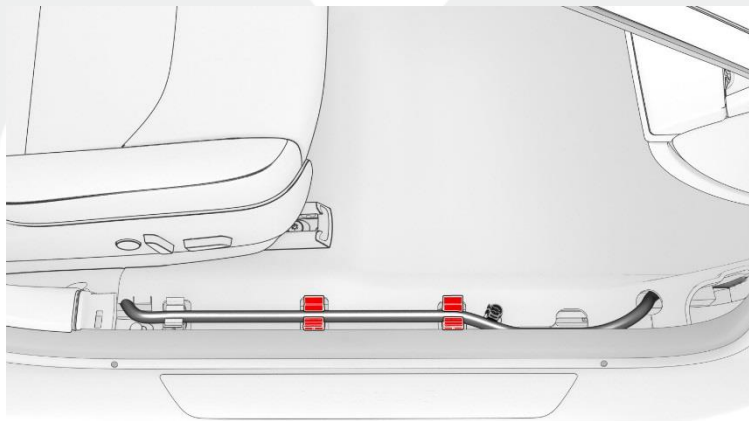
Figure 2

10. Release the seat electrical harness from the clips to allow the RH front carpet to fold back more (Figure 2).

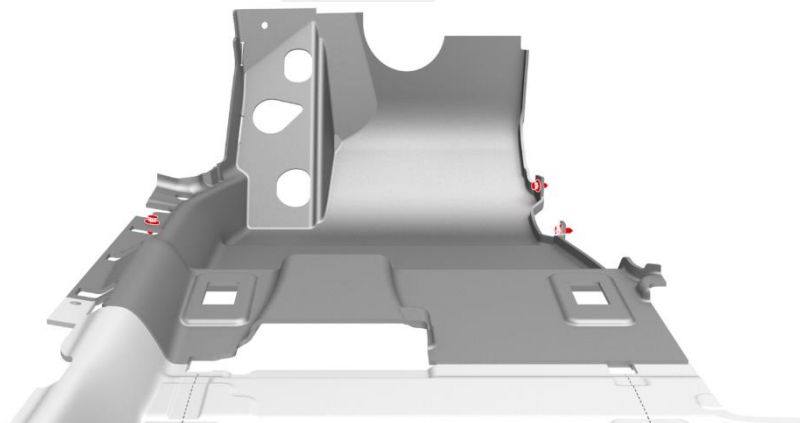
Figure 3

11. Remove the clips (x3) that attach the LH front carpet to the vehicle (Figure 3).

19. Unfold the LH front main carpet back to its original position, and then secure the seat electrical harness with clip.
20. Install the clips (x3) that attach the LH front carpet to the vehicle (Figure 3).

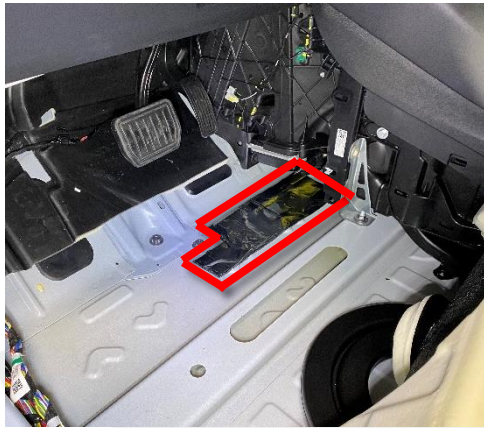
✓ Figure 4 – Butyl patch installed on LH side

- If butyl patches are already installed on the floor panels (Figures 4 and 5), there might be something else causing a similar kind of noise that is not related to this document. Continue normal diagnosis, reinstall the components that were removed for access, and discontinue this procedure.
- If butyl patches are not installed (Figures 6 and 7), continue to the next step.

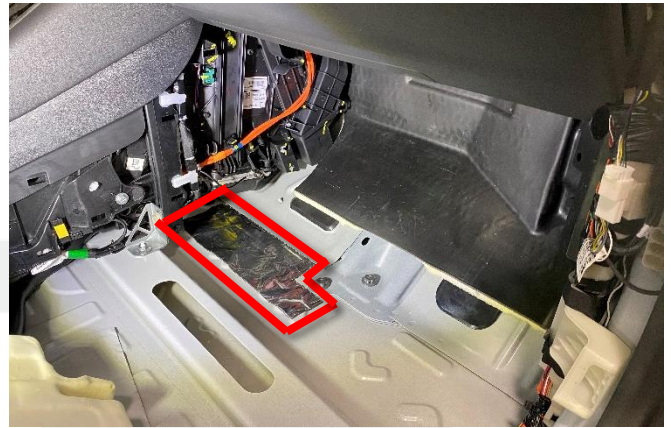
✓ Figure 5 – Butyl patch installed on RH side

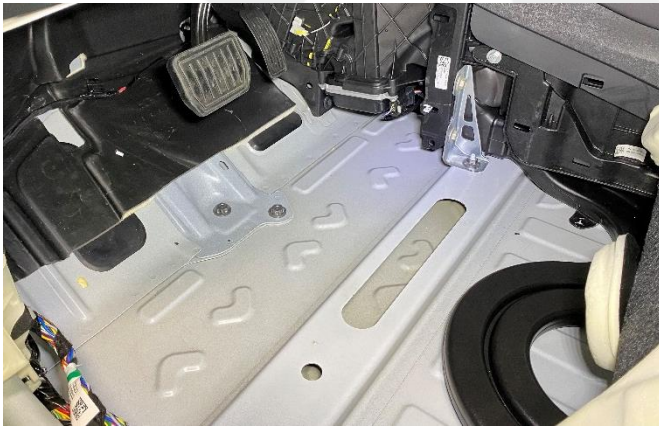
✗ Figure 6 – Butyl patch missing on LH side

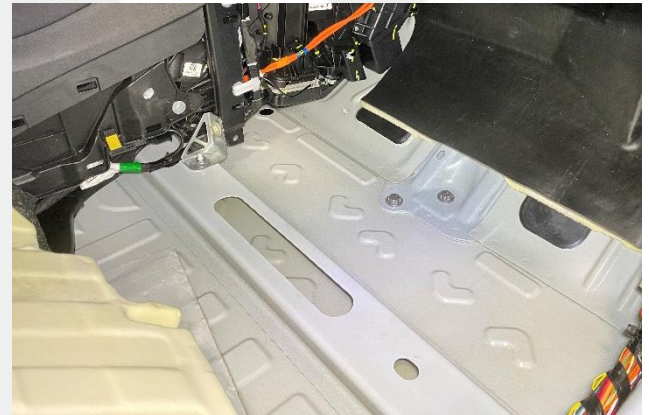
✗ Figure 7 – Butyl patch missing on RH side

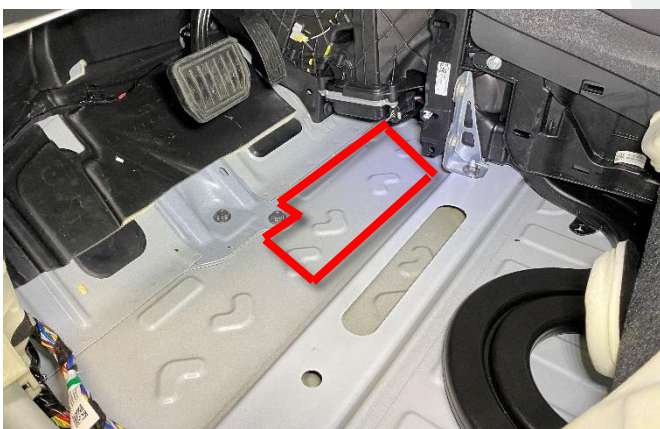
Figure 8 – LH front floor panel

14. Clean the floor panel butyl installation areas highlighted with Isopropyl Alcohol (IPA) wipes (Figures 8 and 9). Allow 1 minute for the area to dry before continuing.

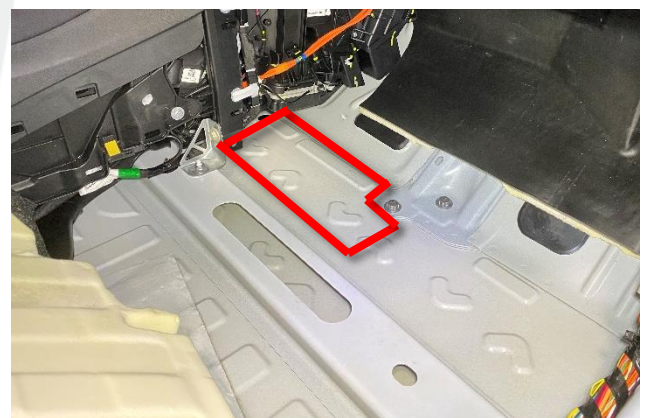
Figure 9 – RH front floor panel

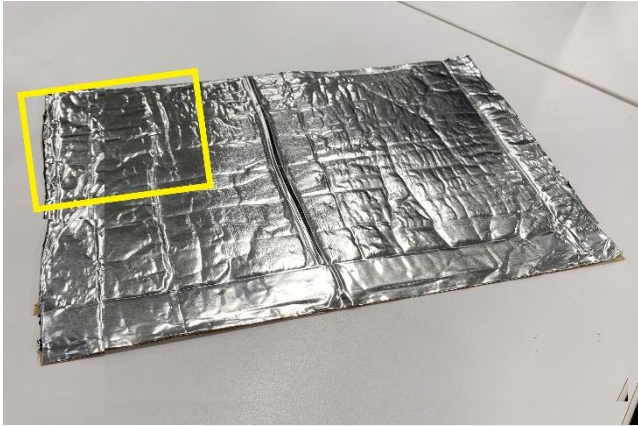
Figure 10 – RH butyl patch

15. Cut and remove a 50 mm x 50 mm square piece from the top LH corner of one butyl patch using scissors (Figure 10). Repeat this step on the other butyl patch but this time cut and remove the top RH corner (Figure 11).

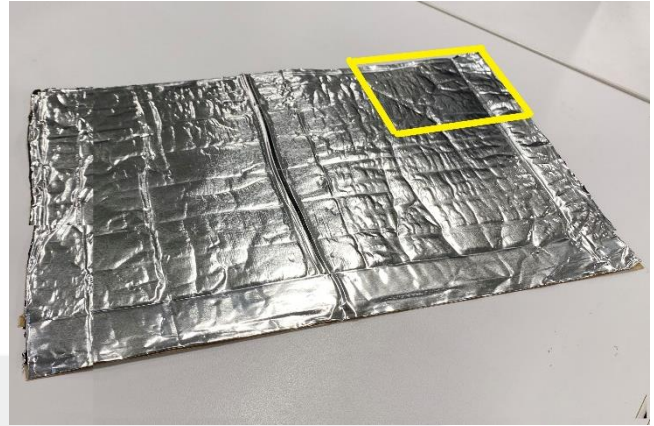
Figure 11 – LH butyl patch

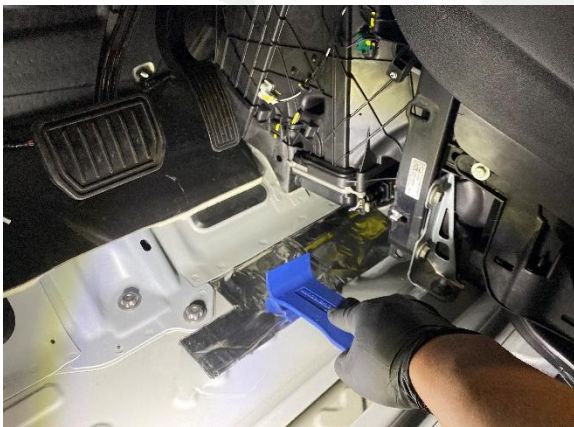
Figure 12 – LH floor panel

16. Align and then install each piece of butyl patch onto the LH and RH floor panel area as shown in Figures 12 and 13.

TIP: Use a plastic trim tool to firmly press the butyl patch onto the floor panel.

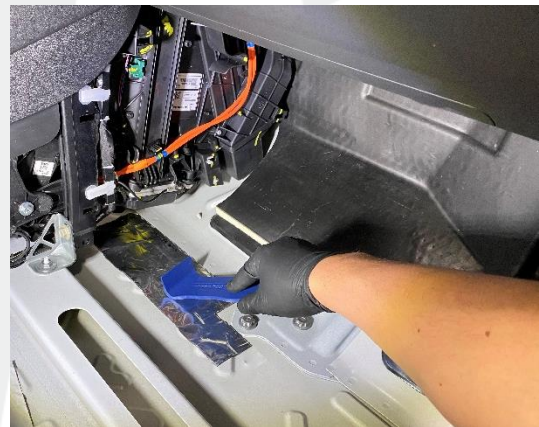
Figure 13 – RH floor panel
