Tesla, Inc. Service Bulletin		<i>Inspect Trunk Power Strut for Presence of O-ring</i>	
SB-21-11-002 October 15, 2021					
Classification		Section/Group		Mobile Service	
Campaign Bulletin		11 - Closures		Can Perform (where permitted)	
Model Year	Model	Country/Region		Version	
2021	Model 3	All		All	
The model(s) and model year(s) listed are a general approximation of the affected VIN list. Refer to the VIN/Bulletin Tracker or Customer/Vehicle profile to determine applicability of this bulletin for a particular vehicle.

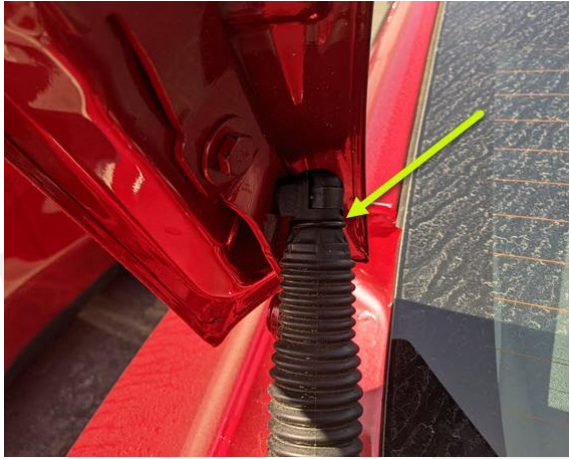
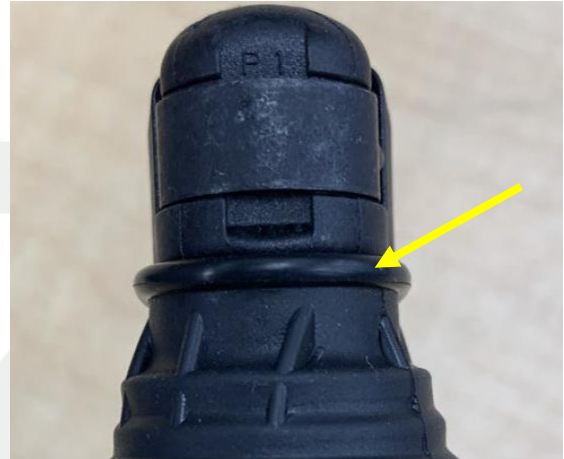
Figure 1

1. Open the trunk.
2. Inspect the LH trunk power strut for the presence of an O-ring on top of the strut bellows (Figures 1 and 2).
 - If an O-ring is present, discontinue this procedure.
 - If no O-ring is present, continue this procedure.

Certain Model 3 vehicles equipped with a power operated trunk lid may experience water ingress into the trunk power strut, eventually leading to the power strut becoming inoperative.

Inspect the LH trunk power strut for the presence of an O-ring at the top of the bellows. If no O-ring is found present, install an O-ring at the top of the trunk power strut bellows.

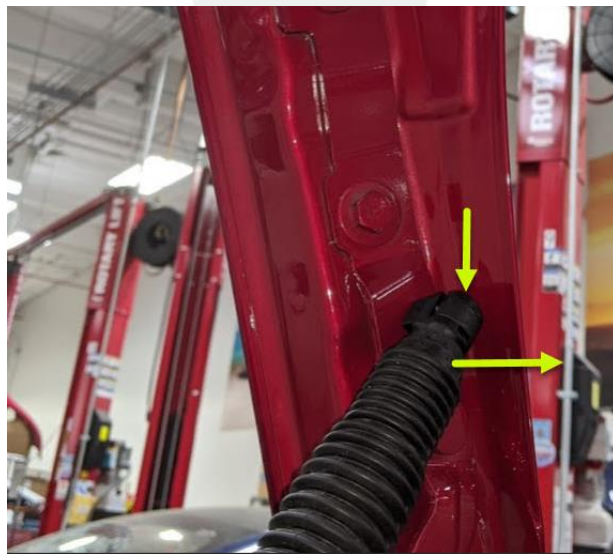
Figure 3

3. Release the C-clip that attaches the upper end of the trunk power strut to the trunk lid, and then separate the power strut from the trunk lid ball stud (Figure 3).

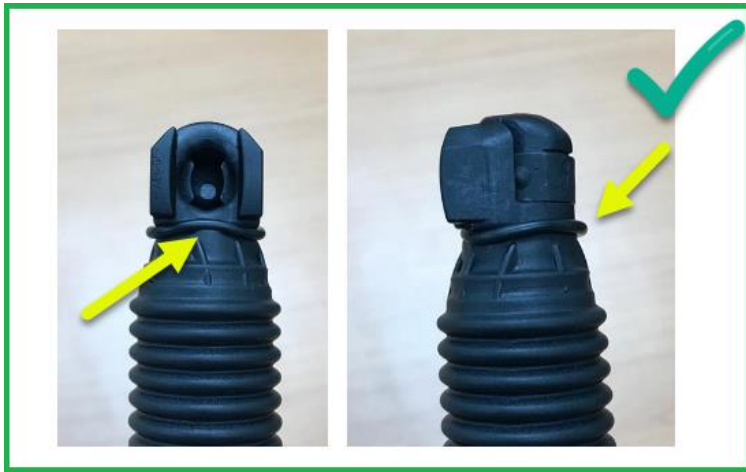
Figure 3 – O-ring seated correctly

4. Install an O-ring onto the power strut: roll the seal over the top of the power strut and fit it between the bellows and the ball stud socket (Figure 3).

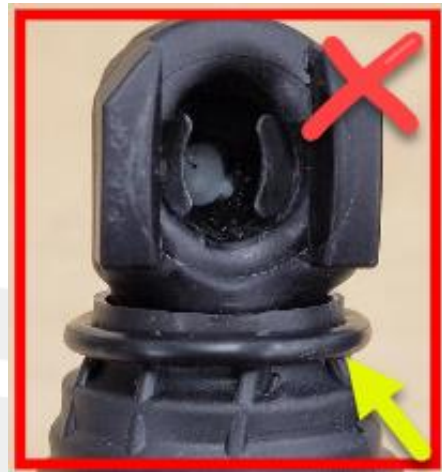
Figure 4 - O-ring seated too low

⚠ CAUTION: Do not install the O-ring over the top of the bellows (Figure 4).

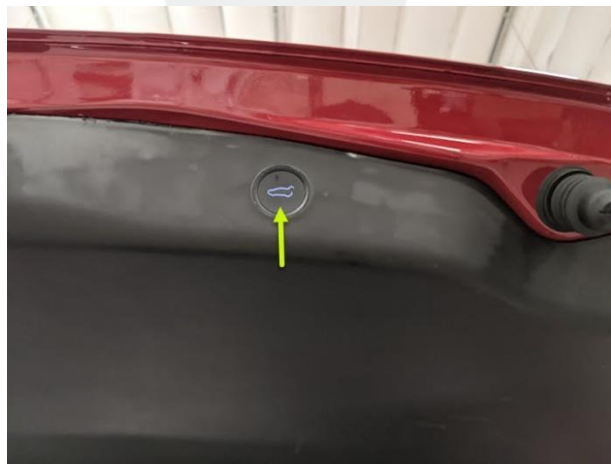
Figure 5

6. Close the power trunk from the power trunk switch (Figure 5).
