TN-19-33-001 R1 January 21, 2022

Tesla, Inc. Tech Notes
Model:	Vehicle System:	Region:
Model 3, Model Y	33 - Brakes	All

Tech Note: Brake Dust Shield Debris Removal

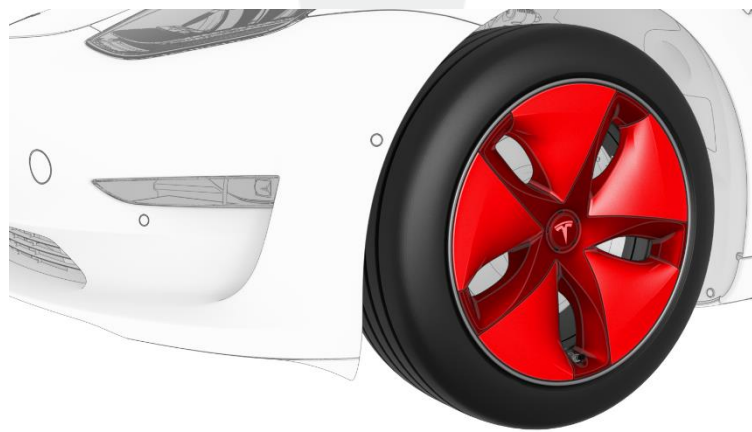
1. If aero covers (Figure 1) are installed, use both hands to carefully pull the aero cover off the affected corner(s) of the vehicle.

Figure 1 (Model 3 LH front aero cover shown; other aero covers similar)

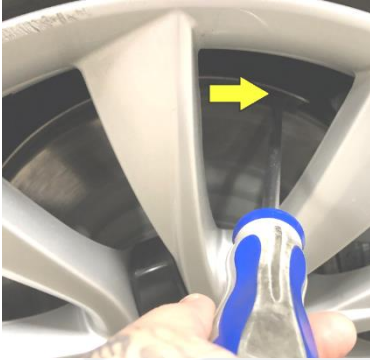
Figure 2

2. Insert a large flat head screwdriver through the wheel spokes and carefully push on the top edge of the brake dust shield (Figure 2). Repeat this action on the left/right (Figure 3) and bottom (Figure 4) edges of the shield to allow debris to fall out of the shield.

⚠ CAUTION: Do not rub the screwdriver against the wheel spokes or brake rotor.

⚠ CAUTION: Do not push too hard, as this could permanently bend the dust shield.

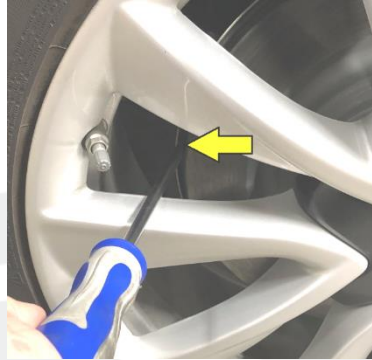
Figure 3 – also push on the right side of the shield, if necessary

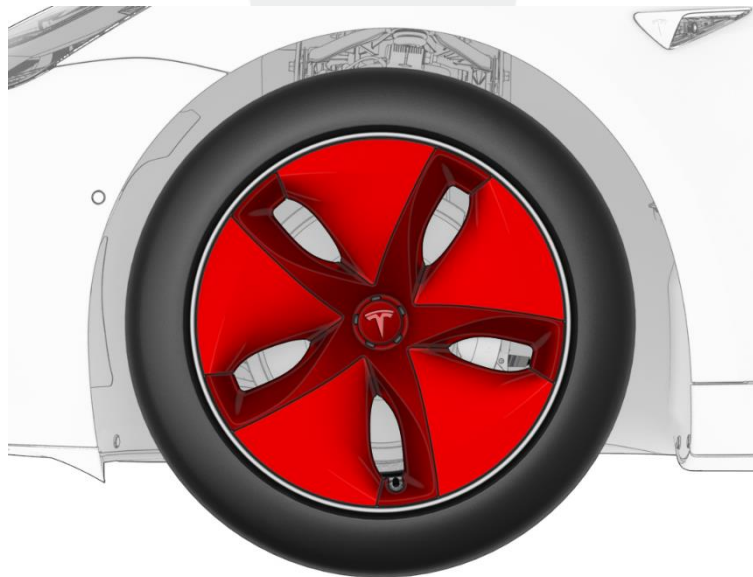
Figure 5

3. Perform step 2 on all affected brake dust shields.
4. If previously removed, position the aero cover over the wheel, and then push on the aero cover until it fully snaps into place (Figure 5). Repeat this step for all aero covers that were removed.
