Contamination Effects on the Passive Optical Sample Assembly Experiments

H. Gary Pippin,* Suzanne L. B. Woll,[†] Valerie A. Loebs,[‡] and Gail Bohnhoff-Hlavacek[§]
The Boeing Company, Seattle, Washington 98124-2499

The passive optical sample assembly I and II experiments were part of an International Space Station risk mitigation study placed on the exterior of the Mir space station. The experiment surfaces were examined postflight for the effects of contamination, atomic oxygen, solar exposure, and particulate radiation. Examination of selected Boeing specimens showed that one or more discrete contamination events distributed material over the surface of passive optical sample assembly II facing away from Mir. Detailed elemental depth profiles were produced for both passive optical sample assembly I and II experiment surfaces using x-ray photoelectron spectroscopy measurements made in conjunction with controlled ion sputtering. The depth profiles showed that the molecular contaminant layer is predominantly composed of silicon-based material. On the space-facing side of passive optical sample assembly I, the thickness of molecular contamination layer was determined to be as great

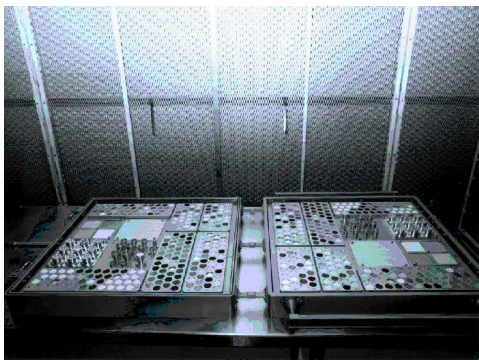
Fig. 1 POSA II, preflight (NASA photograph).

THE passive optical sample assembly (POSA) experiments were part of the Mir Environmental Effects Payload (MEEP). MEEP consisted of five experiments: the orbital debris collector (ODC), the polished plate meteoroid and debris experiment (PPMD), the POSA I and II experiments, and the passive experiment carriers (PEC) that held the four payloads. These combined experiments were an International Space Station (ISS) contamination risk mitigation experiment, flown for the purpose of assessing contamination levels around a large structure in space. Figure 1 is a preflight photograph of the POSA II experiment integrated into its PEC that shows the layout of the specimens.

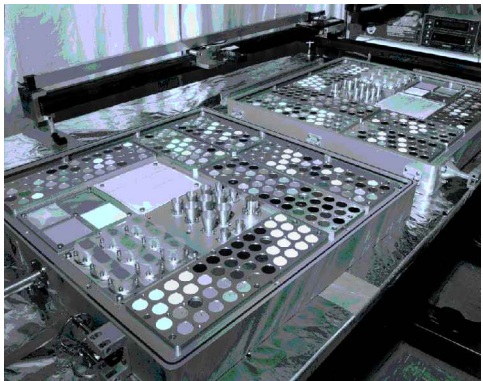
Fig. 6 POSA II, postflight (NASA photograph).

closed by an astronaut during the retrieval EVA. The MEEP payloads were placed back in the side wall containers of the space shuttle cargo bay and returned to Earth. The PEC containing POSA experiments were removed from the space shuttle at NASA Kennedy Space Center within about three days of the space shuttle return to Earth. The PEC were immediately double bagged, placed in shipping containers, and brought to NASA Marshall Space Flight Center (MSFC) for deintegration and the start of postflight examination and testing. Figures 5 and 6 are postflight photographs of the POSA I and II experiments that were taken in

the clean room at NASA MSFC immediately after the containers were opened for initial postflight inspection.

Postflight examination showed an obvious, macroscopic pattern of streaks and droplets distributed over virtually the entire space/STS-facing side of the POSA II, PPM, and ODC experiments. Further examination of the streaks of the contaminant material on POSA II indicated that the distribution had a slight fan shape with an apparent point of origin approximately 25 deg above the plane of the space/STS-facing side of POSA II along the docking module towards the STS. No line-of-sight source was obvious. The discrete contamination event (or events) is presumed to have occurred prior to deployment of the OPM near the POSA II experiment in late April 1997. OPM remained exposed on the docking module until January 1998 and had no such pattern of splattered material.

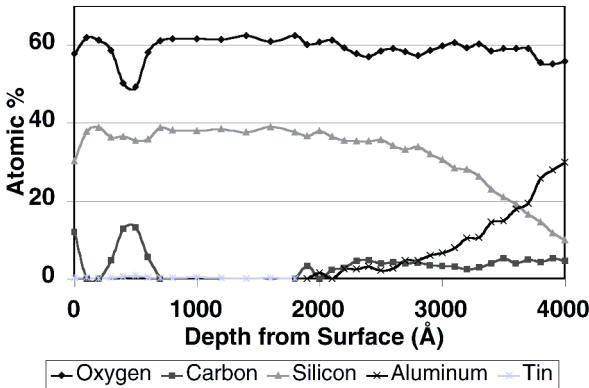
Fig. 7 SAA on 2219-T851 plate, specimen 15-23.

The detailed depth profiles for several specimens from the space-facing side of POSA I show a dip in the oxygen elemental percentage and a corresponding increase in the carbon elemental percentage at a few hundred angstroms below the surface and then again deeper in the profile. These profiles also show very thick depositions of silicone-based contaminant. The depth profile for specimen 15-23 that exhibits these features is shown in Fig. 7.

It is believed that the arrival rate of silicone to the POSA I surface was so great during this time period that the atomic oxygen flux was not sufficient to oxidize all of the silicone to silicate. In support of this theory, it is known that there were three times during the

POSA exposure period that the Mir went into a 100% sun orbit. The surface warming during these times would have increased the silicone outgassing rate from a nearby stowed solar array panel. This solar array panel had a direct line-of-sight view to the space-facing side of POSA I. In addition, large increases in the deposition rate were observed by OPM during the 100% sun exposure orbits in June 1997.
