Benefits of Surface Coatings for Impacted Composites for Cryogenic Tankage

Benjamin C. Findley* and W. S. Johnson†
Georgia Institute of Technology, Atlanta, Georgia 30332-0245

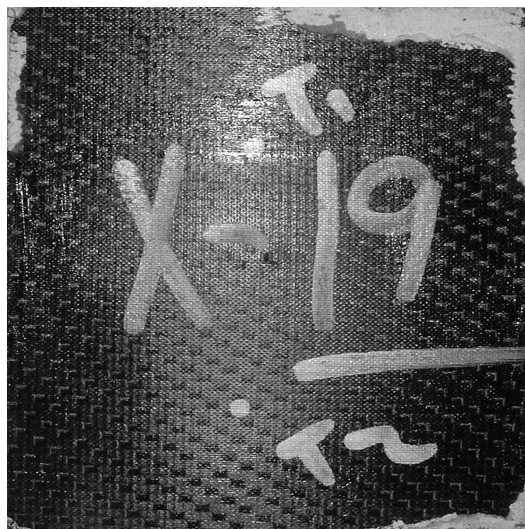
Fig. 3 Moisture-cured aliphatic polyurethane-coated specimen impacted at 4.35 ft · lb (5.90 J): a) indentation in front side of specimen, b) back of specimen, and c) closeup of damage on back of specimen.

It was expected that through the application of polymeric coatings the impact resistance would be improved. Damage would still occur in the composite, but the coatings are sufficiently ductile to remain intact even when the composite cracked, thus eliminating any leakage. On inspection of the impacted specimens, it became clear that the coatings significantly reduced the amount of damage that formed in the composite. Some of the reduction in damage is certainly due to impact energy being dissipated through elastic deformation of the coating, but it is also possible that just by increasing the cross section of the composite slightly the flexural properties change. Figures 3 and 4 show two specimens that were impacted at the same energy. The specimen in Fig. 3 was coated with the moisture cured aliphatic polyurethane, whereas the specimen in Fig. 4 was not coated at all.

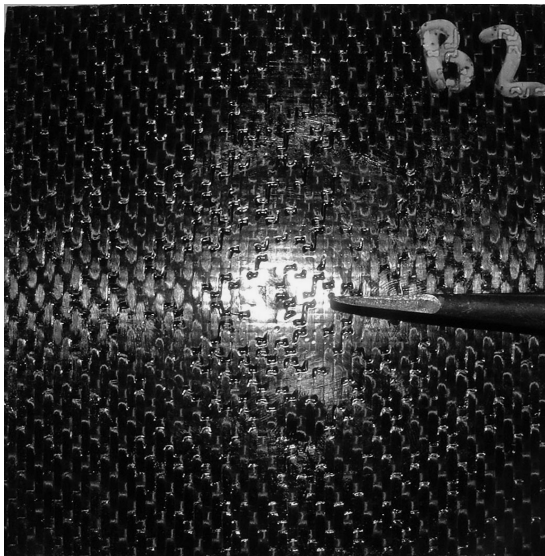
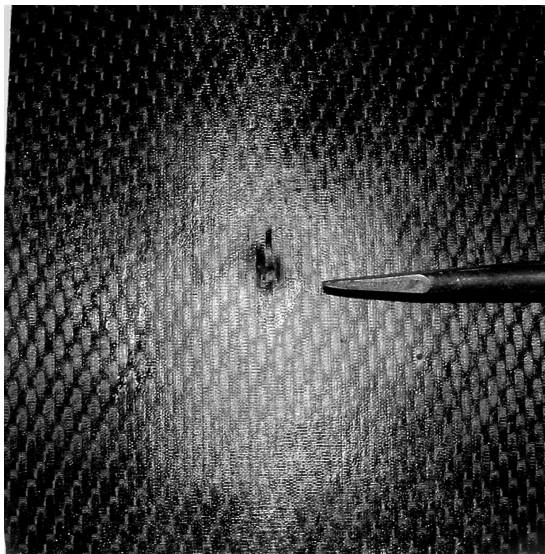
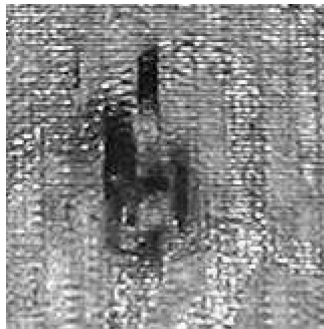
Fig. 4 Uncoated specimen impacted at 4.35 ft · lb (5.90 J): a) front of specimen, b) back of specimen, and c) closeup of damage on back of specimen.

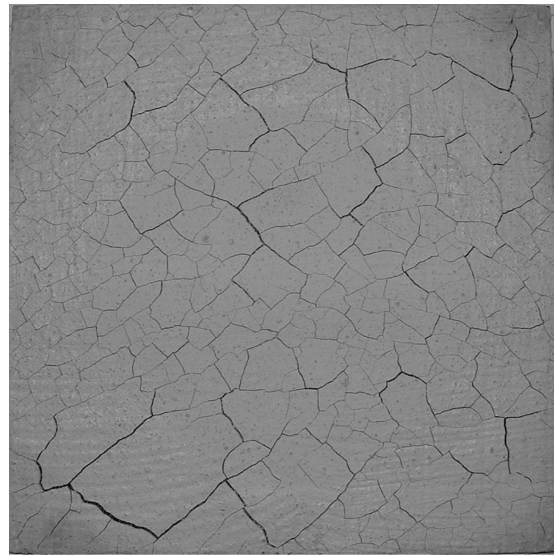
Fig. 5 Thermoplastic-coated specimen after two complete thermal cycles.

Two specimens coated with each material, all initially with leaks, were put through five thermal cycles (ranging from 77 to 394 K). After only two cycles, the thermoplastic coating had completely failed. It had extensive cracking over the entire surface area and also was actually peeling away from the composite substrate. Figure 5 shows the thermoplastic specimen after two thermal cycles.

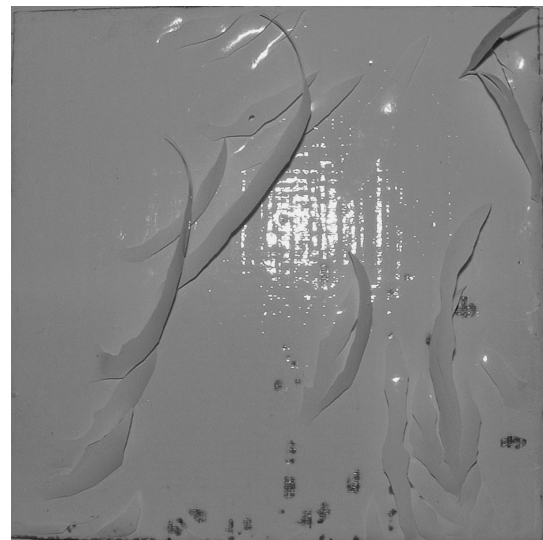
Fig. 6 Polyester aliphatic urethane-coated specimen after three thermal cycles.

The polyester aliphatic urethane coated specimens did not perform much better. After only three thermal cycles, the topcoat of the urethane had almost completely delaminated from the base coat. This phenomenon is shown in Fig. 6.

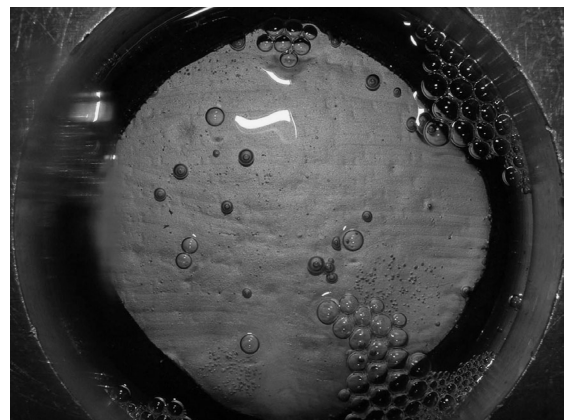
Fig. 7 Specimen coated with the polyurethane with MIO–Al particles being leak tested after thermal cycling.

Despite what Kessler et al.,² Nettles,⁷ and others have found, damage appeared to form in the carbon/epoxy composite at temperatures above 60 K. Both of the specimens coated with the polyurethane with MIO-Al particles initially only had three leaks; yet after thermal cycling, many more leaks were found. This suggests that damage actually initiated throughout the material. Figure 7 shows a specimen coated with the polyurethane with MIO-Al particles being leak tested after thermal cycling. The bubbles are different leaks.
