Surface Step Induced Gap Heating in the Shuttle Thermal Protection System

D. H. Petley,* D. M. Smith,† C. L. W. Edwards,† A. B. Carlson,* and H. H. Hamilton II*
NASA Langley Research Center, Hampton, Virginia

An analytical study has been performed to investigate the excessive heating in the tile-to-tile gaps of the Shuttle Orbiter Thermal Protection System due to stepped tiles. The excessive heating was evidenced by visible discoloration and charring of the filler bar and strain isolation pad that is used in the attachment of tiles to the aluminum substrate. Two tile locations on the Shuttle Orbiter were considered: one on the lower surface of the fuselage and one on the lower surface of the wing. The gap heating analysis involved the calculation of external and internal gas pressures and temperatures, internal mass flow rates, and the transient thermal response of the Thermal Protection System. The results of the analysis are presented for the fuselage and wing location for several step heights.

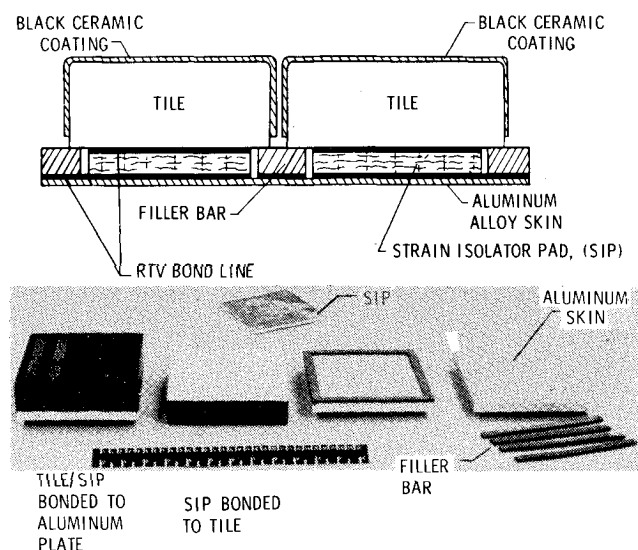
Fig. 1 Tile configuration on lower surface of Orbiter.

THE Shuttle Orbiter Vehicle 102 (Columbia) has flown five orbital missions successfully. The Thermal Protection System (TPS) on the Orbiter exterior¹ performed satisfactorily although damage was observed on random individual tiles on the lower fuselage and lower surfaces of the wings after each flight. The TPS at these locations (Fig. 1) consists of silica tiles typically 6×6 in.² and of variable thickness depending on their location on the Orbiter. The tiles are bonded to the aluminum skin of the Orbiter through a strain isolation pad (SIP). The tiles have gaps between them to allow for differential thermal expansion between the tiles and substrate. A nylon fiber filler bar, that has a silicone rubber membrane on its top surface, is directly beneath the tile-to-tile gaps. The filler bar is bonded to the aluminum skin but not to

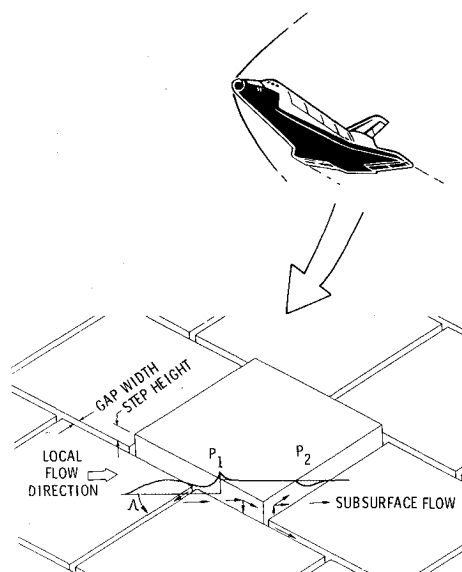
The probable cause of damage to the filler bar is shown in Fig. 2. A tile with a forward-facing step causes a local pressure disturbance in the external boundary layer. The flow tends to stagnate on the forward face directly over the tile-to-tile gap. Similarly, the aft-facing step creates a low-pressure region as the flow leaves the surface of the stepped tile and reattaches downstream. This combination of pressures around a stepped tile causes flow in the tile gaps that would not exist if all tiles were at the same height. The objective of the analytical study was to define the conditions under which a stepped tile could result in damage to the filler bar. To define these conditions, an analysis involving five phases of study was completed. The phases of study were: 1) definition of the local freestream conditions on the lower surface of the wing and fuselage; 2) development of a technique for predicting the distribution and magnitude of the pressure disturbance caused by a stepped tile; 3) predicting the temperature of the gases which enter the tile-to-tile gap from the external boundary layer as a result of the stepped tile;

Fig. 2 Local pressure disturbances caused by a stepped tile.

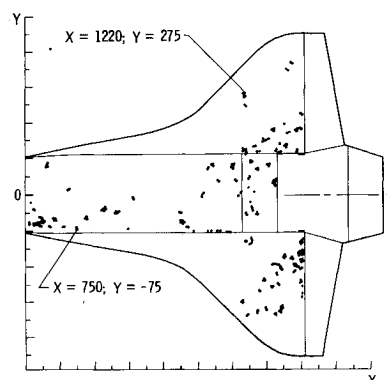
Two locations, one on the lower surface of the fuselage and one on the lower surface of the left wing, were selected for analysis from the regions where damaged filler bar was observed (Fig. 3). The location on the fuselage was selected because local flow conditions during entry can be predicted accurately for this position, flight measurements of pressure and temperature are available, and the boundary-layer thickness will be large since the point is about 40 ft from the nose of the Orbiter. The wing location was selected for the same reasons, except in this case the boundary layer will be relatively thin since the point is about 8 ft aft of the local leading edge. These are 6 × 6 in. tiles with thicknesses of 1.41 in. at the fuselage location and 2.25 in. at the wing location.

Fig. 3 STS-1 Orbiter lower surface, charred filler bar locations for analysis.

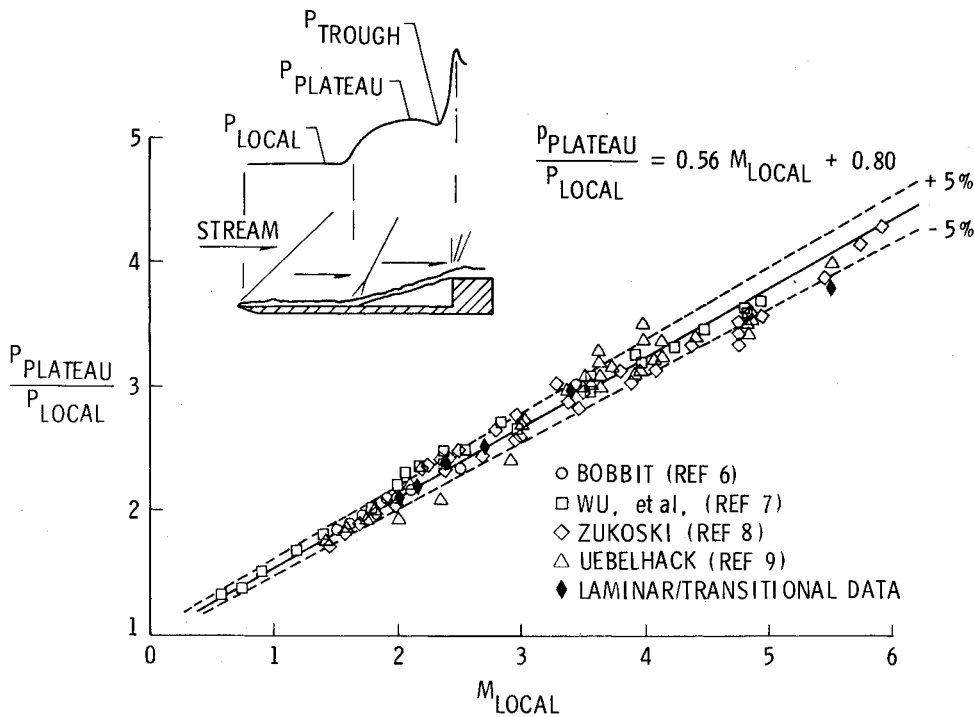
The characteristic shape of the pressure disturbance caused by a forward-facing step in supersonic flow is shown in Fig. 4. The step height needed to cause this disturbance is equal to or greater than the boundary-layer thickness for laminar flow and equal to or greater than 1.5 times the displacement thickness for turbulent flow. The step causes the boundary layer to separate locally from the body forward of the step. In addition, an oblique shock is formed at the point of separation. The pressure behind the shock is called the plateau pressure, P_{plateau} , in Fig. 4. There is a final peak pressure at the face of the step as the flow stagnates. The figure is a plot of $P_{\text{plateau}}/P_{\text{local}}$ vs Mach number from test data reported in Ref. 6 and experimental results reported in the literature.^{7,9} The data are directly applicable to the lower surface of the Orbiter since the local Mach number behind the bow shock ranges from 2.5 to 3.75 during the high aerodynamic heating period of entry. The equation for a straight line correlates the data very well, as shown in the figure.

Fig. 4 Plateau pressure correlation.

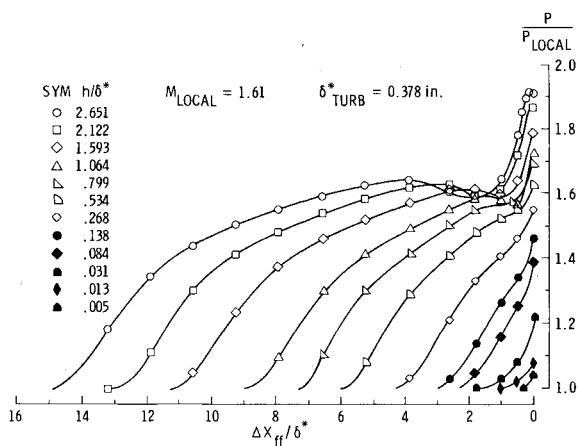
Fig. 5 Experimental pressure data for forward-facing steps.

Tile step heights considered in the analyses were 0.12 in. maximum in accordance with measured tile steps after the first flight. Therefore, forward-facing steps in the tiles were submerged deeply in the boundary layer and do not cause the severe pressure disturbances shown in Fig. 4. Figure 5 shows experimental data pressure distribution vs separation distance for various step heights. The face of the step is at $\Delta X_{ff}/\delta^* = 0$ in the figure. The shaded symbols indicate data that is in the range of step height-to-displacement thickness ratios that apply for the filler bar analysis. A significant feature of the plots in Fig. 5 is the similarity of the curves as step height is decreased. The characteristic shape of the pressure distribution for a large forward-facing step ($h/\delta^* = 1.5$) can be used to obtain the pressure distribution for a smaller step height by using the lower portion of the curve starting at the point of separation and scaling the peak pressures as a function of h/δ^* . A correlation technique was developed to obtain pressure disturbance distributions for small step heights at various Mach numbers between 2.35 and 3.85 based on the

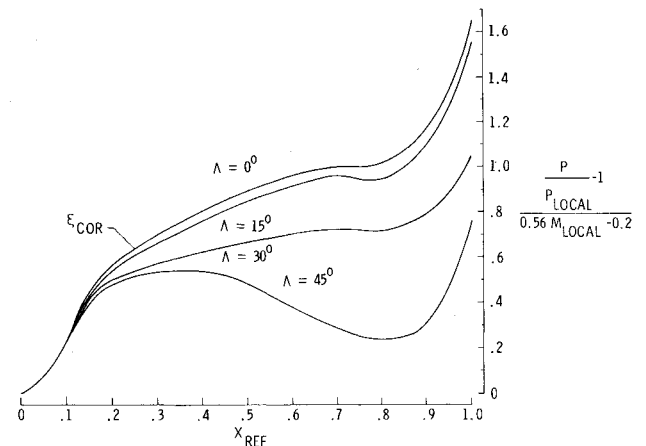
Fig. 7 Pressure distributions ahead of unswept and swept forward-facing steps.

The effect of sweep angle on the pressure distribution in front of a forward-facing step was taken into account using data from Ref. 11 (Fig. 7). The forward face of a stepped tile was assumed to be swept 45 deg with respect to the local flow. Base pressure predictions on the aft-facing steps were based on data from Ref. 12 (Fig. 8). The exponent n in the definition of characteristic length for the Reynolds number was empirically determined to be 0.9 in the reference.

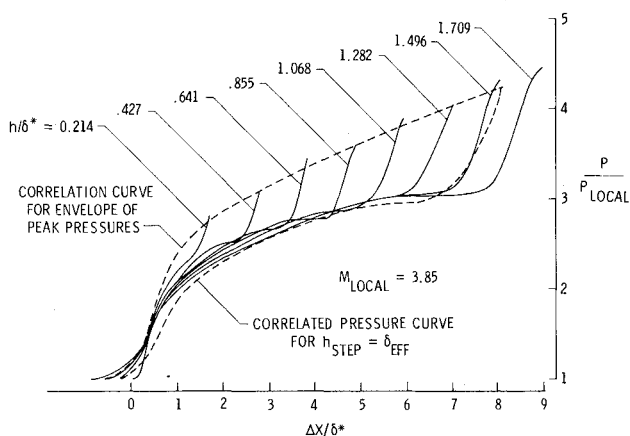
Fig. 6 Comparison of correlation and experimental pressure profile data.

experimental data previously referenced. Figure 6 shows the result of the correlation technique being applied at $M=3.85$. The pressure distribution curves are plotted as a function of the nondimensionalized separation distance. The separation point is at $\Delta x/\delta^* = 0$. The lower dashed curve is the correlated pressure curve for the step height that is 1.5 times the displacement thickness of the turbulent boundary layer ($\delta_{\text{eff}} = 1.5\delta^*$). It has the characteristic shape of a pressure disturbance that has an oblique shock at the separation point shown previously in Fig. 4. The top dashed curve envelopes the peak pressures for various step heights. For the filler bar analyses, the pressure disturbances were obtained by using the lower dashed curve from the point of separation to an appropriate point and then fairing a distribution to the enveloping curve for the step height of interest. Details of the development of the correlation technique can be found in Ref. 10.
