Results of Apparent Atomic Oxygen Reactions with Spacecraft Materials During Shuttle Flight STS-41G

An experimental package (ACOMEX) flown on Shuttle mission STS-41G was designed to investigate the effect of atomic oxygen in Shuttle (low Earth) orbit on polymeric-based spacecraft materials. The experiment included specimens of advanced composite materials, i.e., carbon-epoxy and Kevlar®-epoxy both with and without protective coatings, in addition to a number of thermal protective paints and films. These materials specimens were attached directly to the lower arm boom of the Shuttle Remote Manipulator System (SRMS) and positioned normal to, and in the direction of, flight for a total of approximately 38 h of equivalent normal exposure at 225 km altitude. In addition, a carbon-coated atomic oxygen fluence monitor together with a photographic record obtained by the Canadian payload specialist onboard provided detailed information on the environment experienced by the exposed specimens. The present paper describes the effect of atomic oxygen interaction experienced by the exposed specimens. Mass loss measurements together with high-resolution Scanning Electron Microscope photomicrogra

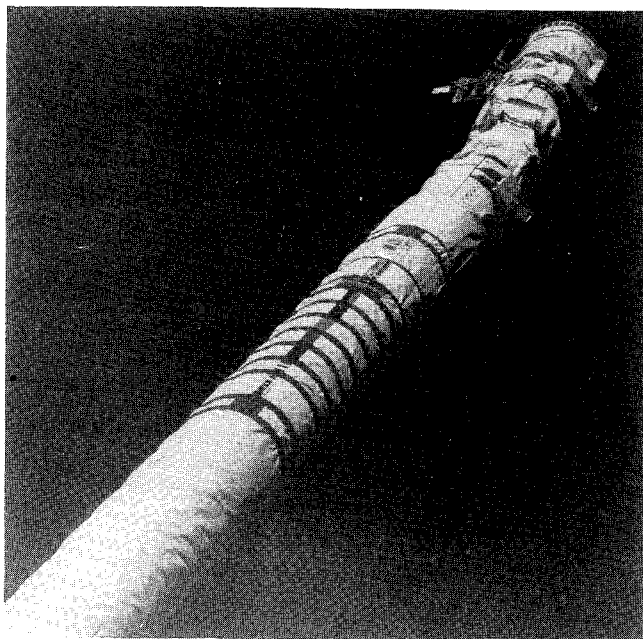
Fig. 3 ACOMEX specimens mounted on Canadarm.

The specimens were mounted directly to the thermal blankets of the lower arm boom of the Canadarm as shown in Fig. 3, by means of both transfer adhesive on the back of each and circumferential bands of Kapton tape. During the mission, the

Canadarm was positioned over the port wing to expose the specimens normal to the direction of the flight velocity vector in order to achieve the greatest effect. The arm was to remain in this position for up to 30 h to accumulate a total fluence of approximately 2×10^{20} atoms/cm². Unfortunately, operational restrictions onboard the Shuttle, due to equipment malfunction of the flash evaporator system, required periodic water dumps from the side water dump nozzle. Because of past problems on STS-41D with ice buildup after this procedure, the Remote Manipulator System (RMS) was repositioned for each water dump (approximately every 12 h) to inspect the side water dump nozzle. Together with other RMS maneuvers, this had the disadvantage of providing off-normal exposure of the specimens but was beneficial in that it allowed the specimens to be closely inspected by the Canadian payload specialist on board. During the mission, the Canadian payload specialist was scheduled to provide a photographic record of the material specimens in order to monitor the rate of change with time and accumulated fluence, as recorded by the carbon-coated fluence monitor and the Kapton film.

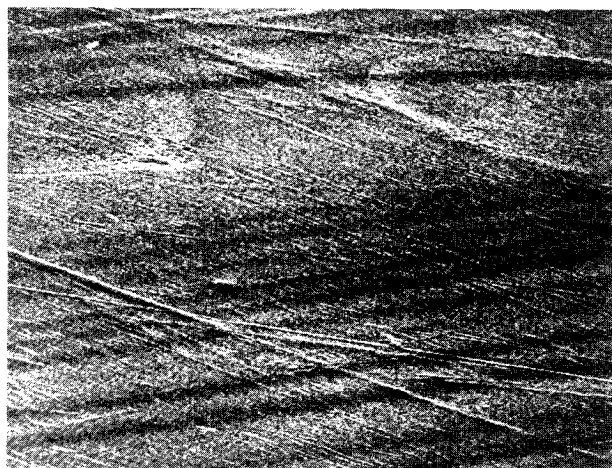
Fig. 4 Control carbon-epoxy specimen (500X).

Detailed analysis of the material specimens confirmed the magnitude of the changes observed visually. The surface of carbon-epoxy specimens before exposure was smooth and glossy with only superficial scratches as shown in the Scanning Electron Microscope (SEM) photomicrograph of Fig. 4. Although it is possible to identify the fiber direction of the upper layer in this figure, the fiber features, covered by a layer of epoxy matrix, are not distinct. After exposure in space, the surface resembled a "corduroy" pattern as shown in the SEM photomicrograph in Fig. 5. The depth of this erosion is approximately 5 μ m, which corresponds to a reactivity of 2×10^{-24} cm³/atom for the epoxy matrix.

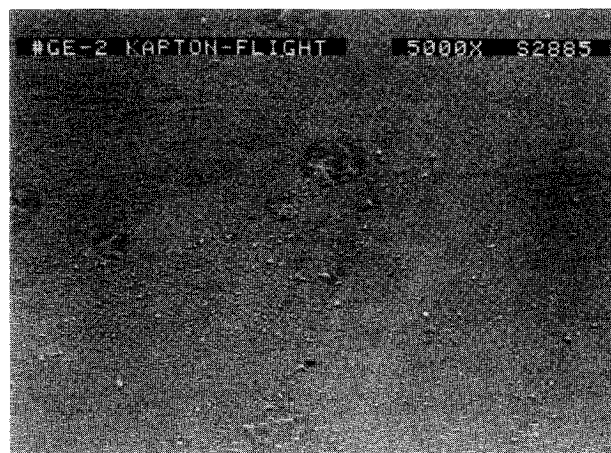
Fig. 10 Exposed Kapton (circa 1969) specimen (5000X).

Although the "old" Kapton (circa 1969) exhibited a similar preflight appearance to "new" Kapton as shown in Fig. 9, after flight the specimen showed a marked decrease in surface roughness compared to "new" Kapton as shown in Fig. 10. In addition, draw lines from the manufacturing process are still

visible indicating that the depth of erosion was small. Subsequent investigation⁵ with the manufacturer suggested that a manufacturing process change incorporated in the late 1960's may be the cause of the different resistance. The previous manufacturing process included a heat treatment to passivate the surfaces and to alter surface tension properties. This treatment was subsequently eliminated because the primary use had changed from electronics to aerospace applications. This possibility warrants further investigation as a possible approach to increasing the erosion resistance of this important thermal control material for spacecraft.

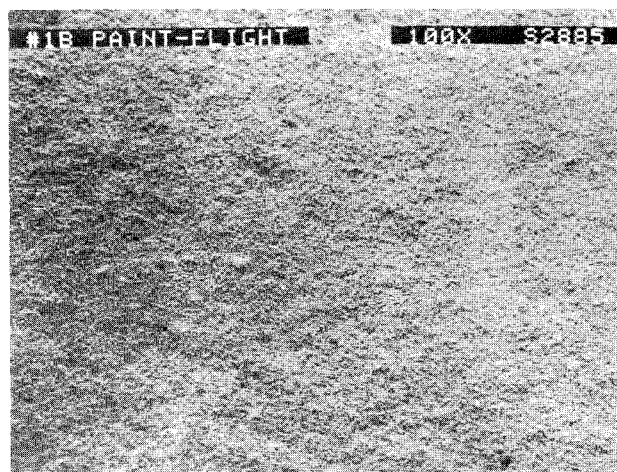
Fig. 20 Exposed Bostic 463-14 paint.

The Galileo thermal control coating specimens that were exposed on ACOMEX represented the few remaining Galileo materials that needed to be "qualified" for atomic oxygen exposure particular to that mission. Fig. 15 shows the SEM appearance of the pre-exposed sample of sputtered ITO/Sheldahl black polyester/Kapton. Fig. 16 shows the effects of flight exposure. Although microcracking had apparently been induced by the exposure to the ambient environment, post-flight testing indicated that the material had remained intact, i.e., did not create particulates from sloughing and had retained its surface conductivity. It is interesting to note that the vacuum-deposited ITO-coated specimens reacted in the exact same manner as the specimen with the spluttered coating even though the stoichiometry was different. Figs. 17-22 show the before and after condition of the remaining Galileo materials exposed in ACOMEX. Of particular interest was the complete lack of attack on the GE-PD-224 coating.

isotope Thermoelectric Generators. If these surfaces become more diffuse with time, the result would increase the operating temperature of these critical power sources where a margin of 10°C⁷ had been established for the operating temperatures. Both the modified Bostic and Chemglaze coatings reacted as expected and pose no threat to the Galileo mission. Results of thermal properties analysis for the Galileo thermal control coatings before and after exposure are shown in Table 1.
