Evaluation of Damage Fields Near Crack Tips in a Composite Solid Propellant

C. T. Liu*

Astronautics Laboratory (AFSC), Edwards Air Force Base, California 93523

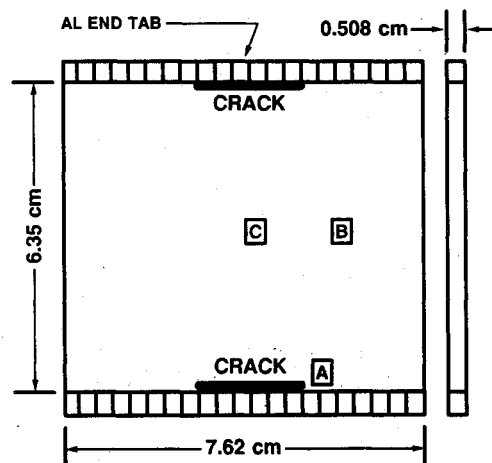
Fig. 1 Specimen geometry.

The effect of cyclic loading on damage characteristics in a composite solid propellant was investigated using precracked specimen. The geometry of the precracked specimen containing two 2.54-cm (1.0 in.) cracks is shown in Fig. 1. The cyclic loading is schematically shown in Fig. 2.

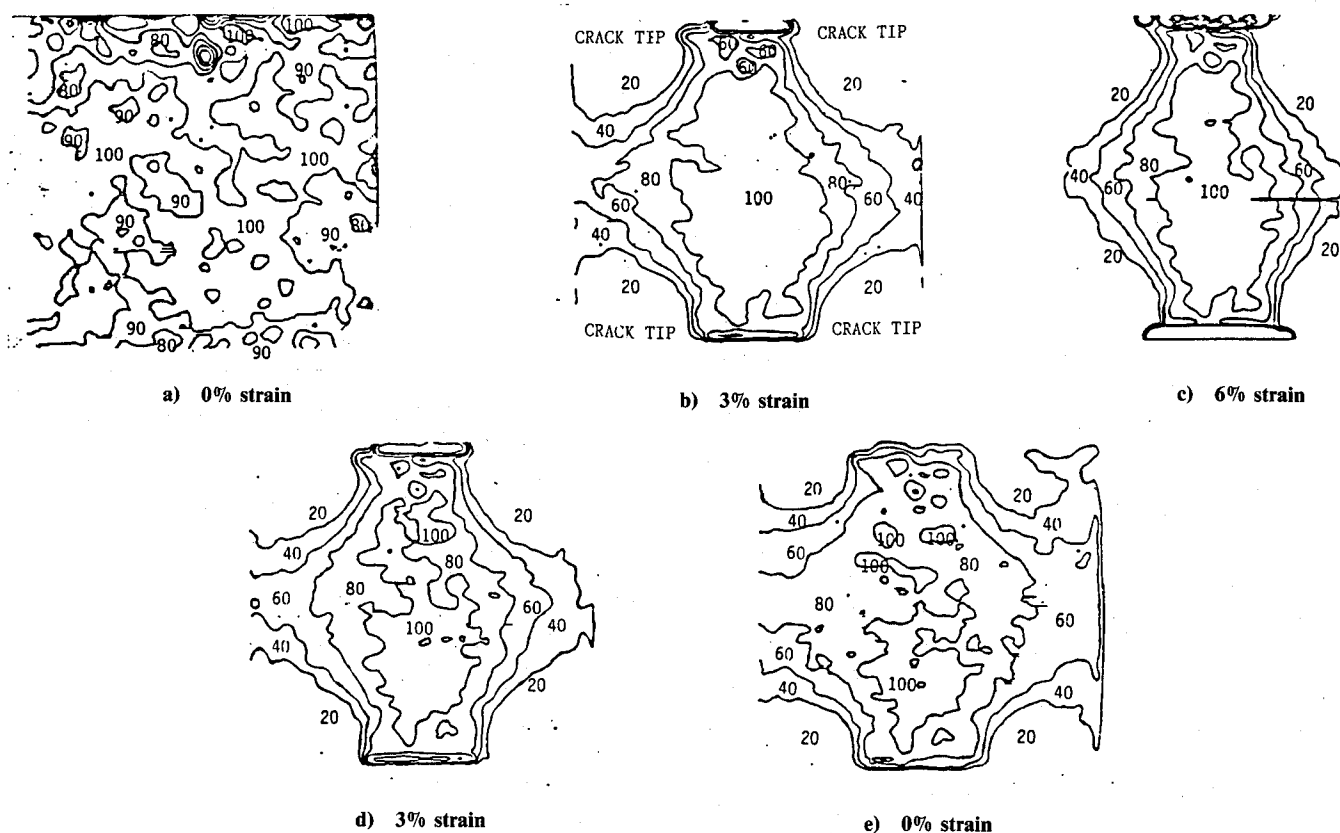
Fig. 5 Iso-intensity contour plots of acoustic images of the propellant specimen (first strain cycle).

Plots of iso-intensity contours of I_t as a function of the applied global strain are shown in Fig. 5. In Fig. 5, the number between two contour lines is the range of I_t between the prior and the next intensity levels. The small number indicates that the intensity of the transmitted acoustic energy is low, or the damage level is high. These contour plots reveal that the size of the damage zone and the intensity of damage in the damage zone increases as the strain level is increased. According to Fig. 5b, the degree of damage in the center of the specimen, or region I, is relatively low, and the shape of the iso-intensity contours of I_t , or the shape of the damage zones, is similar to the iso-strain contours shown in Fig. 4. This implies that the damage distribution is roughly commensurate with the strain distribution in the specimen. It is interesting to note that the increase in strain from 3 to 6% produces a negligible effect on the damage intensity and damage zone size in the center region of the specimen. It should be pointed out that, because of acoustic noise, the size of the apparent crack, as shown in Fig. 5, is relatively larger than the actual crack.

When the specimen is unloaded from 6 to 0%, the experimental results, shown in Figs. 5d and 5e, reveal that the damage zone size and the intensity of damage decrease as the applied strain is reduced. A comparison of Fig. 5a with Fig. 5e shows that extensive damage developed near the crack tip region during the first strain cycle; the existence of the damaged regions indicates that, although the applied strain is zero at the end of the first strain cycle, the local microstrain is not zero. The existence of tensile residual strain will prevent the microvoids and microcracks, generated by the previously applied strains, from closing in spite of the existence of a compressive residual stress field at the crack tip region. Experimental findings reported by Ronay⁵ reveal that, after the applied strain was released, both longitudinal and transverse residual strains were developed near a circular cutout on the surface of a specimen made of an inert solid propellant. It was found that a relatively small longitudinal tensile residual strain and a relatively large transverse compressive residual strain developed near the edge of the circular cutout. The existence of the residual strain ahead of the crack tip is one of the reasons why the damage zone still exists when the specimen is unloaded to 0% strain. However, due to the material's viscoelastic nature and to the redistribution of the residual stress and the residual strain, the magnitudes of the residual stress and the residual strain will decrease as the length of time is increased, resulting in a continuous decrease of the microvoids and microcrack sizes. Consequently, the damage zone size, as well as the damage intensity, will decrease accordingly. This time-dependence of the damage characteristics, measured by the acoustic imaging technique, was reported in Ref. 2.

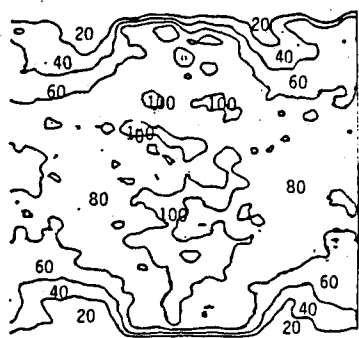
Fig. 6 Iso-intensity contour plot of acoustic image of the propellant specimen at -3% strain.

At the end of the first strain cycle, a -3% strain, or a compressive strain of 3%, was applied to the specimen, and the acoustic data are shown in Fig. 6. A comparison of Fig. 6 with Fig. 5e reveals that the size of the highly damaged regions near the crack tips is reduced and the size of the less damaged regions is increased. This phenomenon is believed to be due to the reduction of the sizes of the microdefects as a result of the presence of the compressive strain. After the specimen was imaged at -3% strain, it was unloaded to 0% strain and reloaded again according to the applied strain history shown in Fig. 2. The results of the acoustic imaging data are shown in Fig. 7. A comparison between Figs. 6 and 7a indicates that when the specimen is unloaded from -3% strain to 0% strain, the size of the highly damaged regions near the crack tip are further decreased and the size of the less damaged regions in the specimen are relatively unchanged. This phenom-
