Electric Propulsion Space Experiment (ESEX) On-Orbit Results

U.S. Air Force Research Laboratory, Edwards Air Force Base, California 93524-7013

The U.S. Air Force Research Laboratory's Electric Propulsion Space Experiment was launched and successfully operated, demonstrating the compatibility and readiness of a 26-kW ammonia arcjet subsystem for satellite applications. The Electric Propulsion Space Experiment is one of nine experiments on the U.S. Air Force's Advanced Research and Global Observation Satellite. Data were acquired to characterize the thruster in four different areas: electromagnetic interactions, contamination effects, optical properties of the plume, and thruster system performance. The results demonstrated that the critical system components including the arcjet, power processor, and propellant system operated well and verified the interoperability of high-power electric propulsion with generic satellite operations.

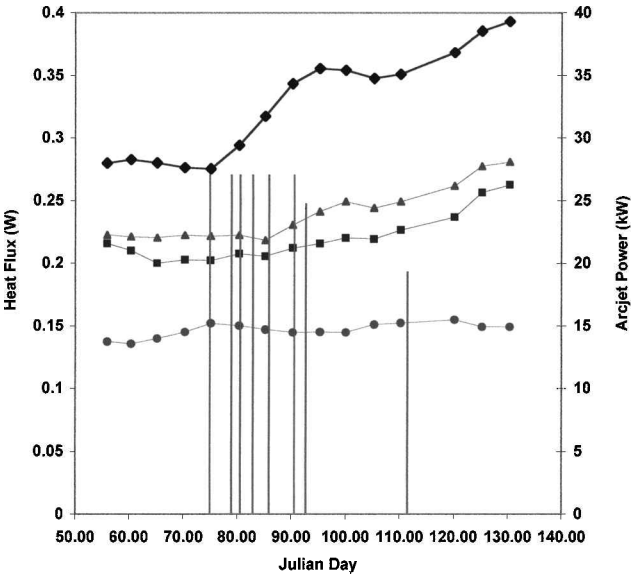
Fig. 6 Radiometer peak heat flux measurements during the ESEX firings. (The eight arcjet firings are indicated by the vertical lines.)

The radiometers are passive devices because they only require two temperature measurements, and so the data from these sensors were recorded throughout the ESEX mission. Measurement of the solar heat flux through the coating identified the degradation of the S13-GLO when subjected to the spectral emission of the high-power arcjet. This degradation is indicative of the effects on the thermal design of a spacecraft using high-power arcjets for propulsion. Figure 6 shows a summary of the maximum heat flux measured by the radiometers during the arcjet firing portion of the mission. In Fig. 6, the firings are indicated by vertical lines, with the corresponding arcjet power shown on the secondary axis. Radiometer 1, placed near the thruster exit with a view of both the arcjet plume and body, experienced an increase in the heat flux during the firings, indicating a degradation of the S13-GLO from the arcjet firings. The other radiometers, which had no view of the arcjet, or a view of only the plume, experienced less degradation as a result of the firings. There is also a noticeable increase in the heat flux on sensors 1, 2, and 4 as a result of the battery anomaly, which occurred on Julian day 114, presumably from the deposition of the battery effluents (this is corroborated by an increase in the mass deposition rates observed on the TQCMs).

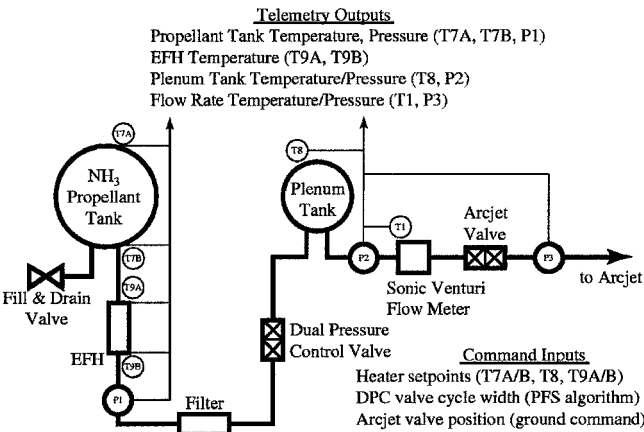
Fig. 10 Schematic representation of the PFS.

A schematic representation of the PFS is shown in Fig. 10. During operation,^{6,18} the ammonia was stored in the propellant tank with the DPC valve closed until an arcjet firing. The system was heated to ensure sufficient pressure to support flow before a firing, the last 2 h of which included disabling the inlet heater on the propellant tank and enabling the heater on the plenum tank. This heater configuration vaporized some of the ammonia and drove that vapor to the propellant tank outlet to help ensure vapor-only flow to the arcjet. The enhanced feedline heater (EFH) was enabled to ready the system for the impending flow 7 min before a firing. The flow was initiated by enabling the PFS algorithm, which controlled the ammonia flow rate by cycling the DPC valve to maintain pressure in the plenum tank corresponding to the commanded flow rate. As a result of the software encoding, however, the DPC valve cycled once at the start of the PFS algorithm regardless of the plenum tank pressure. Finally, the arcjet valve was opened, and the flow to the arcjet was monitored through the sonic venturi flow meter.

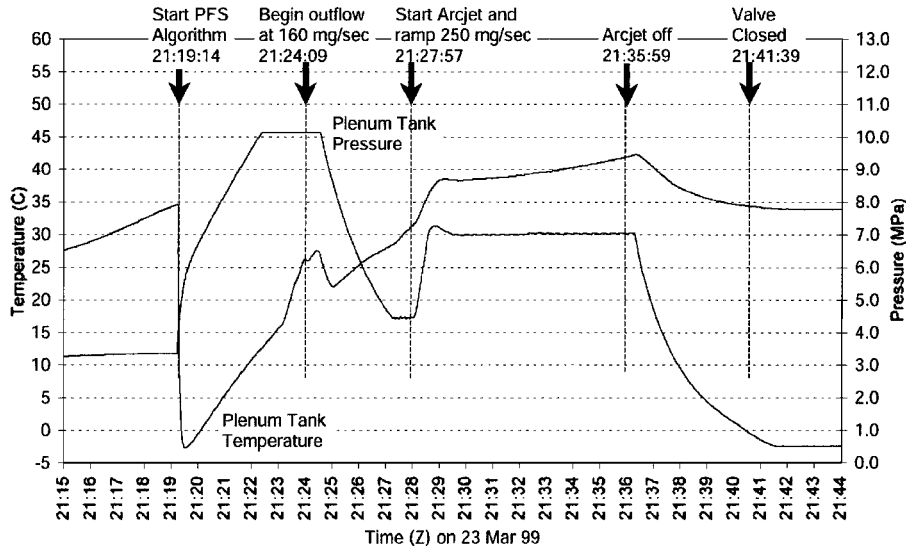
Fig. 9 Typical PFS performance showing liquid ingestion into the plenum tank.

The liquid ingestion was initially observed on the first successful ammonia outflow (R-3; Table 1). On initiation of the PFS algorithm, evidence of a single slug of liquid ammonia ingested into the plenum tank was observed on the initial DPC valve cycle. Figure 9 illustrates the issue for a typical outflow. (Note that the plenum tank pressure output saturates at 6.89×10^5 Pa.) As can be seen, the plenum tank temperature decreases by greater than 35°C within 30 s of initiating the PFS algorithm, indicating that liquid ammonia is expanding into the plenum tank. Approximately 5 min later, the plenum tank pressure and temperature indicate a superheated condition and drying out of the liquid in the plenum tank as some of the ammonia vapor is vented through the open arcjet valve (indicated in Fig. 9 by Begin outflow at 160 mg/s). A flow meter immersion thermistor located just upstream of the arcjet shows no corresponding drop in temperature, indicating that the liquid is confined to the plenum tank and never passed to the arcjet, even before arc initiation. To ensure that no two-phase flow reached the arcjet, however, the arcjet start was delayed until a dry plenum was achieved in all cases. After the initial ingestion, all PFS temperatures and pressures indicate no liquid was passed to the plenum tank or arcjet for any of the outflows or firings.

PFS heater performance before the outflow indicated that the bulk of the ammonia liquid remained away from the outlet of the propellant tank as the design intended. As already described, keeping the liquid ammonia away from the tank outlet was accomplished by differential heating of the propellant tank poles, but was also possibly aided by the angular momentum of the spacecraft in orbit. During the outflow, and throughout the mission, temperatures of the EFH indicated relatively little liquid entering the EFH and 100% vapor outflow at the exit.
