# Mir Solar-Array Return Experiment: Power Performance Measurements and Molecular Contamination Analysis Results

In 1997 a solar-array segment was removed from the Space Station Mir core module and returned for ground-based analysis. The segment, which is similar to the ones the Russians have provided for the Functional Cargo Block and Service Module, was microscopically examined and disassembled by U.S. and Russian science teams. Laboratory analyses by the International Space Station program have shown the segment to be heavily contaminated by an organic silicone coating, which was converted to an organic silicate film by reactions with atomic oxygen within the orbital flight environment. The source of the contaminant was a silicone polymer used by the Russians as an adhesive and bonding agent during segment construction. During its life cycle, the array experienced a reduction in power performance from ~ 12%, when it was new and first deployed, to ~ 5%, when it was taken out of service. However, current-voltage measurements of three contaminated cells and three pristine Russian standard cells have shown that very little degradation in solar-array performance was caused by the si

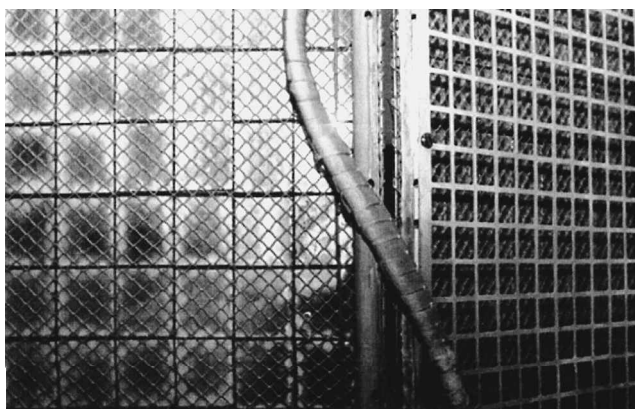
Fig. 4 Photograph of the backside of the array showing the opaque, white silicate film that coated the surfaces of the optical solar reflectors.

As observed in Fig. 4, the contaminant films, which condensed on the back side of the array, are optically diffuse and more concentrated near the edges of the OSRs. Visually, these films appear less concentrated near the centers of the OSRs. The source of these contaminant films appears to be the organic silicone polymer that was used to seal the gaps between the solar cells and to attach the cover glass and OSR to the solar-cell surfaces. Organic constituents that were outgassed from this sealant also formed heavy deposits on the large open-weave fabric that covered the OSRs. This net cloth and the OSRs that it covered are each visible in the photograph of Fig. 4. Figures 5 and 6 include scanning electron microscope (SEM) images of this fabric after it was removed from the solar-array panel. As indicated by these images, it was heavily coated with a brittle

The nonuniform colorations of the previously white handrail and a power diode box cover are easily visible in Figs. 7 and 8, respectively. The shadow pattern on this cover was produced by the protective grid cover (see the section on the right in Fig. 4), which was mechanically attached to the backside of the panel. During LEO exposure, this cover shielded the white regions of the diode box from solar ultraviolet radiation and direct impingement of atomic oxygen atoms. Previous studies have identified similar clear areas on Long Duration Exposure Facility (LDEF) experiment surfaces in regions, where the arriving silicone contaminants were shadowed from atomic oxygen and solar UV exposure.

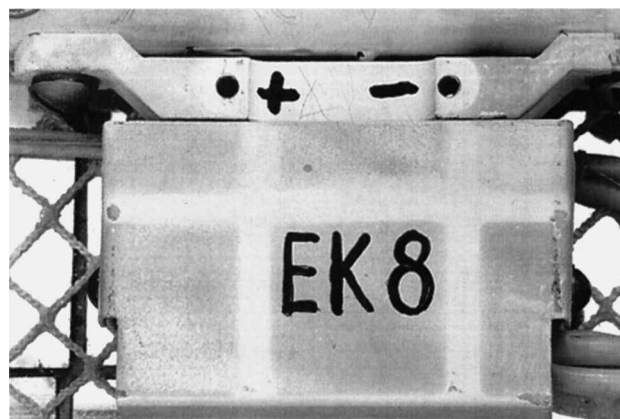
Fig. 8 Power diode box cover on back of solar array showing shadow pattern produced by the protective grid cover.
