Induced-Contamination Predictions for the Micro-Particle Capturer and Space Environment Exposure Device

The Boeing Company, Houston, Texas 77059

Japan Aerospace Exploration Agency, Ibaraki 305-8505, Japan

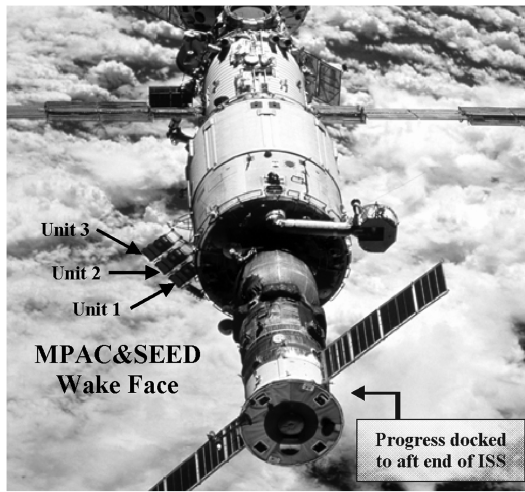
Fig. 2 MPAC&SEED on-orbit, wake-facing side (image courtesy of NASA).

The MPAC&SEED experiment consisted of three identical units, which were mounted outside the Russian service module (SM) on 15 October 2001. The first unit was removed in August 2002, the second in February 2004, and the third in August 2005. Figure 1 shows a view of the fully deployed experiment. This is a view of the ram-facing side (i.e., the side that pointed into the ISS velocity vector for the majority of the experiment). Figure 2 shows a view of the experiment from the wake-facing side. The MPAC experiment was

On the MPAC&SEED wake face, the most significant thruster contamination source for MPAC&SEED was a Progress braking engine. The braking engines are fired during approach and separation to the docking port on the aft end of the ISS. (See Fig. 2 for an on-orbit image of an aft-docked Progress.) One of the Progress braking engines had a near-centerline view to the MPAC&SEED wake side. Figure 6 provides a hemispherical view from this thruster when 20 ft

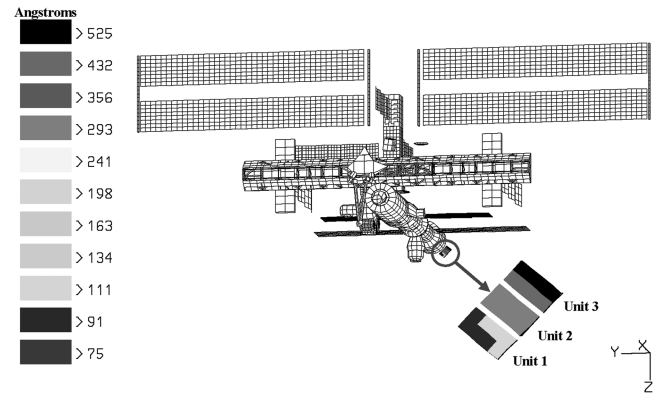
Fig. 8 Predicted contamination on MPAC&SEED ram face.

shown in Fig. 8. In this figure, contamination predictions at the time of retrieval are shown for each MPAC&SEED unit. It should be noted that the contamination level changes gradually across the units; the appearance of sharp gradients (e.g., greater than 91 \AA and greater than 111 \AA on unit 1) is due to resolution of the scale and grids in the geometric model.
