Investigation of fish product–metal container interaction using scanning electron microscopy–X-ray microanalysis

Scanning electron microscopy (SEM) and X-ray microanalysis (EDS) were used to investigate metal can discoloration and lacquer adhesion failure in enameled food cans containing tuna in vegetable oil and octopus in brine, respectively. Black and brown spots on the internal surface of the can body were caused by the formation of FeS and SnS, respectively. The source of metal can discoloration was traced to inadequate lacquering of the tin plated steel, exposing both tin and iron to sulfur containing amino acids originating from the tuna product. Enamel adhesion failure in canned octopus was also traced to local defects in the lacquer coating enabling both NaCl and citric acid contained in the brine to cause enamel blisters on the can body leading to lacquer peeling and in turn to local detinning and steel corrosion. The first defect known as “sulfide staining” is harmless to human health and does not usually affect the product. The second defect may cause extensive detinning and steel corrosion possibly affecting the safety of the canned product. This postulation is suppor

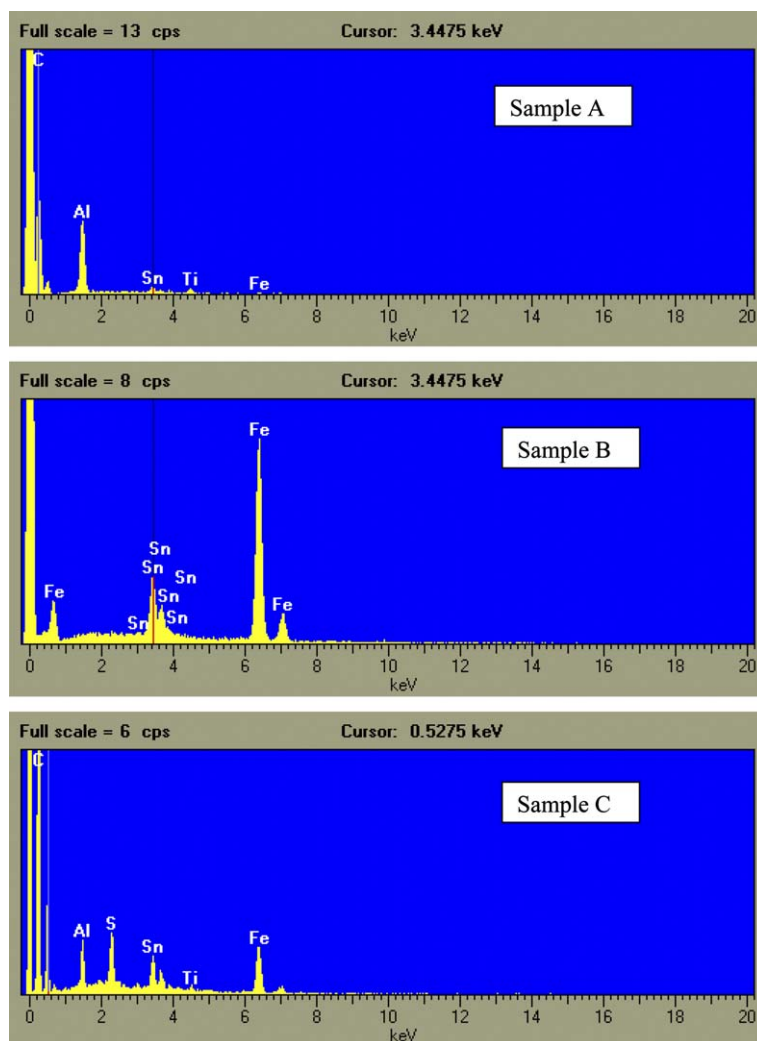
Fig. 1. SEM of images of (A) good, (B) intentionally scratched and (C) defective cans.

The appearance of black and/or brown corroded areas on the internal wall may be attributed to lacquer failure, as in both C and D samples, Al value considerably decreased. Considering that any defects of lacquer result in iron and tin exposure, in combination with the appearance of an extra peak in the EDS spectra (Fig. 1), attributable to sulfur, we can safely support that black spots are the result of reaction between exposed tin from the container with sulfur containing compounds from the product to form black FeS precipitate. Similarly, brown spots are the result of reaction between exposed tin from the container and sulfur to form a brown SnS precipitate. Sulfur compounds such as sulfur containing amino acids are a typical breakdown product of fish protein during intensive thermal treatment (retorting). Increase of the C content (17–51%) over the black and/or brown corroded areas is an extra evidence for the presence of amino acids or breakdown product of proteins.

Above results, which are also presented as SEM images (Fig. 1) are further supported by microscopic data which clearly show black and brown corroded areas on the internal walls of the defective cans (C)

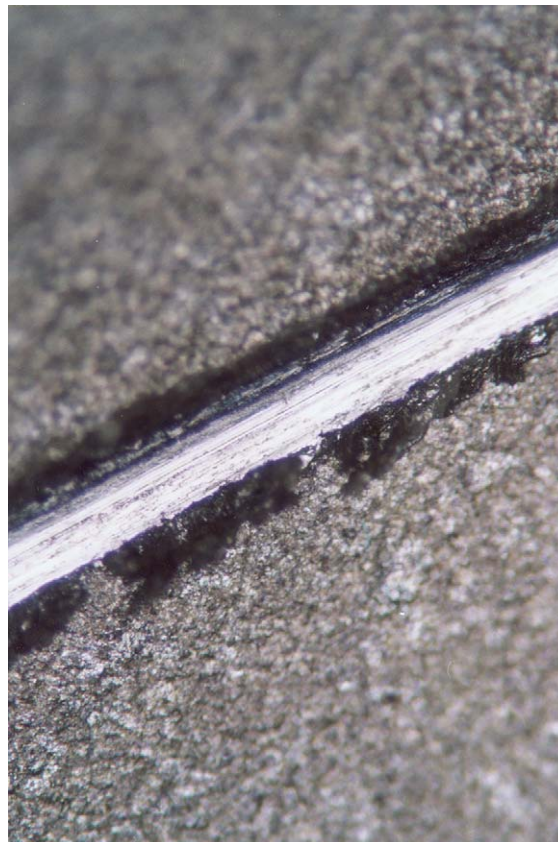
Fig. 3. Intentionally scratched (B) can.

(Fig. 2). The results of scratching internal walls of intact cans is shown in Fig. 3.

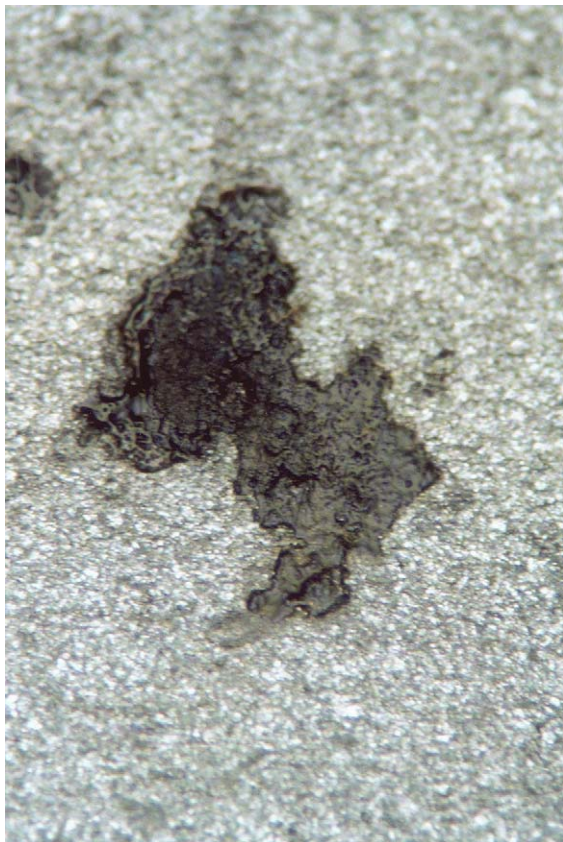
To further test above postulation the cysteine test was carried out on A and C samples. Fig. 4 clearly shows black spots composed of FeS formed through the reaction of cysteine with exposed iron on can internal walls due to lacquer failure. Discoloration was noted only on can internal walls and was evaluated as “very strong”. Good (A) can samples produced no discoloration at all due to adequate protection provided by the lacquer.

Fig. 4. Sulfide staining on internal walls of defective (C) cans using the “cysteine” test.

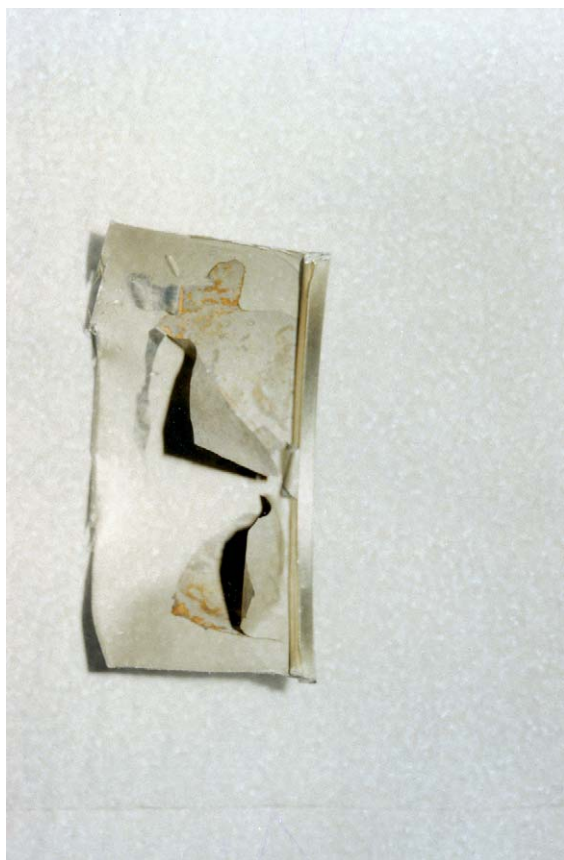
In this particular case it is postulated that due to incomplete enamel coating resulting in the formation of local pores or cracks, citric acid (known for its high

detinning potential) made its way through such pores or cracks on the enamel surface and caused local detinning of the can wall resulting in tin migration into the contained product and solution. As tin is dissolved the underlying iron is exposed, initiating corrosion of the can wall and simultaneous migration of iron into the contained product and solution. This postulation is further supported by iron and tin content of the product (octopus) and brine shown in Table 4. That is, in the “bad” product (F) there was a 5–6-fold increase in iron content of both the product (octopus) and the brine as compared to the “good” (E) product. Respective increase for tin was 7-fold, with the tolerance level of tin in the EU being 200 mg/kg wet weight of product, for cans containing food (Commission Regulation 242/2004).

Fig. 5. Enamel adhesion failure on internal walls of defective (F) cans.

from the NaCl in the brine) move towards the vicinity of the enamel failure and form NaOH in the presence of excess OH^- . The NaOH formed accumulates on the metal surface causing migration of water molecules from the brine to the metal (due to osmosis phenomena) causing the formation enamel blistering around initial pores or cracks on the enamel surface (Doherty & Sykes, 2004). As blistering advances, enamel adhesion failure is observed (Fig. 5). Given the presence of citric acid in the brine in this particular case steel corrosion is greatly enhanced.

lacquering of the can created a major enamel adhesion failure problem given the specific product composition (sulfur containing amino acids, NaCl and citric acid).
