Investigation of an alleged mechanism of finger injury in an automobile crash

Abstract This investigation centers on the case of an adult male whose finger was allegedly amputated by the steering wheel of his car during a crash. The subject claimed to have been driving with his left index finger inserted through a hole in the spoke of his steering wheel and was subsequently involved in an offset frontal collision with a tree. The finger was found to be cleanly severed at the mid-shaft of the proximal phalanx after the crash. This injury was alleged to have been caused by inertial loading from the rotation of the steering wheel during the crash. To determine whether this injury mechanism was plausible, three laboratory tests representing distinct loading scenarios were carried out with postmortem human surrogates loaded dynamically by the subject's steering wheel. It was found that the inertial loads generated in this loading scenario are insufficient to amputate the finger. Additionally, artificially constraining the finger to force an amputation to occur revealed that a separation at the proximal interphalangeal joint occurs rather than a bony fracture of the proximal phalanx. Ba

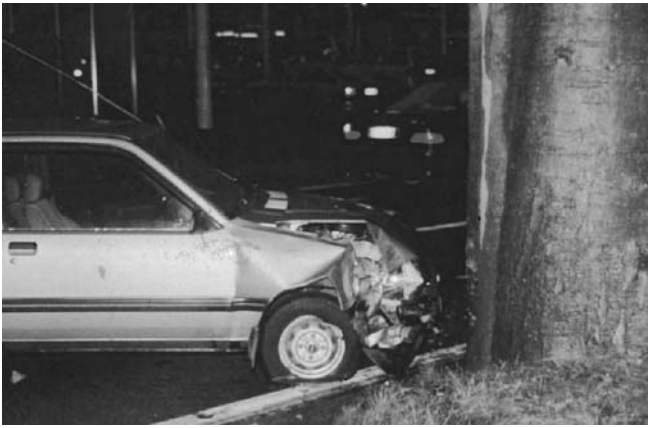
Fig. 1 Photograph of the case vehicle taken shortly after the collision with the tree. All of the damage to the vehicle is localized in the front passenger side

Photographs taken at the scene (Figs. 1 and 2) show damage to the right front quarter panel, hood and bumper, as well as the steering wheel turned 90° to the left (counterclockwise from the driver's position). The steering wheel is a custom wheel with two holes drilled through the aluminum spokes, each approximately 20 mm in diameter (Fig. 3).

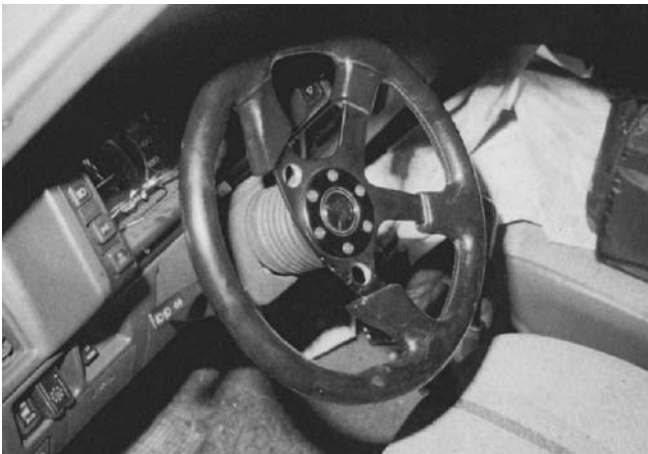
Fig. 2 Photograph of the interior of the case vehicle at the accident scene. Note the traces of blood near the bottom (*left*) hole in the steering wheel, and that the wheel is rotated approximately 90° counterclockwise

Photographs of the subject vehicle taken shortly after the collision showed that the wheel rotated approximately 90° to the left. This was used to define the range over which the tests would be performed. Acceleration pulses of vehicles striking narrow objects in offset frontal configurations were analyzed to establish a reasonable time duration over which the 90° rotation occurred [2–7]. From the literature, a range of 110- to 170-ms impact duration was identified. Since the subject collision was concentrated generally in the region of the right front wheel, it was assumed that any collision-induced wheel rotation would occur over a time duration similar to the duration of the collision; therefore, a 90° left-hand rotation over approximately 100 ms was chosen as the target design specification for the test fixture.

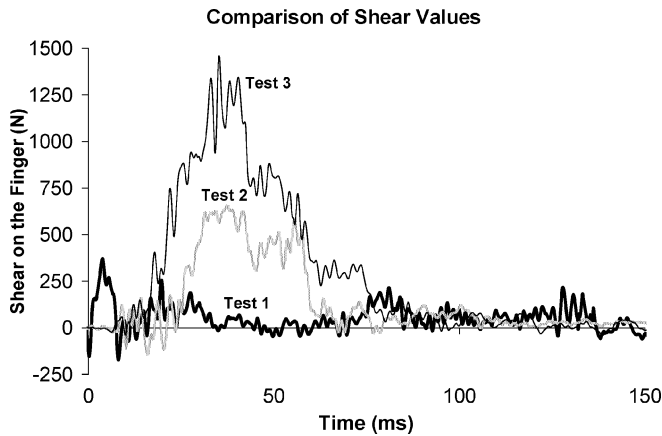
Fig. 5 Comparison of the shear force experienced by the finger for each of the three test conditions

Figure 5 summarizes the shear force experienced by the finger for each of the three loading scenarios. For comparison, the angular rate of rotation and linear velocity (for test 1 only) are shown in Fig. 6. Note that the more rigidly the finger was constrained, the greater the peak shear force on the finger and the greater the risk of amputation or disarticulation.

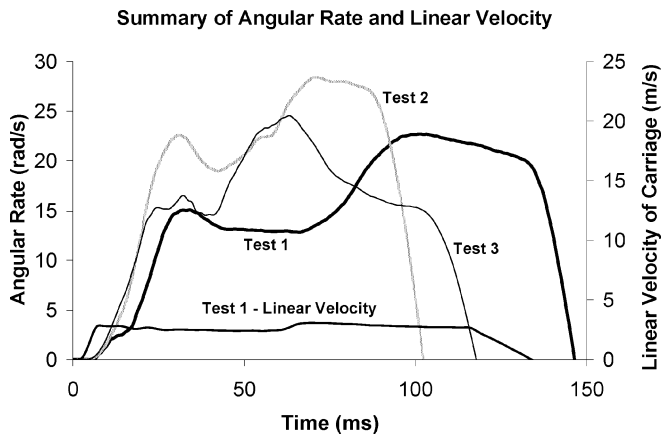
Fig. 6 Graphical representation of the angular rate for each of the three tests, as well as linear carriage velocity for test 1

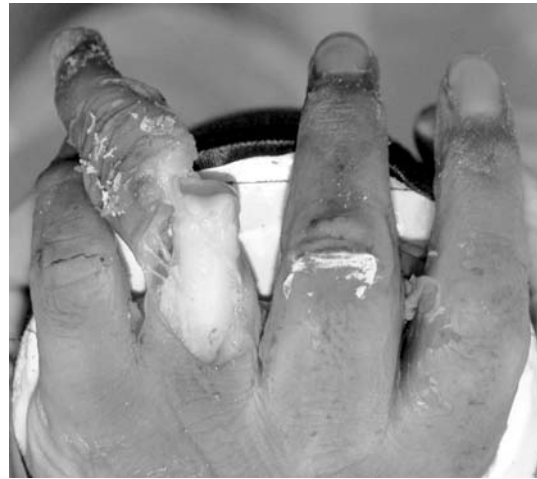
Fig. 7 Photograph taken after tests 2 and 3. Note skin laceration and absence of bony injury to the second digit, and disarticulation of the fourth digit at the proximal interphalangeal joint

finger was disarticulated at the proximal interphalangeal joint, with the flexor tendon being the only remaining attachment between the finger and the metacarpal (Fig. 7). A tuft fracture at the proximal end of the middle phalanx was noted. There was no bony fracture of the proximal phalanx, no “clean-cut” amputation, nor any other visible injury to the proximal phalanx.

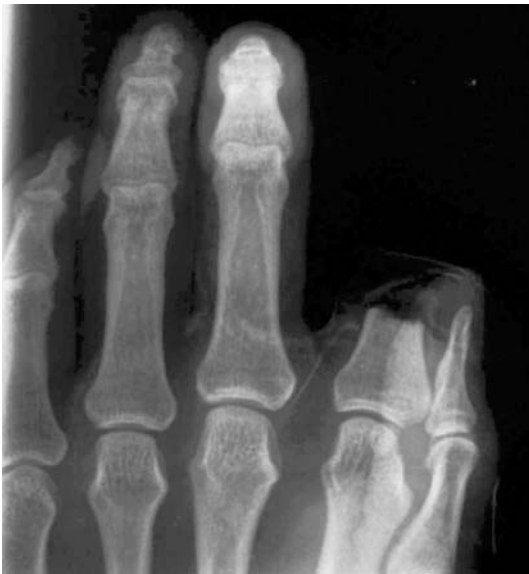
Fig. 8 Radiograph of case subject’s left hand taken shortly after the injury, showing a clean amputation of the second finger at the mid-shaft of the proximal phalanx

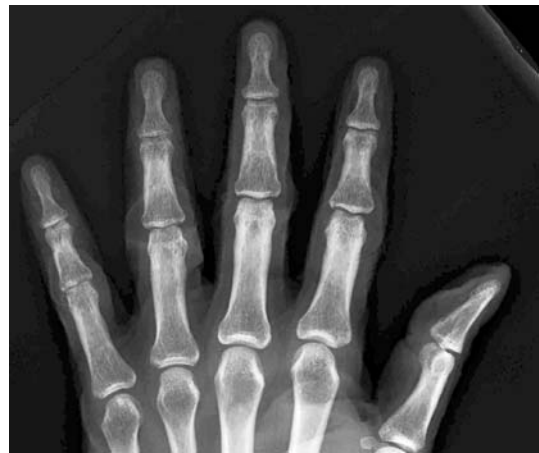
Fig. 9 Radiograph taken after test 1. No bony injuries are evident on X-ray, and none were found upon dissection

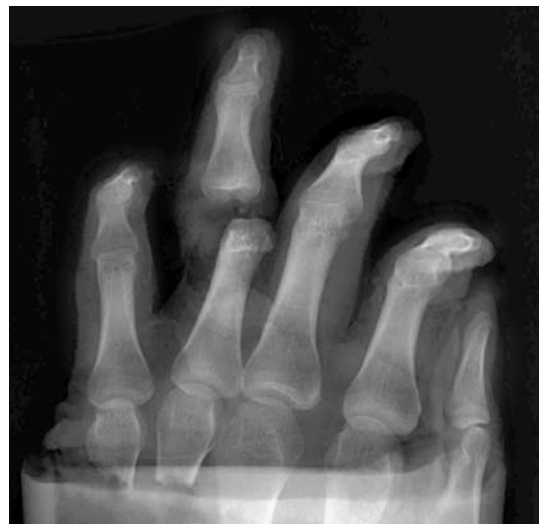
Fig. 10 Radiograph taken after tests 2 and 3. Note absence of bony injury to second digit, and complete disarticulation of fourth digit at the proximal interphalangeal joint
