Complete decapitation of a motorcycle driver due to a roadblock chain

Keywords Decapitation · Motorcycle accident · Roadblock chain · Rotational movement · Law of conservation of angular momentum

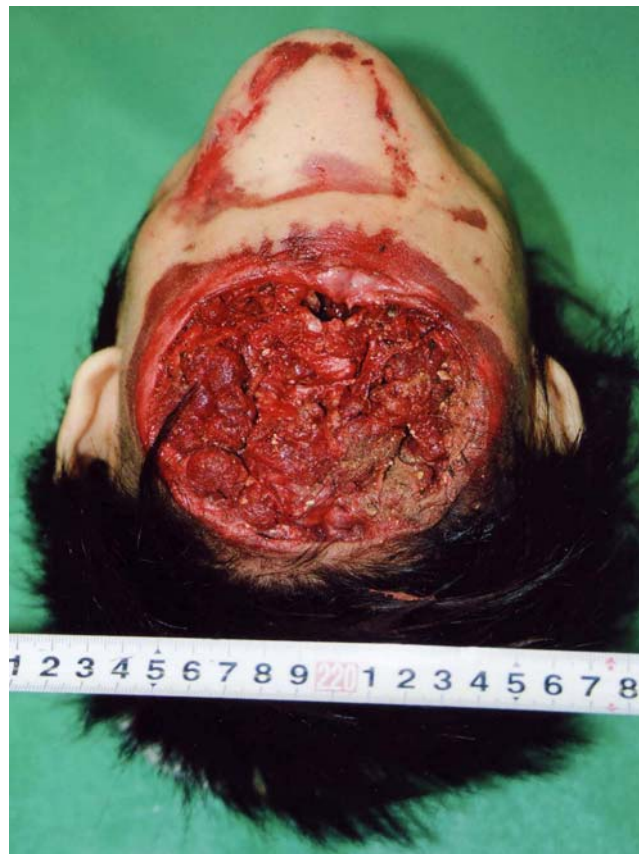
Fig. 2 The head side of the severance plane. Severance edge with band-like abrasion and submental lesion

The head was completely severed from the trunk and weighed 4.3 kg. The decapitation injuries of the head and the torso corresponded perfectly, without apparent loss of tissue. The severance plane passed horizontally through the upper cervical region, and the edge was sharply delineated (Fig. 2). There were band-like abrasions on the anterior three quarters of the severed edges. The severance plane passed through C4 with a comminuted fracture, and the cervical spine was severed at the level of C4. The epiglottis had been torn off and remained on the head segment, and the airway was severed at the trachea, between the hyoid

On the head, there were bruises and abrasions on the face and a submental lesion (Fig. 2), without a skull fracture or intracranial injury. There were slight bruises and abrasions on the trunk and extremities. Linear bruises on the back of the trunk extended from the upper right to the lower left, and the upper-right end of the line of bruises approached the severed edge (Fig. 3). Internal findings revealed bilateral third rib fractures at the costovertebral joints and exsanguination of internal organs. The post-mortem blood tested negative for alcohol.

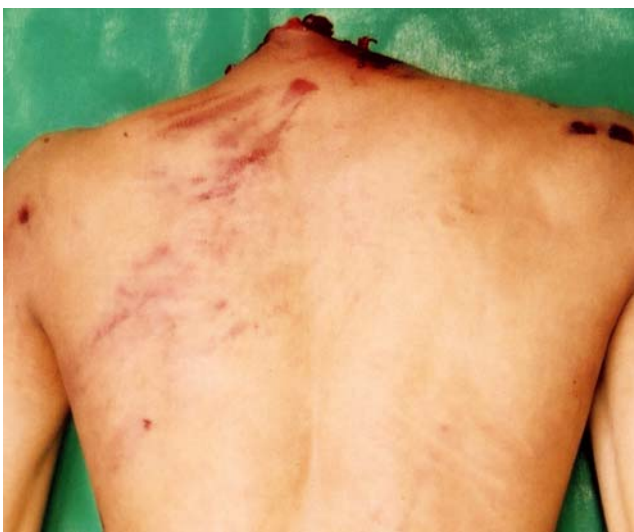
Fig. 3 The linear bruises distributed in a direction from upper right to lower left on the back

We considered another force contributing to the decapitation. Considering the movement of the chain, the chain wrapped itself around the driver's neck from his back. This pathway corresponds with the autopsy findings with band-like abrasions of the severance edges and bruises on the back (Fig. 3). A point 30 cm from the left end of the chain impacted the neck, as revealed by the bloodstain and tissues. Consequently, after the initial blow, a 30 cm length of the left end of the chain continued to rotate around the center of the neck. Because the right end of the chain was attached to the block, as long as the motorcycle was going forward, the chain was under strain from the right. As a result, the chain wrapped around the driver's neck strangled him through the tractive force from each end (Fig. 6).

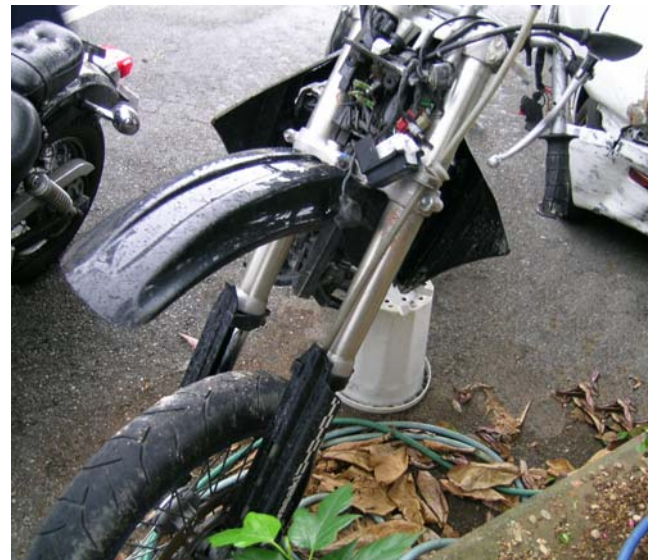
Fig. 4 The off-road motorcycle: the space between the fender and front wheel

The off-road motorcycle involved has a space between the fender and the front wheel designed to ease racing over varied terrain of gravel, mud, and sand (Fig. 4). There were scratches made by the chain under the fender, which was attached at about 70 cm above the ground. The chain slipped under the fender at the collision, and the tension of the chain broke the left-side padlock. The chain was then subjected to two force vectors, a forward strain force exerted by the motorcycle and a backward reaction force (Fig. 5(a)). Under their influence, the chain began a rotational movement, with the fender of the motorcycle acting as the center of rotation (Fig. 5(b)).
