CEMENT-LINED PIPES FOR WATER LUBRICATED TRANSPORT OF HEAVY OIL

Abstract—This paper presents different strategies for preventing oil from fouling the walls of core–annular flow pipelines and also for restart from an unexpected pipeline shut-down. The most promising of these strategies is to use cement-lined pipes. Experiments presented here show that hydrated cement-lined pipes are highly oleophobic and therefore resist fouling for long term. A pilot scale cement-lined core–annular flow pipeline using No. 6 fuel oil never fouled in over 1000 h of operation. Repeated and determined attempts to soil properly hydrated cement-lined pipes with heavy Venezuelan crudes always failed.

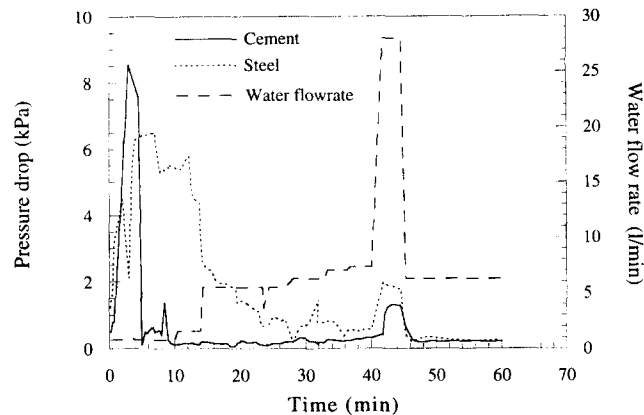
Figure 11. Restart after 5 days of rest in the 25 mm pipeline. The water flow rate is gradually increased. The cement-lined pipe is free of oil in a few minutes, while the steel pipe is noticeably fouled after 45 min. The peak from 40 to 44 min corresponds to a large increase in the water flow rate. At this time, the pressure gradient is much larger in the steel than in the cement-lined pipe and indicates the degree of fouling (normally, the pressure gradient in the smooth steel pipe is smaller than in the rough cement-lined pipe).

Figure 11 shows the evolution of the water flow rate and the pressure drop in the cement-lined pipe and in the steel pipe for the duration of the test. Since the cement-lined pipe is in a dangerous position, the pressure drop was higher than in the steel pipe during the first few minutes, but rapidly decreased and stayed at very low levels afterwards. In contrast, higher pressure drops were required to move the flow through the steel pipes after the initial transient. After an hour, the pump was stopped and the pipes disassembled. Once again, the cement pipe was completely clean (even in the critical region close to the injection nozzle) and the steel pipe was heavily fouled.
