# Fatigue Behavior of Epoxy and Polyester Resins

LAWRENCE J. BROUTMAN† and SATISH K. GAGGAR‡

*Department of Metallurgical and Materials Engineering  
Illinois Institute of Technology, Chicago, Illinois 60616*

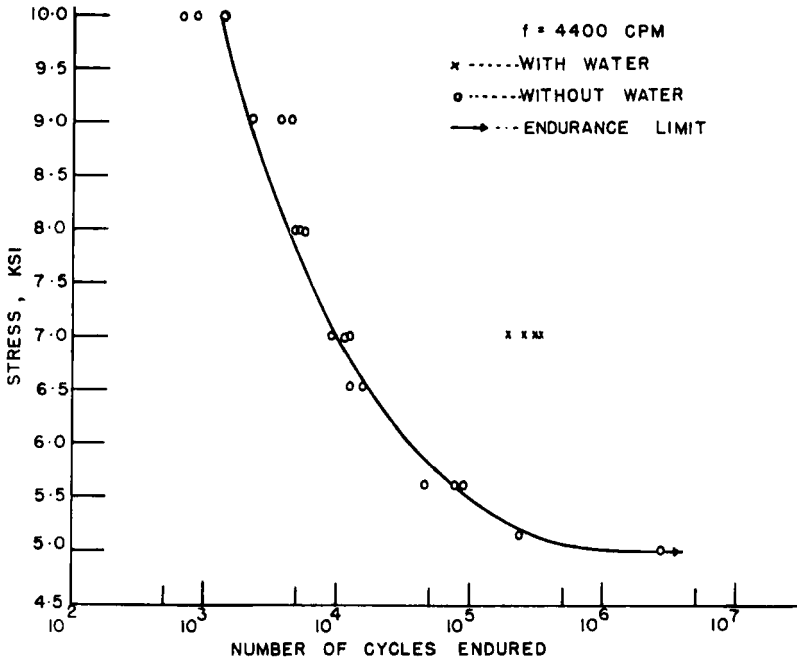
The actual fatigue results obtained are presented in Figures 2 and 3. Nearly 100 specimens have been tested to establish these curves. For the epoxy resin, only a small stress range could be evaluated because of the low modulus of the material and resulting large deflection of the specimen when loaded. Thus an upper limit is placed on the stress which can be applied to the specimen.

FIGURE 3 S-N curve for polyester resin

Due to this limitation, only scatter bands have been shown in the fatigue curve for the epoxy resin. The fatigue curves for these two materials resemble fatigue curves for metals and it appears that endurance limits exist for these materials. For each material 5 specimens were tested at a stress level below the endurance stress limit and none of them failed after  $10^6$  cycles were applied. These curves have been established only for one cyclic frequency and the fatigue life data are quite sensitive to the cyclic frequency as will be discussed later.

The increase in fatigue life of these materials in the presence of a coolant is further demonstrated by tests performed with the specimens immersed in water. A chamber is placed around the specimen in the fatigue machine and water is circulated through the chamber. The composite effect of water is not only to reduce the temperature of the specimen but also to provide a different environment for the specimen. The results for epoxy and polyester resin are indicated in Figures 2 and 3, respectively.

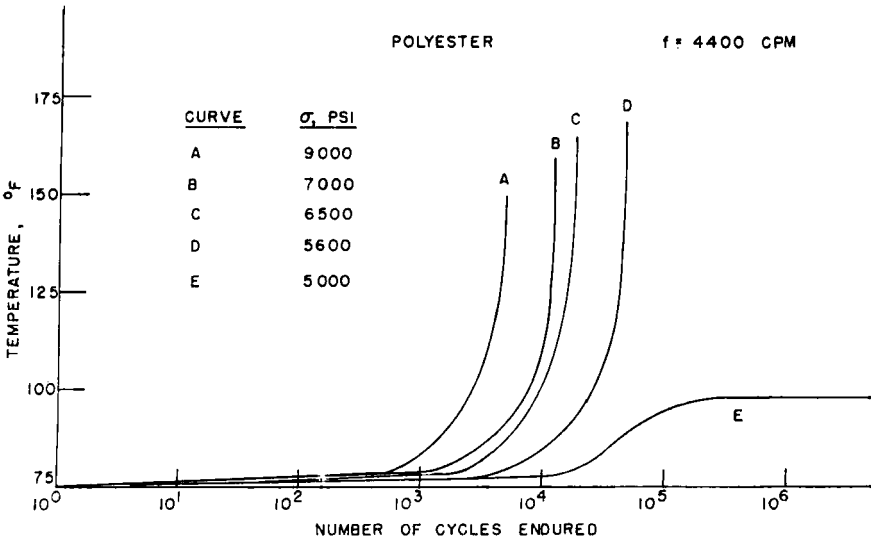
The temperature rise curves for the polyester resin at various levels are shown in Figure 5. These curves are somewhat different from those observed

FIGURE 5 Temperature rise as a function of fatigue cycles

for epoxy resin. For the polyester resin, a very rapid increase in surface temperature is observed in the last few cycles of its life.

The increase in surface temperature of specimens during fatigue testing is attributed to the hysteresis loss in the material. To understand the relatively sharp temperature rise of a polyester fatigue specimen during the last few cycles of its life, specific hysteresis loss data were determined from cyclic flexural tests on an Instron at various temperatures. These data for the epoxy and polyester resins are presented in Table Ia and Table Ib respectively. It is observed from these results that the specific hysteresis loss increases with increasing temperature for the polyester resin. Hence it can be inferred that as the temperature of the specimen increases during the fatigue test, an increasing amount of hysteresis heating takes place during the last few cycles. For epoxy resin, the specific hysteresis loss is not sensitive to temperature, and this results in more uniform hysteresis heating during each cycle.

It is observed from these curves that the surface temperature at fracture increases with decreasing stress. This is expected because the specimen endures more cycles to failure at lower stresses and this increase in number of cycles results in more hysteresis heating of the specimen.

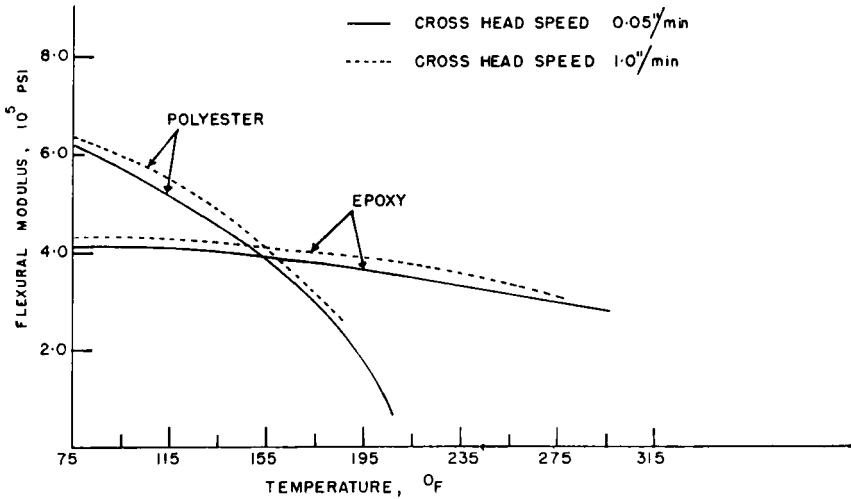
FIGURE 7 Variation of flexural modulus with temperature

epoxy resin and polyester resin are found to be 142°F and 95°F, respectively (at 4400 cpm). The temperature rise of a specimen influences the fatigue life by lowering the ultimate strength and stiffness of the material. These properties are dependent upon temperature and Figure 6 and Figure 7 show the flexural strength and flexural modulus at various temperatures. It is observed from these curves that the flexural strength and modulus of the polyester resin are greatly reduced as the temperature is increased. For the epoxy resin, these properties are less altered by the same change in temperature. Thus, if the temperature of the specimen rises during fatigue tests, the flexural properties are changed significantly which in turn should influence the fatigue life.

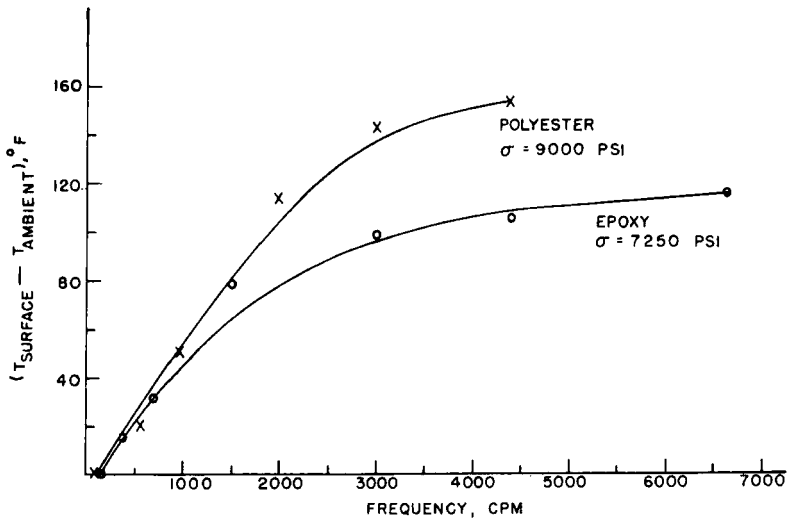
FIGURE 8 Temperature increase versus frequency

As mentioned earlier, the maximum surface temperature of the resins is influenced by cyclic test frequency. The frequency versus maximum surface temperature curves for the epoxy and polyester resin are shown in Figure 8. The curve for the epoxy resin indicates that at a stress level of 7250 psi, the surface temperature will not increase above ambient unless the cyclic frequency is greater than 150 cycles per minute. For the polyester resin, there is no increase in the surface temperature of the fatigue specimen at frequencies below 100 cycles per minute for a stress level of 9000 psi. These results would vary with the shape and size of the fatigue specimens.

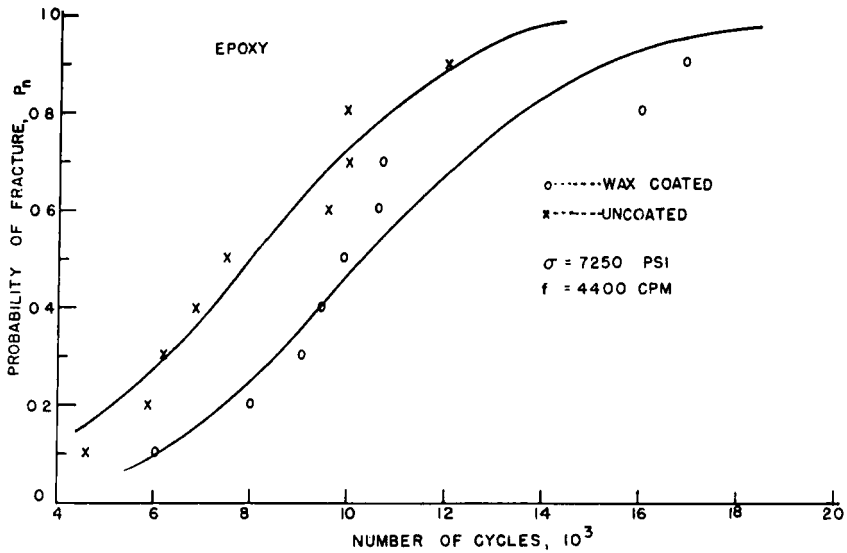
vapour in the atmosphere was to coat the specimens before they were fatigued. The epoxy and the polyester specimens were held at 100°C and 50°C respectively for 2 hours and then coated with a graphite coating. The coating was applied in the oven so that the specimens could not absorb any water from the atmosphere during the coating operation. Finally, a silicone wax was applied to the surface over the graphite coating. These specimens were then cycled at one stress level and frequency and the number of cycles to failure are compared with those of uncoated specimens subjected to the same stress level and frequency. The probability of failure is plotted versus the number of cycles to failure for the epoxy and polyester resins in Figures 9 and 10, respectively. The life of epoxy resin is increased by the coating. For epoxy resin, the loss in weight after heating was measured to be 0.103% of the original weight. It is thought that the water absorbed in the epoxy resin acts as a plasticizer and thus reduces the flexural strength. Thus, the increase in fatigue life of coated specimens can be attributed to the expected increased flexural strength due to removal of water. For polyester resin, there is no increase in

FIGURE 9 Effect of wax coating on probability of fatigue fracture

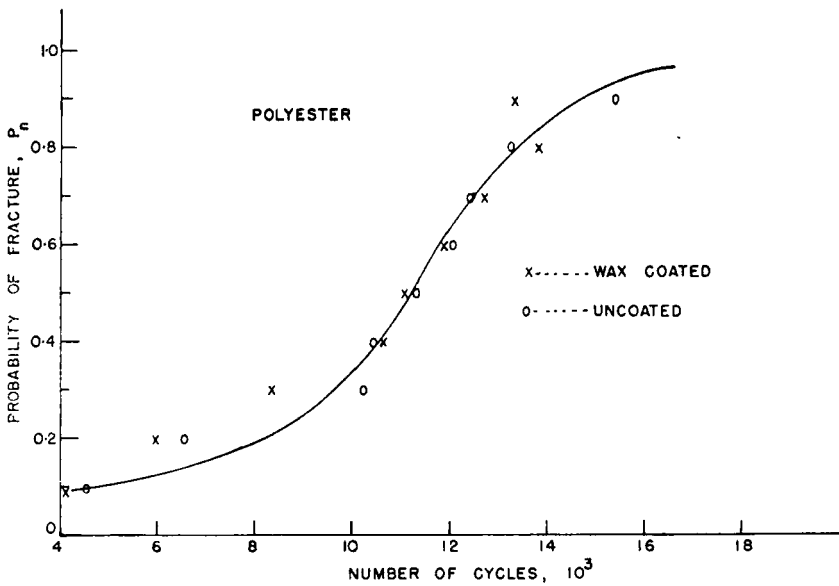
FIGURE 10 Effect of wax coating on probability of fatigue fracture

fatigue life with the protective coating. However, as already stated, these specimens could only be heated to 50°C as they distorted too much above this temperature. This temperature is not sufficient to drive off water absorbed in the specimen or absorbed on the surface. The loss in weight after heating was found to be only 0.016% of the original weight of the specimen.

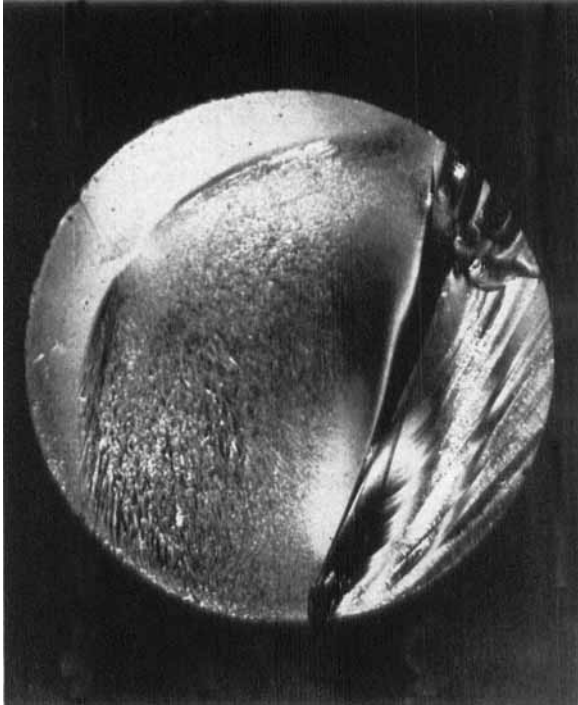
Figure 16 shows a fracture surface for a specimen cycled at  $\sigma = 6000$  psi. A well defined tongue shaped crack front is clearly seen here. Figure 17 shows the crack front at higher magnification. The brittle striations near the crack origin are very closely spaced but the spacing increases with each load cycle. It is observed that brittle striations are continuous at tear lines whereas ductile striations bow at tear lines as explained earlier.

FIGURE 16 Fracture origin at the surface and tongue shaped crack front ( $\times 19$ )  
 $\sigma = 6000$  psi,  $f = 4400$  cpm

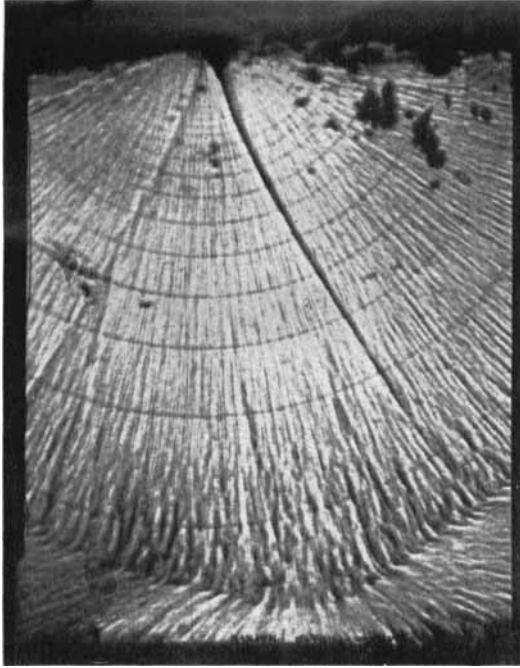
FIGURE 17 Enlarged view of crack front and brittle striations in mirror region ( $\times 200$ )

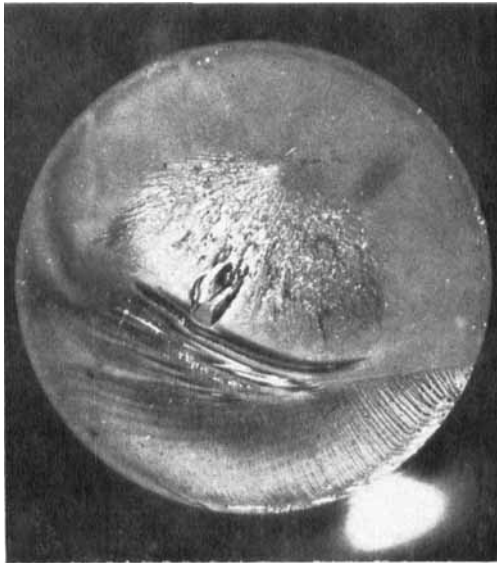
In Figure 18 the fracture initiates from a flaw well inside the specimen away from the boundaries where the applied bending stress is lower than at the boundary. The stress concentration at this flaw site causes the fracture to initiate from that point and there are no brittle striations present. It has been observed that brittle striations either do not appear or are less pronounced when the fracture originates at an inclusion inside the material. This may be because very high stresses due to a stress concentration can occur at inclusions even if the applied stress is low. This results in very few or no striations as the brittle striations are favored at low stresses, as the stable crack can grow and reach a greater length before unstable crack propagation occurs. For example,

FIGURE 18 Crack origin at an inclusion well inside the surface ( $\times 19$ )  
 $\sigma = 5600$  psi,  $f = 4400$  cpm

Figure 19 shows a specimen cycled at approximately the same stress level as the specimen of Figure 18, but note the brittle striations in Figure 19.

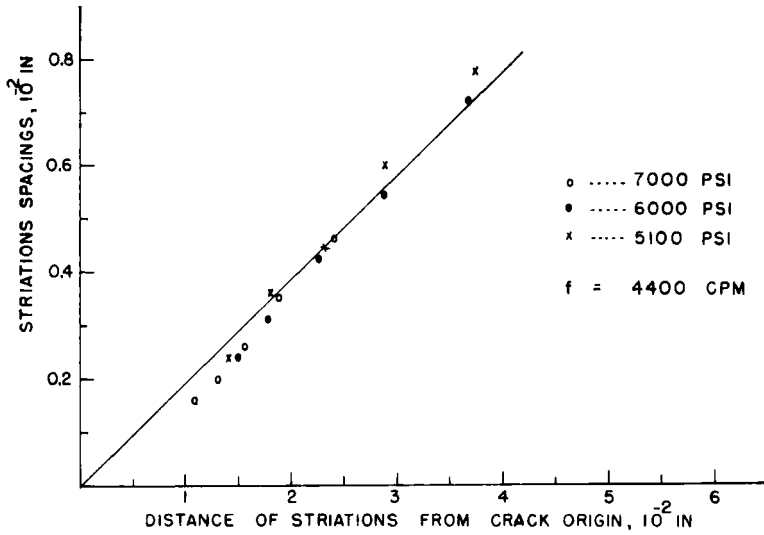
Figure 20 shows a plot of striations spacing versus distance of striations from the crack origin for several specimens cycled at various stress levels. A linear relationship exists between the crack length and striation spacing. The results are based on the last five brittle striations in the mirror area. The linear relationship is expected because the crack velocity is progressively increasing as the uncracked area is decreasing. This also supports the view that mirror area is the area of stable crack growth. Striations are not observed on specimens cycled at stress levels greater than 8000 psi regardless of the cyclic frequency. Thus, the formation of striations is only dependent upon the stress level and occur at the lower applied stresses.

FIGURE 20 Striations spacing versus crack length
