## International Journal of Polymeric Materials

# SEM Analysis of Polymeric Mechanical Failures in Polyetherimide

Different modes of fracture, which consisted of tension, bending, impact, biaxial flexure, torsion, fatigue, and cutting, were selected to determine fracture surface characteristics of polyetherimide under controlled conditions. Fractography, examination of fracture surfaces, was performed using a stereomicroscope and scanning electron microscope (SEM) to characterize and compare modes of failure. The stressed samples exhibited ductility, deformation, and finally brittle fracture shown by a primary fracture surface: mirror, transition region with mists and hackles, and a rough region with Wallner lines. The impacted samples exhibited stress cracking from the point of impact. The cut sample exhibited tear characteristics. Stress corrosion cracking was exhibited by dissolving polyetherimide in a partially halogenated hydrocarbon, trichloroethane.

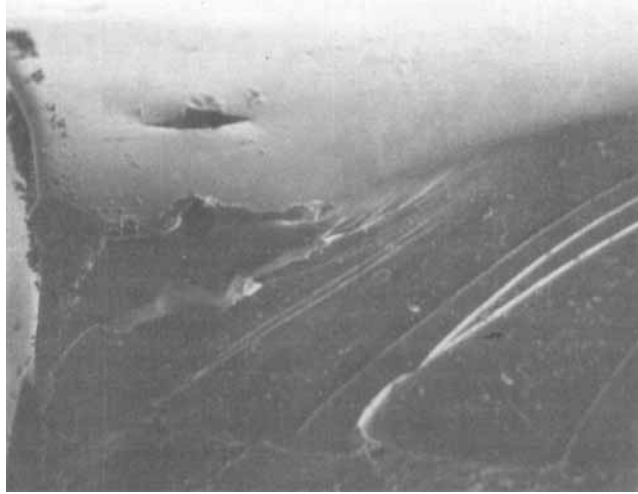
FIGURE 7 SEM photograph of the bending fracture surface.

A pronounced void was revealed in the sample at the upper left side of the slightly mirrored fracture surface in Figure 7. Craze and fracture bands can be observed at the edge of the mirror. A wavy formation of a tear fracture can also be noted in the SEM photograph shown in Figure 7.

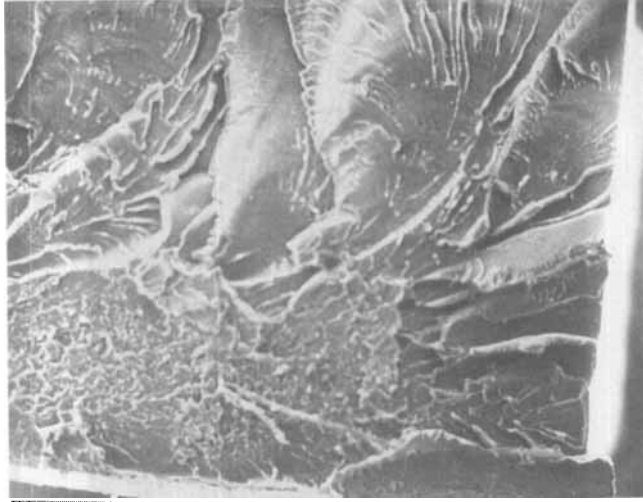
FIGURE 9 SEM photograph of notched edge at higher magnification.

a “flaky” fracture surface morphology over the entire surface and a feathery texture of the concave areas within the fracture paths as shown in Figure 9.<sup>1</sup>

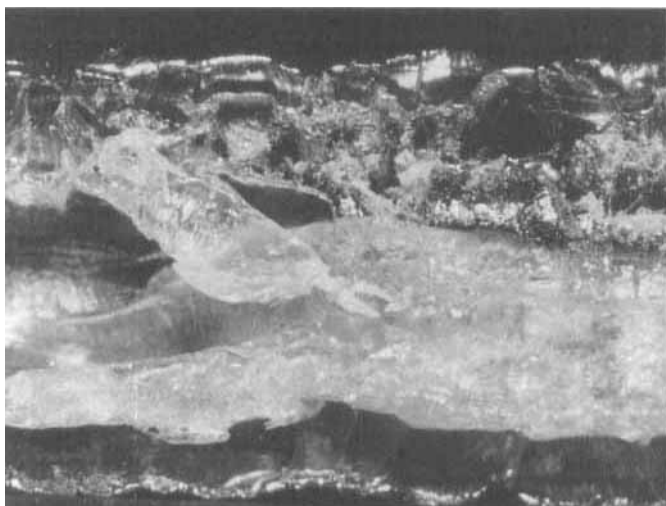
FIGURE 16 Stereomicroscope photograph upon dissolution in trichloroethane.

was allowed to remain in the solution of trichloroethane for a long period of time, dissolving of the sample occurred as shown in Figure 16.
