Degradation mechanism of the misch metal alloy hydride electrodes

Xia Baojia*, Shi Pengfei, Yin Geping, Zhou Ding

Abstract

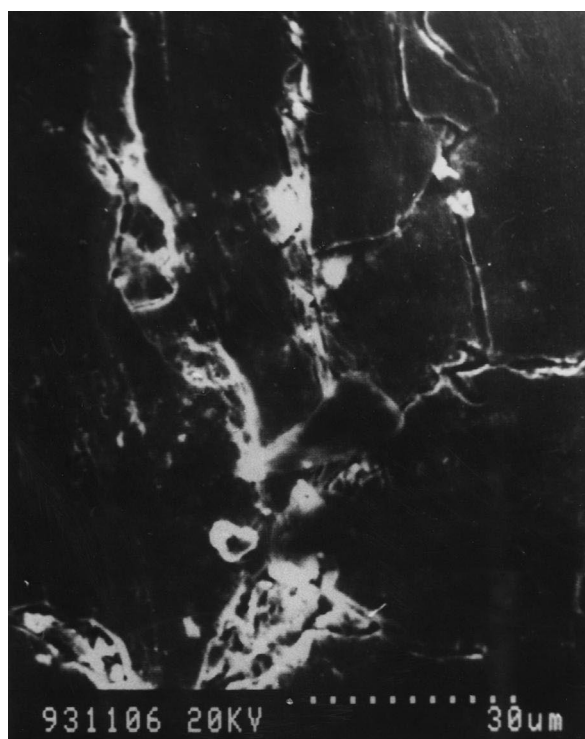
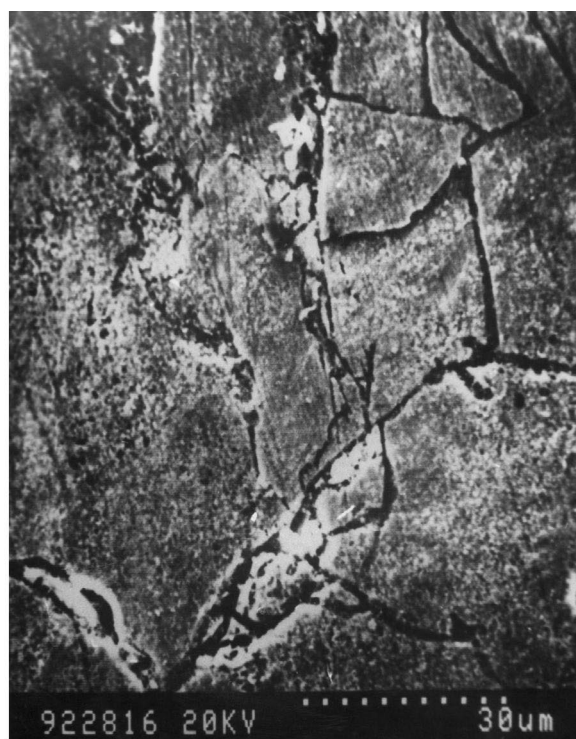
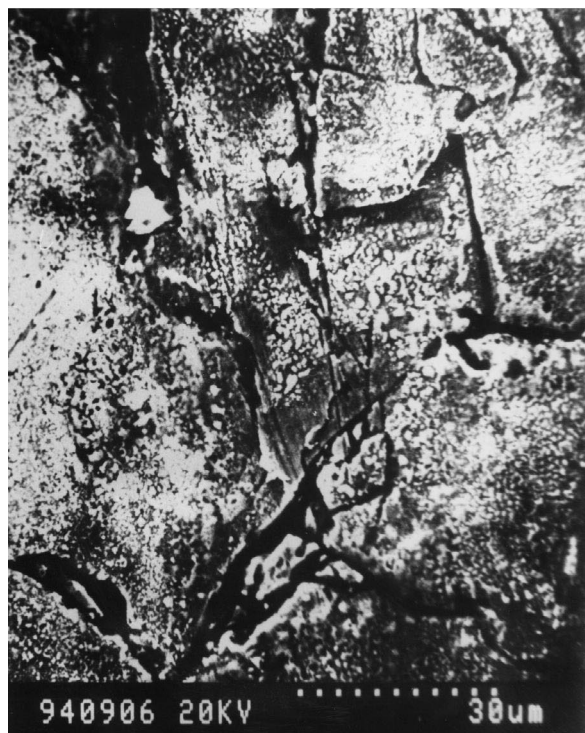
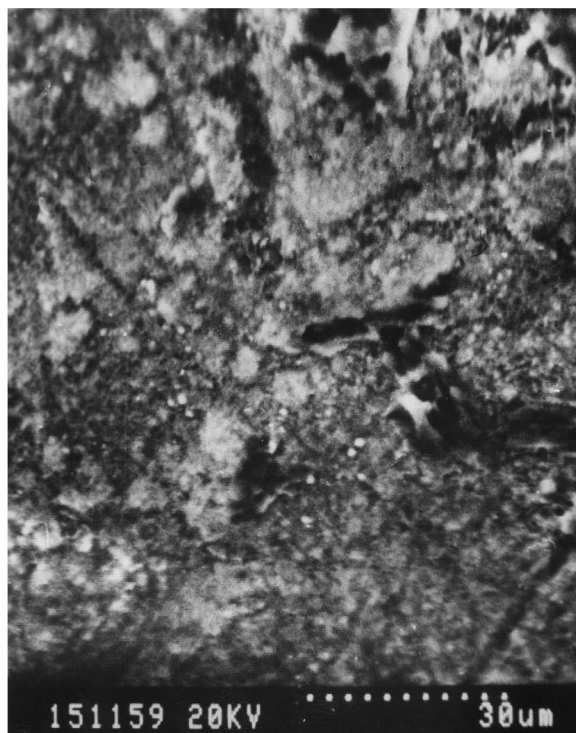
Fig. 1. Morphologies of the WEs in H_2 and O_2 . (a) 0 h (in H_2); (b) 10 h (H_2); (c) 100 h (H_2); (d) 200 h (H_2); (e) 0 h (in O_2); (f) 10 h (O_2); (g) 100 h (O_2); (h) 200 h (O_2).

Fig. 1a–d shows that in H₂ atmosphere WEs expanded evidently, the surfaces were corroded seriously, and the pits were obvious on the surface after 10 h of charging. Intergranular boundaries were thickened after 100 h of

charging, and the area of smooth surface reduced remarkably.

Experimental results are shown in Fig. 1.

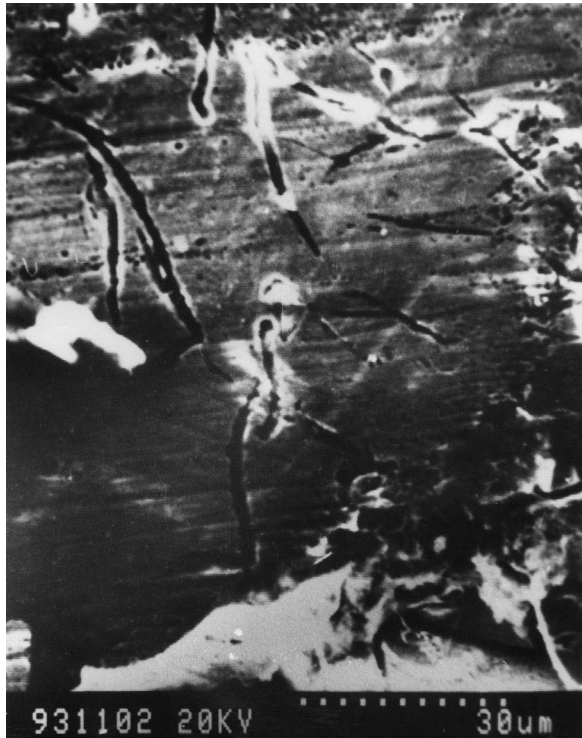
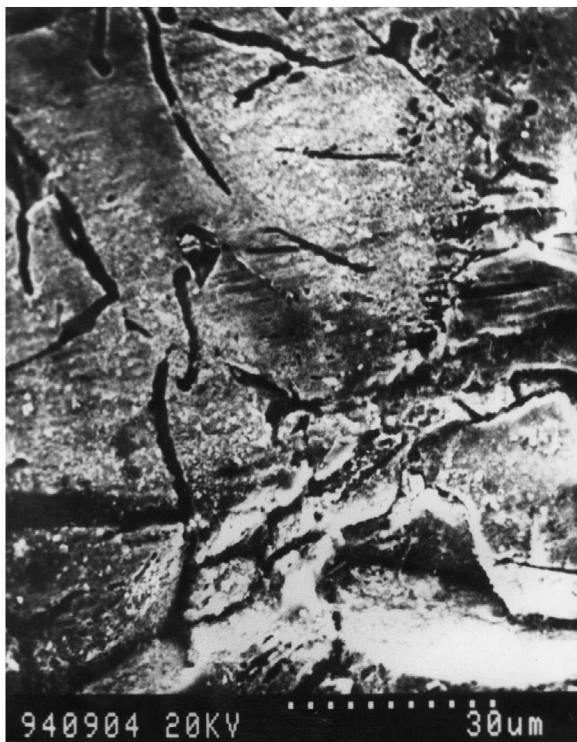
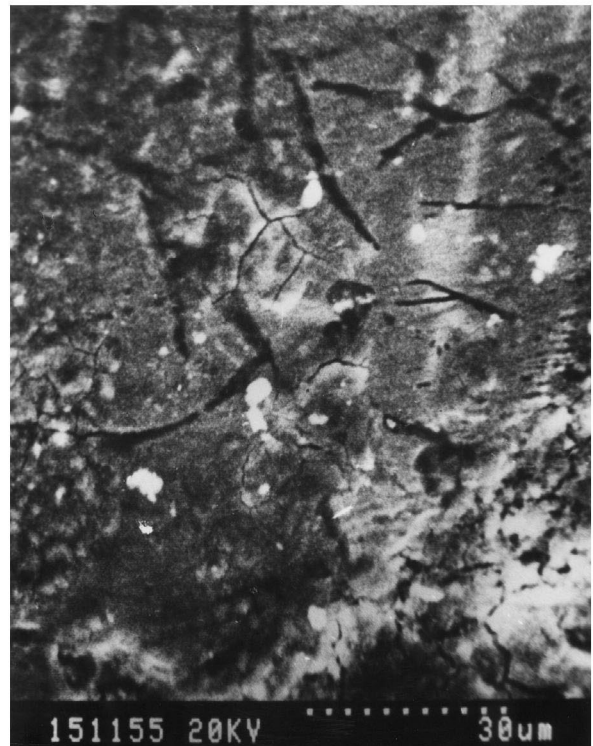
Fig. 1. (continued)

Fig. 1e–h shows that the changes of electrode surface in O₂ atmosphere were much less than that in H₂ atmosphere within the same time of charging. Although the intergranular boundaries were thickened slightly, the surface of WEs were still smooth. Therefore we believe that the main causes for the degradation of WEs are the increase of internal stress, the expansion of crystal lattice and the preferential dissolution of Mm in a charged state, rather than the oxidation of the alloy by oxygen.

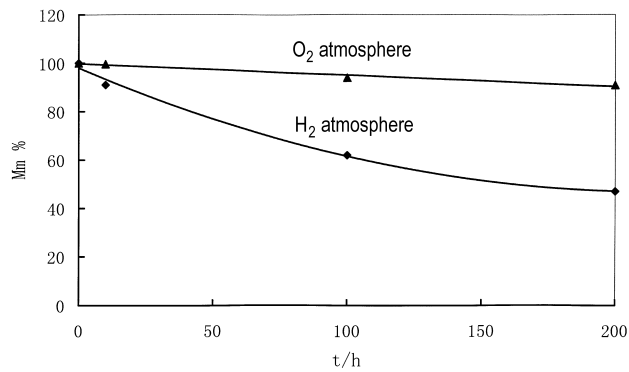
It can be seen from the data that the contents of Mm on the surface rapidly decreased with the duration of charging in H₂ atmosphere, and rather slowly in O₂ atmosphere, as shown in Fig. 2.

Fig. 2. Relations of contents of Mm and charging time.
