## Letter to the editor

### Fracture of laryngoscope blade

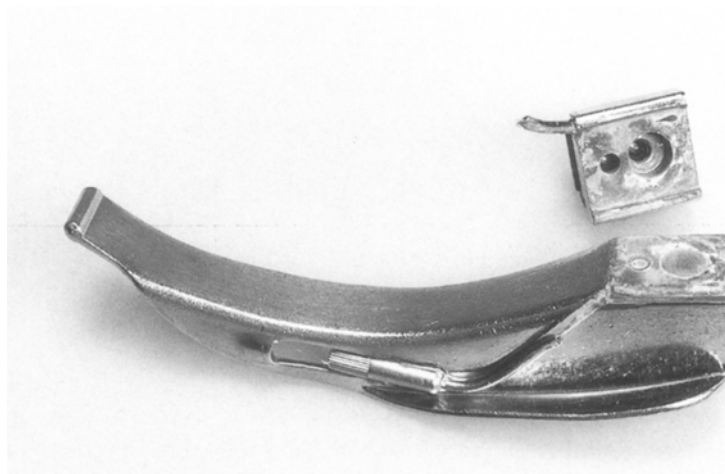
A 55-year-old woman with opacity of the vitreous was scheduled for vitrectomy. Anesthesia was induced with i.v. 200 mg of thiamylal, and ventilation was assisted using nitrous oxide (66%) and isoflurane (2%) in oxygen. After i.v. 6 mg of vecuronium was administered, an attempt was made to intubate the trachea using a laryngoscope with a #3 blade. When the blade was inserted into the vallecula and the laryngoscope was pulled forward and upward for orotracheal intubation, the blade abruptly fractured where the hook-on base was attached to the web (Fig. 1). Fortunately, the teeth

**Fig. 1.** Laryngoscope blade fracture between hook-on base and web

Since laryngoscope malfunction is a frequent problem [1], the user should keep at least two laryngoscopes on hand, each fitted with the type of blade the user anticipates will be best for the patient, and the light of each laryngoscope should be checked for adequate intensity. We had preoperatively confirmed that the size of the blade was suitable for the patient and that the light had adequate intensity; we had not noticed any looseness between the base and the web of the blade. Thus, this fracture appears to have been induced by the force of orotracheal intubation in the present patient.

The blade of a laryngoscope is composed of several parts: base, tongue, flange, web, tip, and socket [2]. The hook-on base and web are welded together; however, considerable force is exerted on the face when the laryngoscope is pulled forward and upward to the glottis for each orotracheal intubation. This blade had been in service for over 15 years; the long use might have induced metal fatigue.

Although there are some reports describing aspirated laryngoscope bulbs [3,4], to our knowledge, no other instrument hazards associated with the laryngoscope have been reported. Fracture between the base and the web of the blade appears to be a rare case of failure. Since it was probably due to metal fatigue of the blade, we should keep in mind that even metal components
