Operating table failure and suggested safety precautions

To the editor: The Jackson Spine Table has been introduced to facilitate spine surgery involving fusion and instrumentation [1]. A recent paper has documented a patient falling from a Jackson Table (MIZUHO OSI, Union City, CA, USA) during anesthesia when the indicator lights on the bed were lit, confirming rotational locked status [2]. However, it has not been confirmed whether one can intentionally rotate this table in the condition in which the 180° rotation lock indicator is illuminated. As shown in Fig. 1a, the addition of some weight (80 kg) at the right side was capable of producing rotation of

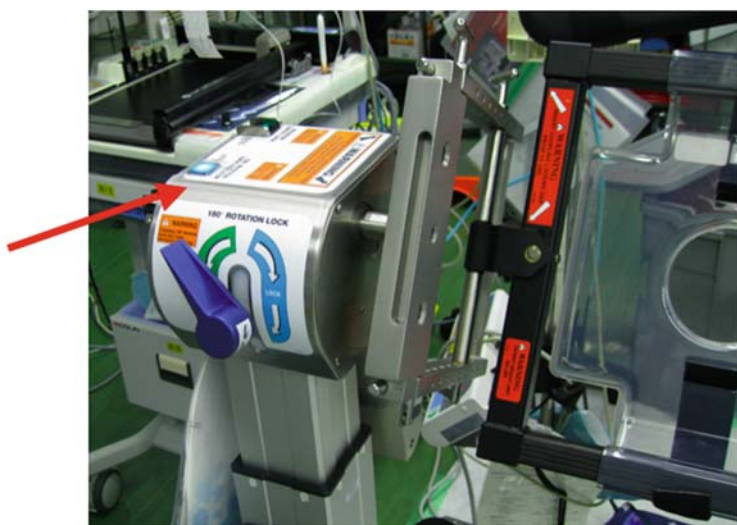
Fig. 1. **a** The OSI Jackson Table model #5843 can rotate in a condition in which the 180° rotation lock indicator is illuminated (*red arrow*). **b** A gap between the 180° rotation lock lever and the head-end base surface (between the *blue arrows*). **c** A 5-mm-thick rubber board (*black arrow*) is placed between the 180° rotation lock lever and the head-end base surface to ensure that the lever is safely secured

the table when we turned the rotation lock lever clockwise until the lock indicator was lit, but the lever was not fully rotated. This is apparently contradictory to the operating manual, which describes that when the 180° rotation lock indicator is illuminated, the light indicates the lock is engaged and the table cannot be rotated 180° [1]. We found the gap between the 180° rotation lock lever and the head-end base surface was 8 mm upon the table rotation and the gap was 5 mm when the lock lever was secured (Fig. 1b). It is also crucial to note that the 180° rotation lock lever does not simply act as a lever switching to the left or right, and that upon the rotational locked status, the operator has to rotate the lever clockwise more than 360° until it is secured. These shortcomings appear to be the reasons for the operating failure of a Jackson Table. Accordingly, we prepared a 5-mm-thick rubber board and adopted it to show the correct direction of the 180° rotation lever to lock the Jackson Table, as well as appropriate degree of the locking crank rotation (Fig. 1c). We decided to put this board between the 180° rotation lock lever and the head-end base surface, and to turn the lever clockwise until it was attached to the indicator board to ensure that the lever was

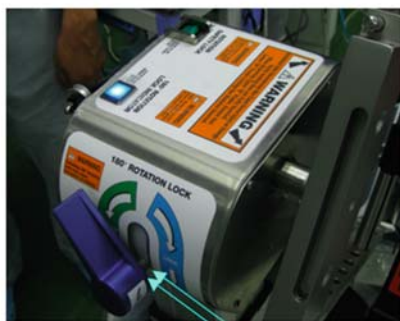
b

A gap between the 180° rotation lock lever and the head end base surface
