The Effect of Water Lubrication on Polymer Wear under Rolling Contact Conditions

M. D. LUTTON and T. A. STOLARSKI*

Department of Mechanical Engineering, Brunel University, Uxbridge, Middlesex UB8 3PH, U.K.

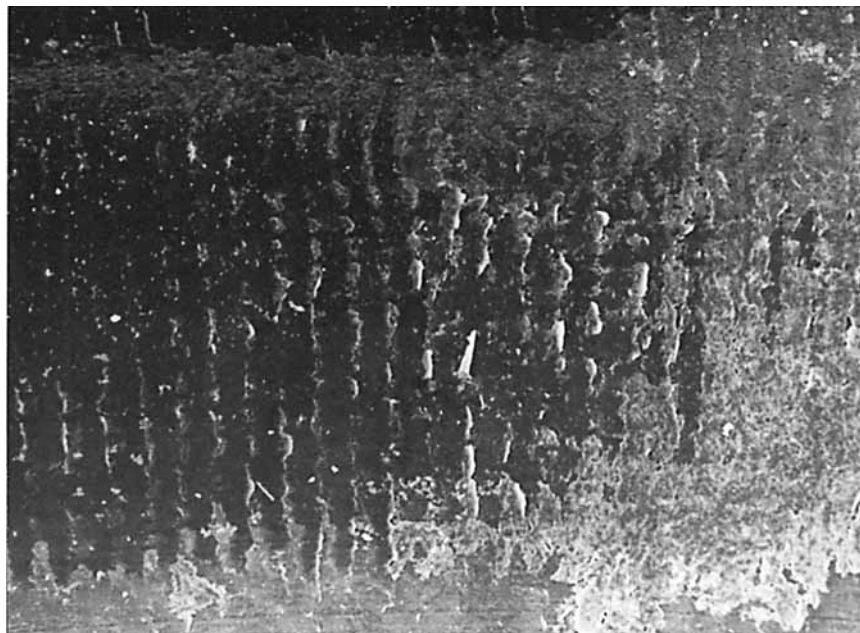
Figure 4 Trailing edge of reattached polymer at magnification ($\times 50$). Remaining data as in Fig. 3 legend.

A close-up of the leading edge of this patch, Figure 4, shows vertical lines of reattached material that have started to form. If the test had continued, these

lines would have eventually merged and formed an area as seen in Figure 3. There are a number of possibilities as to the reason the polymer has formed these vertical lines. One reason is that a slight vibration of the apparatus might cause the balls to run unevenly on the cup surface, thus attaching ma-

terial at regular intervals. However, an alternative reason could be that the surface was rippled by the motion of the balls and that the flakes produced by fatigue of the polymer have been reattached to the ripples. Figure 5 shows the extreme bottom edge of the above-mentioned reattached flakes. Here it is

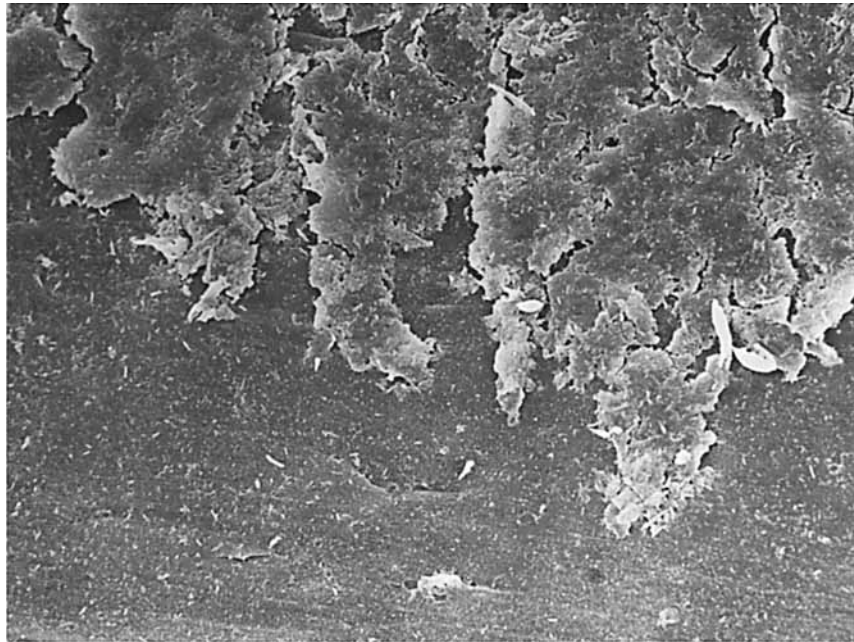
Figure 5 Extreme bottom edge of contact path region at magnification ($\times 500$). Remaining data as in Fig. 3 legend.

possible to see how four lines of transferred material are forming into one continuous layer. The photograph also shows how the polymer flakes were pressed on top of each other to form this layer.

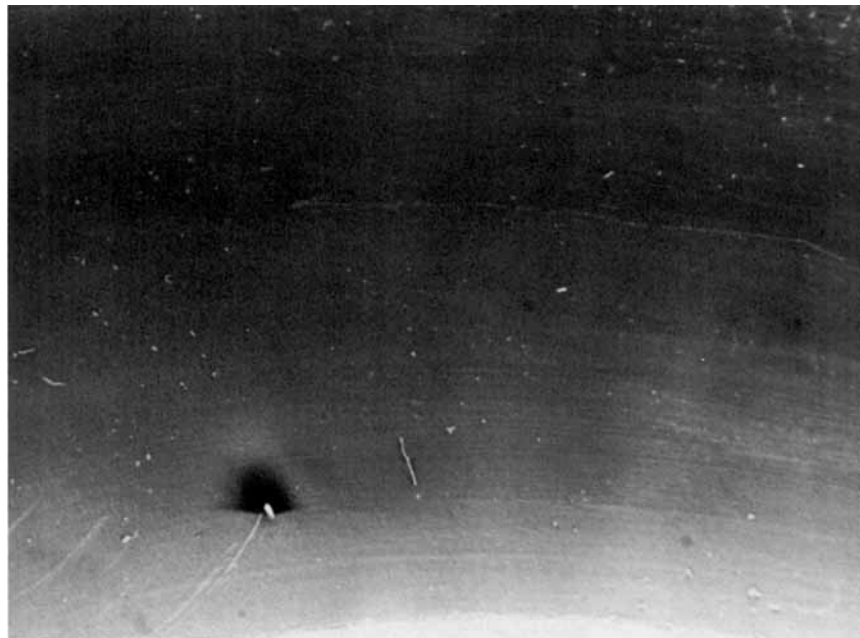
Figure 7 Section of the contact path at magnification ($\times 12$). Nylon 6.6 cup. Velocity: 400 rpm. Load on the contact: 120 N. Dry conditions.

Figure 7 shows a similar cup area to that shown in Figure 3, but after a test under dry conditions. A contact path is barely visible as a band running from

right to left across the photograph. Machining marks can still be seen above and below the contact path. Figure 8 shows the same region in more detail at higher magnification.

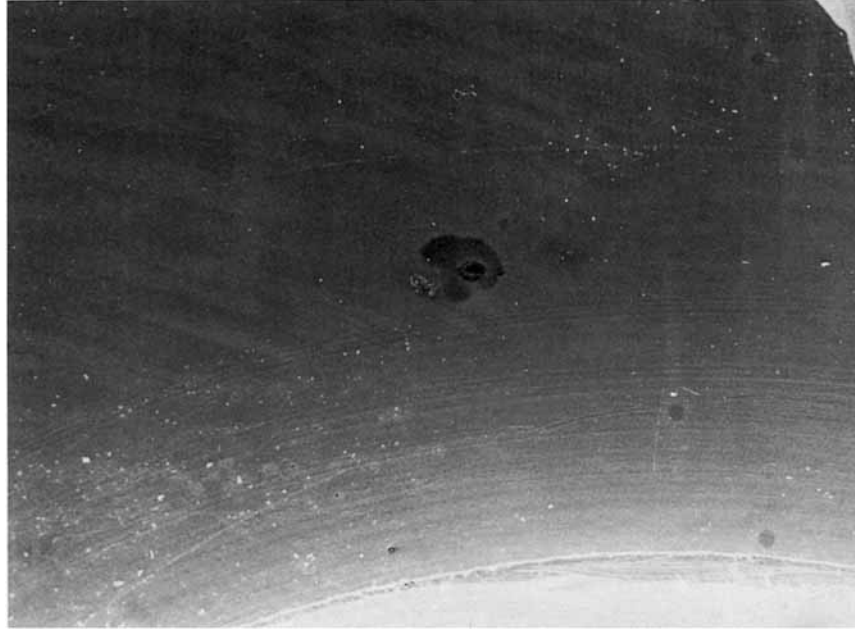
Figure 13 Contact path at magnification ($\times 20$). Polyacetal cup. Velocity: 400 rpm. Load on the contact: 160 N. Dry conditions.

For comparison, a polyacetal cup was also tested under dry conditions. Figure 13 shows that in dry

conditions the contact area is affected less than it is under water lubrication conditions. At higher magnification, shown in Figure 14, it is seen that some damage has occurred. This could be produced by the action of ball motion causing flattening of machining marks within the contact path.
