Complications During Herbst Appliance Treatment

ETJE SANDEN, DDS, DMD
HANS PANCHERZ, DDS, OD, FCDS HK(Hon.)
KEN HANSEN, DDS, OD

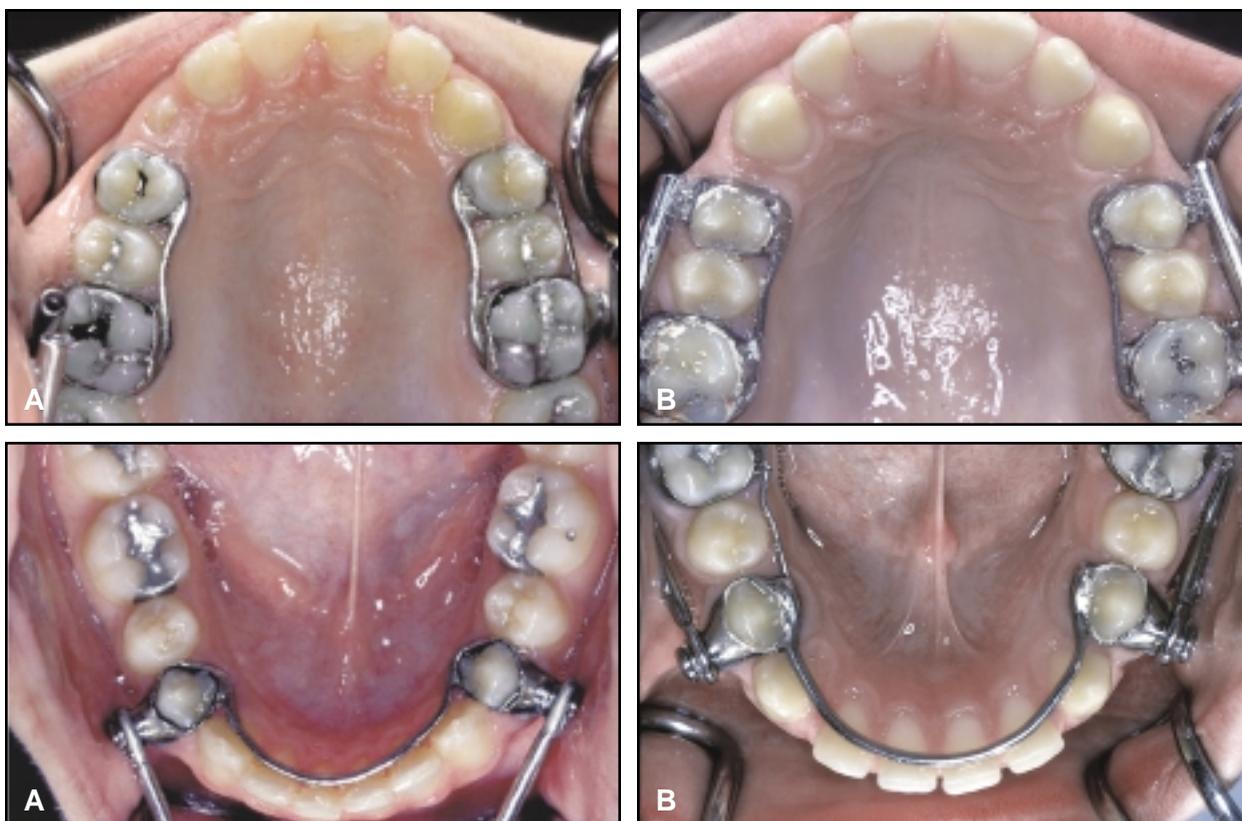
Fig. 1 Banded Herbst appliance. A. Partial anchorage. B. Total anchorage.

Two forms of anchorage were used for the banded Herbst appliance (Fig. 1). Either the mandibular first premolars only (partial anchorage) or the first premolars and first molars (total anchorage) were banded. The first premolars were connected with a sectional wire contacting the lingual surfaces of the anterior teeth. With both types of mandibular anchorage, the maxillary first premolars and first molars were banded and connected with sectional lingual wires.

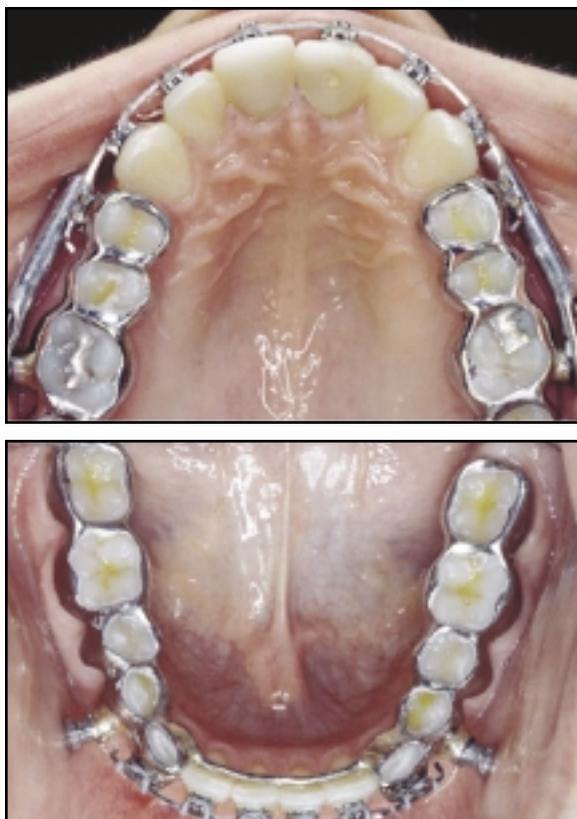
Fig. 2 Cast-splint Herbst appliance.

In the cast-splint Herbst appliance, the bands were replaced by cobalt chromium splints

(Fig. 2). In the maxillary arch, the splints covered the premolars and first molars; in the mandibular arch, the canines, premolars, and first molars. The splints in both arches were connected with sectional wires.

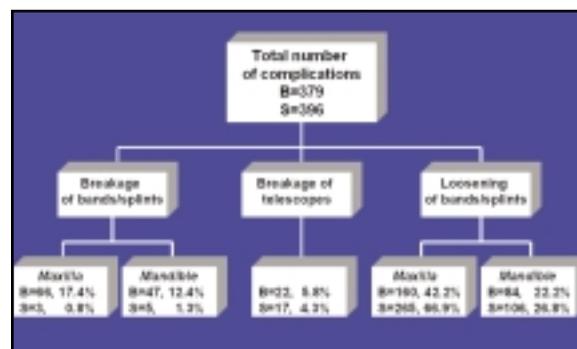
Fig. 3 Frequency and type of complications in 90 subjects treated with banded Herbst appliance (B) and 110 subjects treated with cast-splint Herbst appliance (S).

Of the 134 banded Herbst patients, 44 (33%) showed no complications during treatment. The remaining patients experienced 379 complications, which were categorized as follows: 17.4% maxillary band breakages, 12.4% mandibular band breakages, 5.8% telescope breakages, 42.2% maxillary band loosening, and

22.2% mandibular band loosening (Fig. 3).

Seventy-two (40%) of the 182 cast-splint Herbst patients had no complications at all. The remainder experienced 396 complications: .8% maxillary splint breakages, 1.3% mandibular

splint breakages, 4.3% telescope breakages, 66.9% maxillary splint loosening, and 26.8% mandibular splint loosening (Fig. 3).

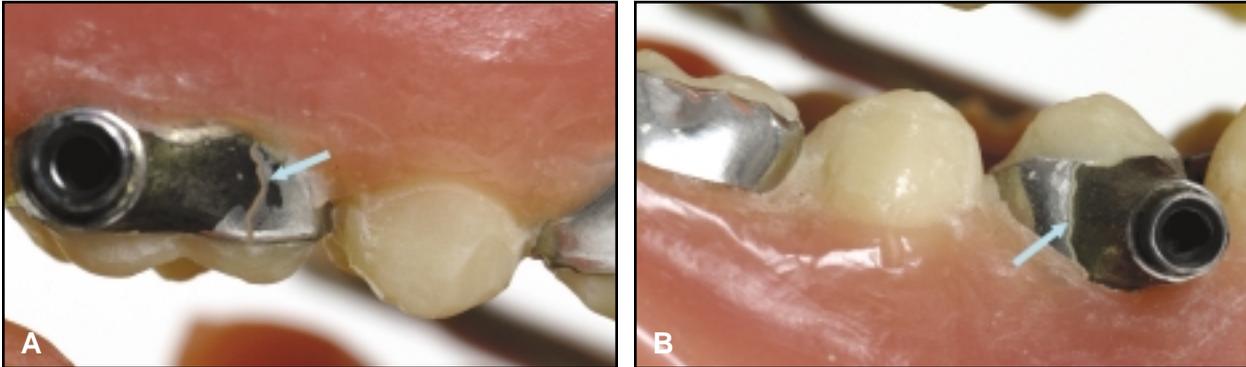
Fig. 4 Common band breakages. A. Mesiobuccally at maxillary first molar. B. Distobuccally at mandibular first premolar.

much thicker than the .15-.18mm band material, which is further weakened by soldering when the axles are attached to the bands. Because of the forces acting on the upper and lower anchorage teeth, the majority of band breakages were seen mesiobuccally at the maxillary first molar bands and distobuccally at the mandibular first premolar bands (Fig. 4). The few cast-splint breakages noted were caused by the casting material being too thin (Fig. 5).

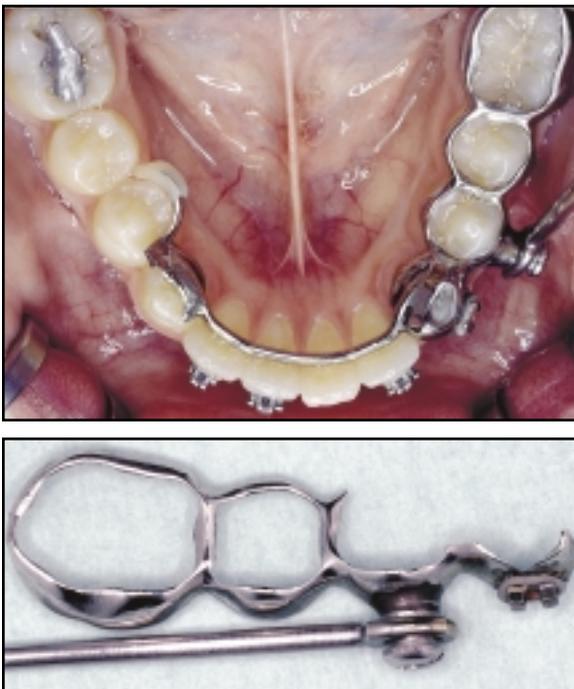
Fig. 5 Cast-splint breakage at mandibular first premolar.

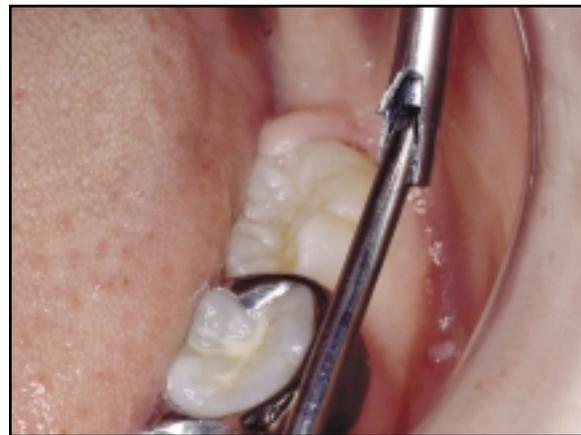
Fig. 6 Bent plunger and split tube of telescoping mechanism.

Telescope breakage was about equally common in both groups. This complication tends to occur in patients who can open their mouths so wide that the tube and plunger nearly disengage from each other. The patient then panics, closing the mouth so forcefully that the plunger gets stuck in the tube opening and bends or causes the tube to split (Fig. 6). Patient education is important in preventing this problem, as is ensuring that the plunger is long enough.

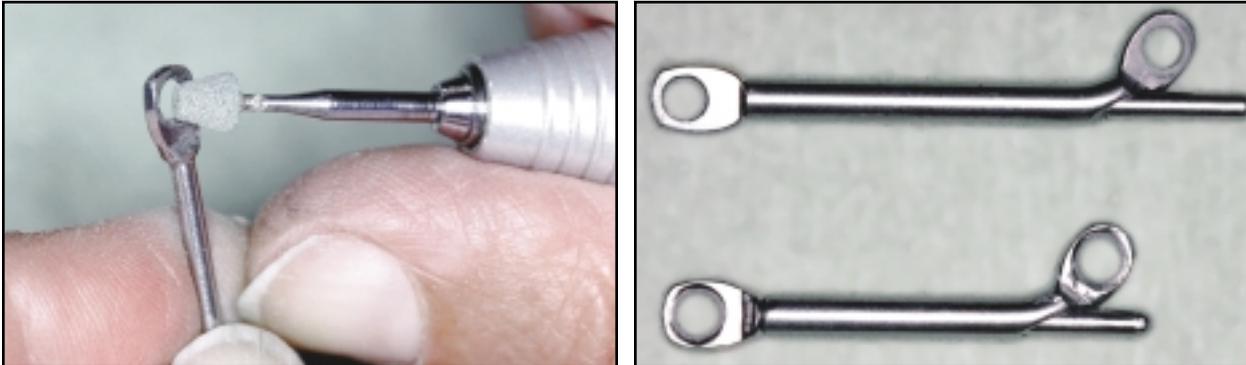
Fig. 7 Pivot openings of plunger and tube widened to enhance lateral movement of mandible.

In general, loosening and breakage of bands and splints are caused by the biting and chewing forces transmitted by the telescoping mechanisms to the anchorage units. An adequate capacity of lateral jaw movement is critical in reducing the lateral component of force transmission. In our department, this is enhanced by widening the pivot openings of the plunger and tube (Fig. 7). The forces acting on the bands and splints can also be reduced by advancing the mandible in stages rather than all at once. Further research is needed in this area.
