WEAR ON St.5 STEEL DUE TO JETS OF DILUTE
AQUEOUS SOLUTIONS CONTAINING HIGH
POLYMERS OF VARIOUS TYPES

I. M. Gryaznov and A. M. Kudin

Wear cavities in St.5 steel samples created by jets of aqueous solutions containing polymers of various kinds are examined; the cavities are evidently formed by an impact mechanism arising as a result of the sudden deceleration of viscoelastic associates of the polymer solutions at the steel surface.

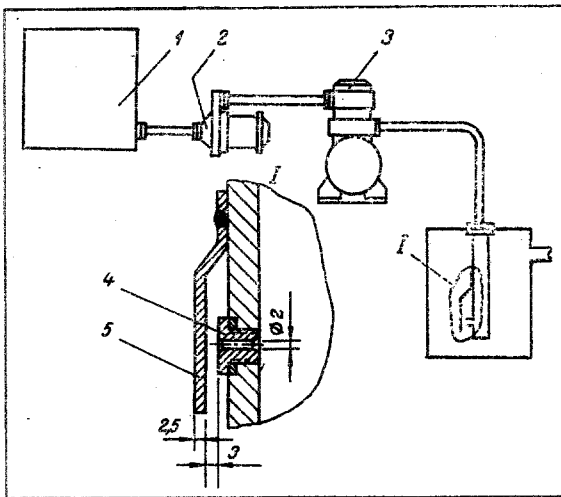
In order to study the effect of the liquid jet on the metal samples we used the apparatus depicted schematically in Fig. 1. From the vessel 1 the solution was directed by means of the centrifugal pump 2 to the plunger (piston) pump 3, which raised the pressure of the liquid to 320 atm and gave a rate of flow

Fig. 1. Arrangement of the apparatus.

equal to 1.1 liter/sec. The high-pressure liquid passed to the nozzle 4 which had an internal diameter of 2 mm. The sample 5 was placed perpendicularly to the jet of liquid, at a distance of 3 mm from the tip of the nozzle.

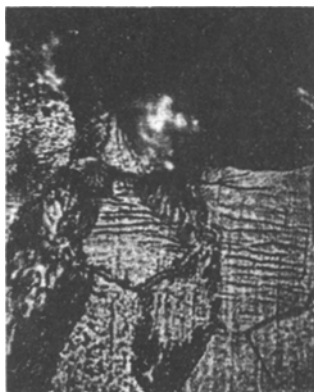
On the sample subjected to the jet of polymer solution, the edge of the cavern was characterized by bending of the grains and series of slip bands, indicating plastic deformation (and hence work hardening) in a very narrow zone 1–3 grains thick. Figure 2 clearly shows the branched slip bands characteristic of ferrite. It should be noted that in no case did twins appear in the ferrite grains of the work-hardened layer or in its neighborhood.

Fig. 2. Slip bands in ferrite grains at the edge of the cavity. $\times 2000$.

The average microhardness (H_{20}) at the edge of the cavern was 227 and at a distance of 0.05 mm from the edge 170 (in the original structure it was 170). The microhardness at the edge of the cavity was

clearly higher than in the interior of the sample as a result of work hardening.

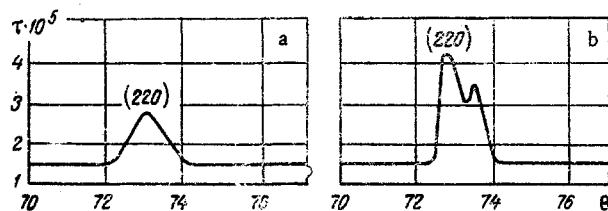
Fig. 3. X-ray recordings of the (220) done before and after removing the work-hardened layer: a) after the action of a jet of polymer solution; b) the same place after removing the work-hardened layer; τ , pulses /min, θ , deg.

In order to avoid errors during the recording of the x-ray diffraction patterns, the cavity was etched in the sample holder, i. e., the latter was not readjusted. After the action of the jet of polymer solution, the (220) lines were broadened and the doublet became diffuse, these effects vanishing after deep etching. There was also a sharp (~50 times) reduction in block size, an increase of an order of magnitude in the microstresses within the steel, and also an increase in the number of crystal-lattice defects, this being a typical result of the plastic deformation of the metal (Fig. 3).

The fine crystal structure of the samples was studied by recording x-ray diffraction patterns in a URS-50I instrument, using the radiation of an iron anode and recording the intensities with a scintillation counter.

We used samples previously subjected to metallographic analysis. The x-ray beam was directed toward the bottom of the cavity. The sample was installed in the holder in such a way that the bottom of the cavity coincided with the reference plane of the holder. X-ray diffraction patterns were recorded before and after etching.

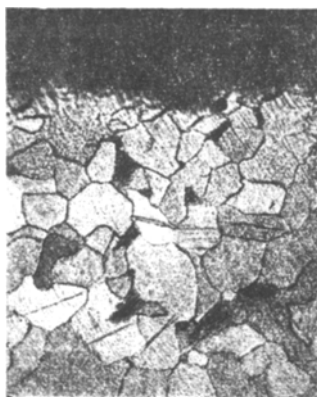
For comparison purposes we made some experiments to determine the effects of a jet of sand-carrying water. The experiments were carried out with samples of St.1 steel. The action of the water jet containing 4 vol. % sand was far more intense than that of the water containing polymer additives with the apparatus working in the circulation mode; after 5 min a cavity 10 mm deep appeared in the sample. In this cavity we found a work-hardened layer and a large number of twins (Fig. 4). The latter indicated a severe impact action of the sand particles.

Fig. 4. Twins in ferrite grains at the edge of the cavern. $\times 400$.

The severe abrasive action of the water jet containing sand is due to the fact that the hardness of the sand particles is greater than the hardness of the steel, as a result of which, in addition to work-hardening, the sand particles cut the surface layers of the barrier.

The absence of twins during the action of the water jet containing polymers shows that in this case the steel barrier is receiving impacts from particles softer than sand. It would appear that the wear of steel by water jets containing soluble polymers constitutes a case of wear by particles with a hardness lower than the hardness of the metal.
