SEM Microstriation Characterization of Bullets and Contaminant Particle Identification

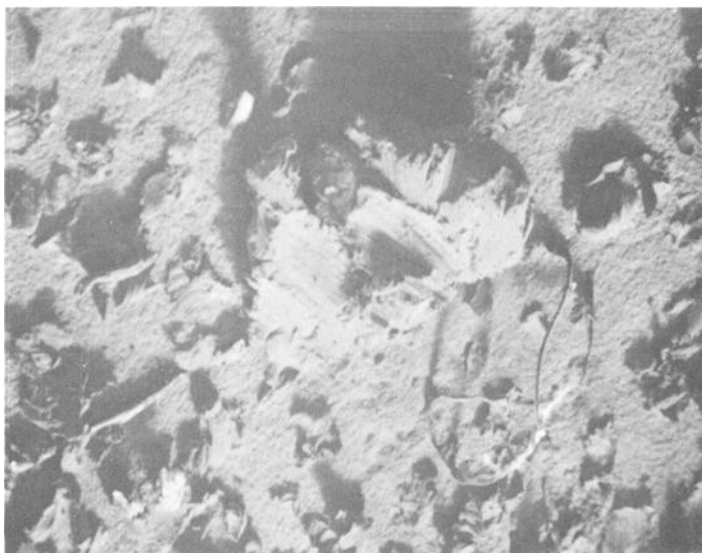
FIG. 11—SEM photomicrograph of contaminant particles obtained by vacuuming the clothing of a brass grinding room worker. Grinding striae visible on particles. Large particle gave chemical spectrum shown in Fig. 12 (original magnification $\times 65$).

Figure 11 shows a scanning electron micrograph of a particle obtained by vacuuming the clothing of a brass grinding room worker. The surface of the particle is rough and scarred with parallel scratches which are likely to be the result of the grinding process. The X-ray spectrum of the particle showing its chemical construction appears in Fig. 12. The element in greatest concentration is copper, which is indicated by the tallest peak. Zinc, an alloying element in brass, is present in the particles, as well as silicon, sulfur, and other trace elements. The particle was observed in the light microscope and had the

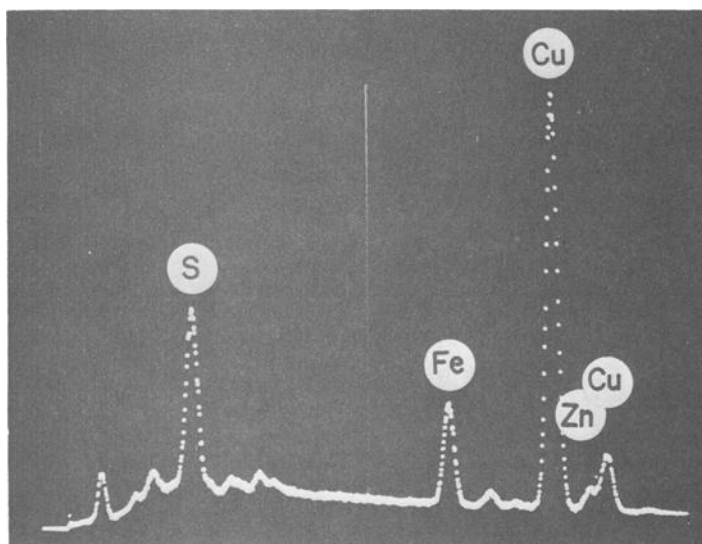
FIG. 12—Energy dispersive X-ray analysis spectrum (EDS) of the large particle in Fig. 11. Spectrum peak height gives semiquantitative information about the relative amounts of chemical elements contained in the particle. This particle shows copper and zinc expected from brass particle. Sulfur is present as an impurity. Iron and aluminum peaks are due to fluorescence of sample holder and stage.

Figure 13 shows an SEM micrograph of a particle obtained from a brass foundry worker. The particle is smooth and rounded. The spectrum (Fig. 14) shows an X-ray spectrum for the particle which is nearly identical to that of the particle of the brass grinding room worker (Fig. 12).

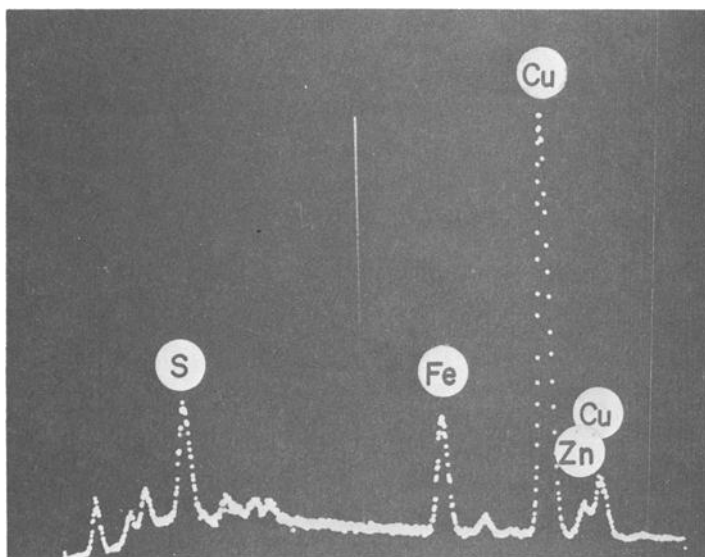
FIG. 14—EDS chemical spectrum of particle in Fig. 13. It is nearly identical to spectrum in Fig. 12.

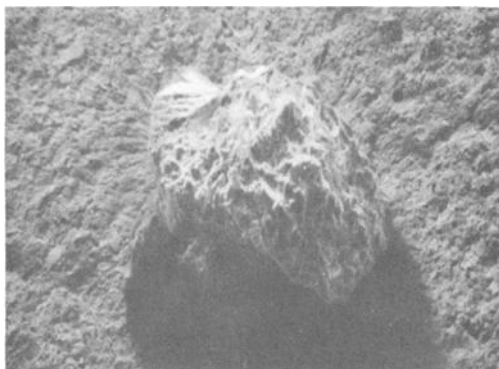
FIG. 16—SEM photomicrograph of contaminant particle obtained by vacuuming clothing of a quarry foreman. Rough surface morphology is typical (original magnification $\times 270$).

The appearance of a typical particle obtained by vacuuming the clothing of a quarry foreman may be seen in Fig. 16. The X-ray spectrum of the particles from this worker contained large quantities of calcium and silicon, which varied in relative concentration from particle to particle. Particles appearing black in the optical microscope typically contained more calcium, and particles appearing white or sandy colored contained more silicon. A typical spectrum is seen in Fig. 17. The particles obtained from the cement plant worker were smaller and uniform in size and texture. These particles gave chemical spectra of calcium and silicon in the same manner as in the quarry. Large quantities of the powdery material were obtained which appeared gray to the unaided eye, but could be resolved into the white particles and black particles by the optical microscope. The clothing of the office worker in the cement plant contained particulate matter within a
