## Use of Scanning Electron Microscopy and Energy Dispersive X-Ray Analysis (SEM-EDXA) in Identification of Foreign Material on Bullets

**REFERENCE:** DiMaio, V. J. M., Dana, S. E., Taylor, W. E., and Ondrusek, J., "Use of Scanning Electron Microscopy and Energy Dispersive X-Ray Analysis (SEM-EDXA) in Identification of Foreign Material on Bullets," *Journal of Forensic Sciences*, JFSCA, Vol. 32, No. 1, Jan. 1987, pp. 38-47.

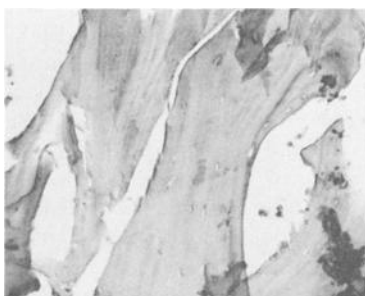
FIG. 9—This photomicrograph of one of the particles that was fixed, rehydrated, and processed for routine light microscopy demonstrates the typical lamellar pattern of bone. Lacunae are easily seen, although the cells are not apparent.

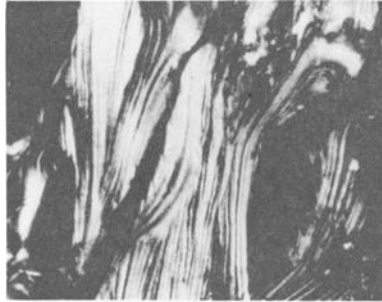
FIG. 10—This is the same particle of bone demonstrated in Fig. 9 now viewed in polarized light to confirm the typical birefringent nature of lamellar bone.
