Upper Cervical Trauma in Motor Vehicle Collisions

REFERENCE: Shkrum, M. J., Green, R. N., and Nowak, E. S., "Upper Cervical Trauma in Motor Vehicle Collisions," *Journal of Forensic Sciences*, JFSCA, Vol. 34, No. 2, March 1989, pp. 381-390.

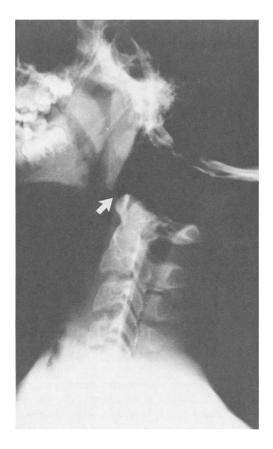
FIG. 4-Radiograph of atlanto-occipital dislocation, Case 2.

A 16-year-old male pedestrian, 175 cm tall and weighing 66 kg was struck by a late model sedan traveling 60 km/h (35 mph). Corresponding to right bumper and anterior hood contact, there were fractures of the left tibia-fibula and the left pelvis. Hyperextension of the thoracic spine caused fracture-dislocation of the eleventh thoracic vertebra. A tear of the descending thoracic aorta was also noted. Subgaleal hemorrhage was seen over the entire scalp. The atlanto-occipital ligaments were completely disrupted (Fig. 4) and the cervico-medullary junction was transected. The cervical spine was intact.

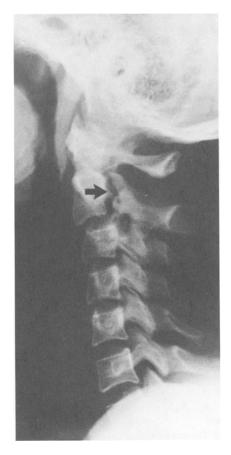
FIG. 8-Radiograph of axis pedicle fracture, Case 6.

A 34-year-old woman was the right front passenger in a car traveling 80 km/h (50 mph). The car went off the road, the front end hitting a culvert, which partially arrested the vehicle's forward motion. It became airborne for 9 m (30 ft) and landed on its roof. The subject was wearing a lap and torso belt with the bucket seat fully reclined. She was found tangled in the seat-belt webbing suspended above the underlying roof. She was briefly unconscious. Numbness and tingling in both shoulders, neck and shoulder pain, and decreased strength and numbness in the legs were noted. X-rays (Fig. 8) showed fractures of the axial pedicles. Halo traction improved leg symptoms, but right arm and hand weakness persisted for months.
