Examination and Analysis of Seat Belt Loading Marks

REFERENCE: Gorski, Z. M., German, A., and Nowak, E. S., "Examination and Analysis of Seat Belt Loading Marks," *Journal of Forensic Sciences*, JFSCA, Vol. 35, No. 1, Jan. 1990, pp. 69-79.

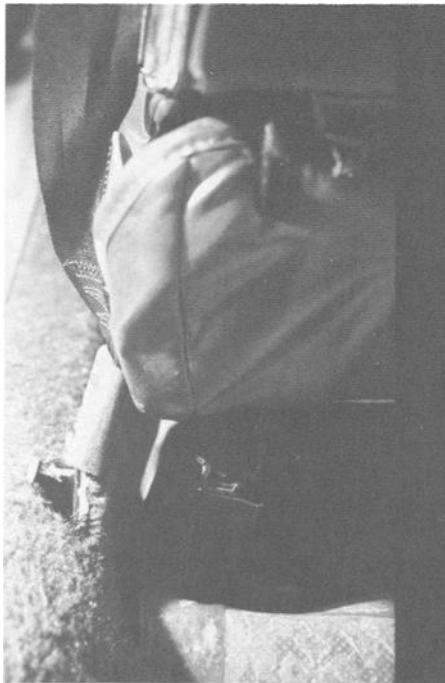
FIG. 3—During collision loading, the webbing that passes through a small access hole in the carpet rips it and makes the hole larger.

Sometimes the anchor bolt is covered by the floor carpet and the webbing passes through a small access hole. During collision loading the webbing may press against the carpet, rip it, and make the hole larger (see Fig. 3).

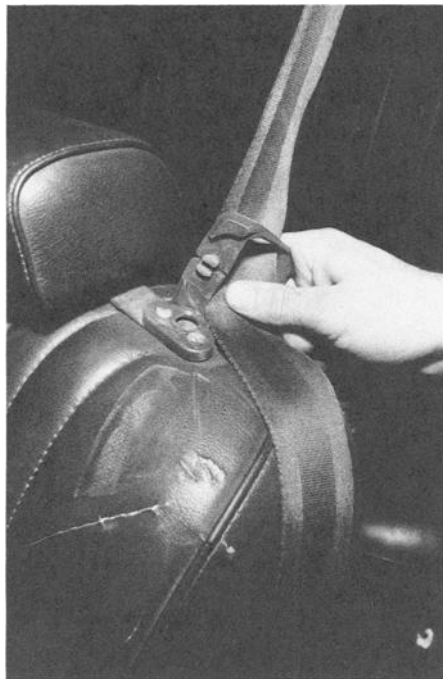
FIG. 6—During collision loading, the webbing can force the plastic guide located on the seat outboard top corner to pop out of its anchor or fracture.

Some seat back types have a plastic loop or guide located on their outboard top corner. This device works to guide the torso portion of the webbing into a proper fitting position. During collision loading the webbing can force the plastic guide to pop out of its anchor or it may simply fracture (see Fig. 6). Also, because this guide is often made of plastic, it will sometimes become abraded by the webbing. Either condition may add further proof to the suspicion that the belt was worn.

Note, however, that such evidence can be misleading as shown by the example in Fig. 6. A light-colored abrasion to the seat back shows the webbing was lying flat against the seat back when it was loaded (instead of over the driver's shoulder). Such loading occurs

when the seat back is loaded from the rear by another occupant, or by heavy cargo. The abrasion on the seat back travels too far down along the front surface of the seat back and is angled to the outboard edge of the seat instead of inboard. This loading pattern is indicative of the seat belt being in its stowage position at the time the load was applied.

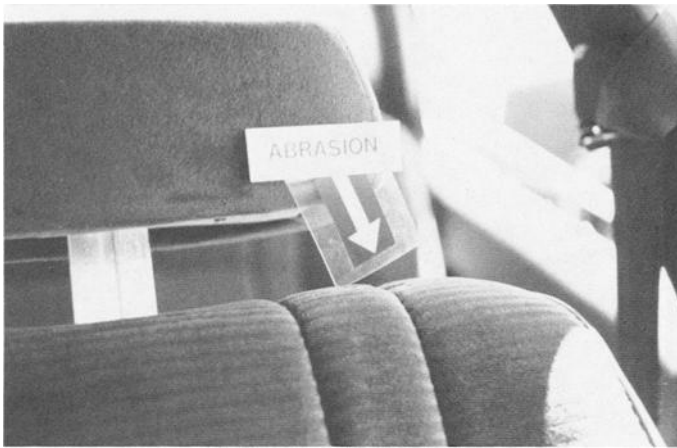
FIG. 7—In collision situations, the torso portion of the webbing can rub over the top surface of the seat back.

In other collision situations the torso portion of the webbing can rub over the top surface of the seat back. Such action can rub off some of the plastic, vinyl, or cloth material of the seat back and this may be transferred onto the webbing (see Figs. 7 and 8). Note that in this example, the seat belt was probably in use by the driver. The shoulder belt ran across the top of the seat back and over the driver's shoulder. Thus, the abrasion was located on the top surface of the seat back (rather than on the front surface as shown in Fig. 6).

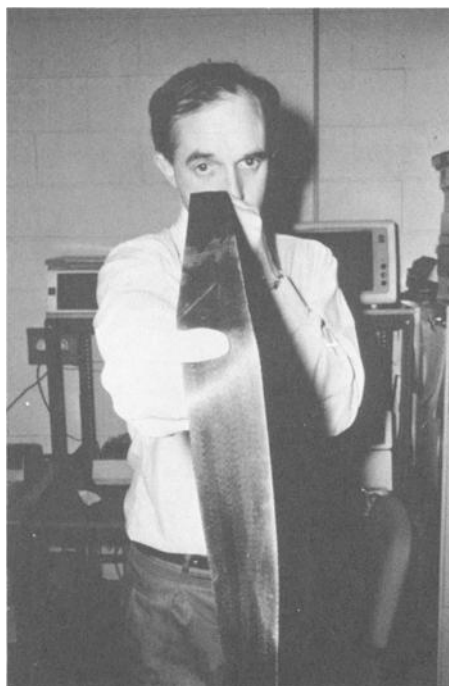
FIG. 11—Method for locating D-ring transfers on webbing.

Also note that sometimes D-ring transfers on webbing are faint and difficult to locate. A method for locating transfers is shown in Fig. 11. One end of the webbing is brought to the eye and the other is extended out with a straight arm. The investigator should scan the surface of the webbing for changes in material color, contours, and texture. The webbing should be moved to different positions and angles relative to a light source until the optimum viewing conditions are obtained.
