## Skull Fractures in Fatalities Due to Motor Vehicle Collisions

**REFERENCE:** Shkrum, M. J., Green, R. N., McClafferty, K. J., and Nowak, E. S., "Skull Fractures in Fatalities Due to Motor Vehicle Collisions," *Journal of Forensic Sciences*, JFSCA, Vol. 39, No. 1, January 1994, pp. 107-122.

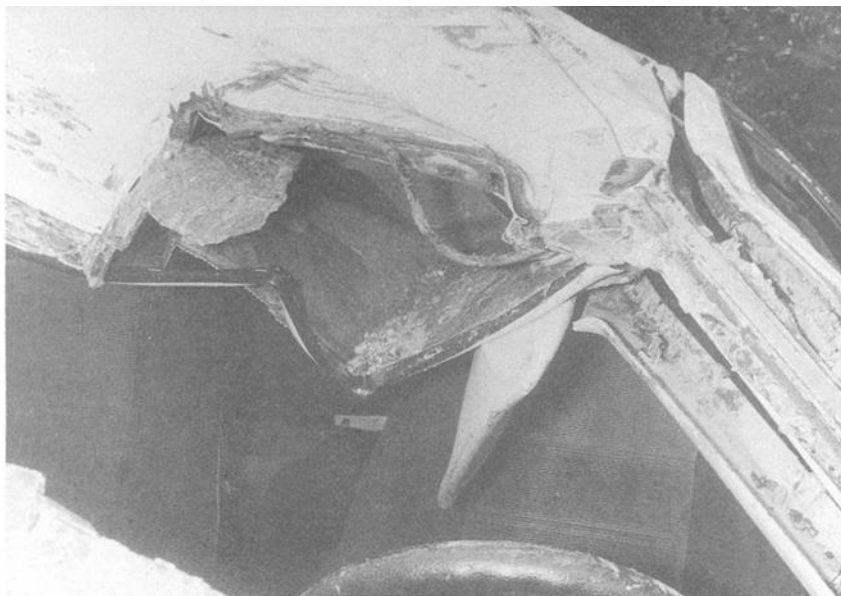
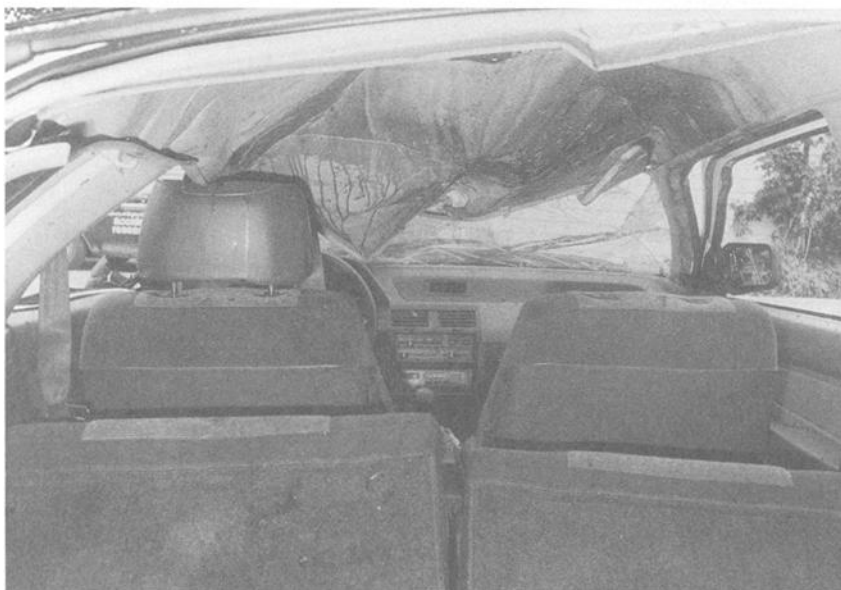
FIG. 5—a) *Skull fracture seen in restrained driver whose head contacted car roof following partial ejection on initial impact (driver's side). Fracture extended into base of skull.*  
 b) *Deformed roof (driver's side) from initial impact. Blood was noted on roof.*  
 c) *Driver found in her seat. Blood spatter on car roof interior from right scalp laceration.*

however, in one case of a partially ejected restrained driver, the fracture was more localized (Fig. 5). In another similar rollover, the head of the restrained driver, who was partially ejected, contacted the ground. The postmortem examination revealed severe crushing of the skull. No diagram was available.

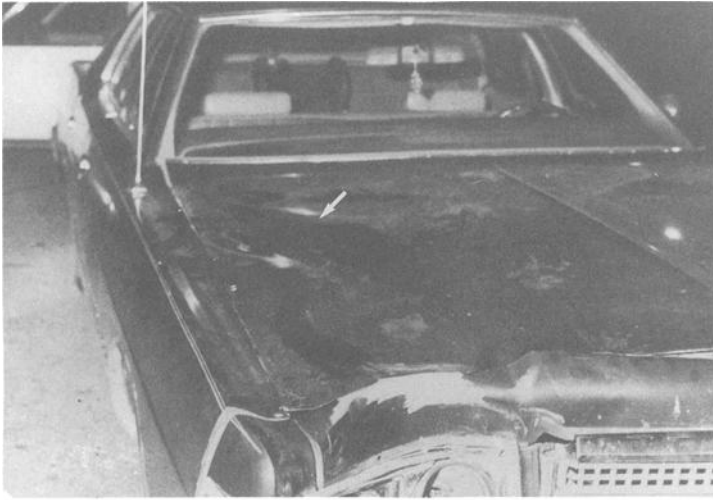
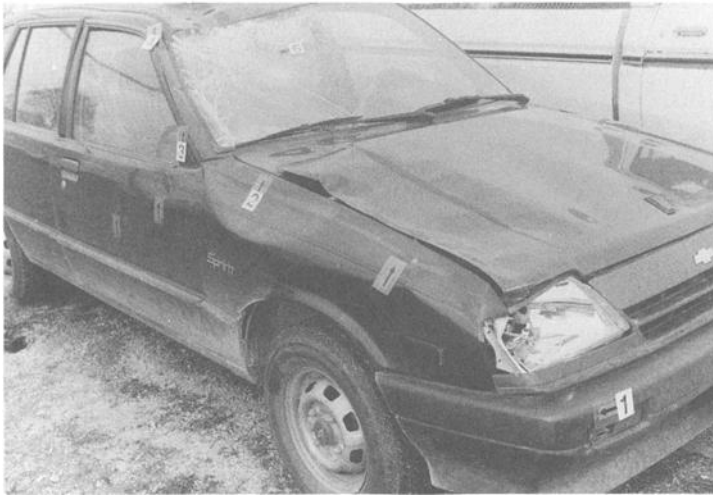
FIG. 6—Skull fractures observed in certain pedestrian-car collisions.  
a) 2 yr. old F. Head contact with hood edge (arrow) of car traveling about 50 km/h (30 mph).  
b) 20 yr. old M hit by car going about 35 km/h (22 mph). Contacted hood of vehicle (arrow).  
c) 29 yr. old M hit by car travelling 80 km/h (50 mph). Contacted hood, windshield and roof of vehicle (arrows).

Sixteen individuals (two children) died after being struck by cars. Ten were dead at the scene. Known head contacts included: hood edge (two-year-old and four-year-old hit by vehicles travelling at estimated speeds of 30 km/h (19 mph) and 50 km/h (31 mph) respectively); hood surface (four deaths, speeds estimated at 35 km/h (22 mph) and 60 km/h (37 mph) in two cases) and windshield area including A-pillar and roof rail (six deaths; in four cases, speeds estimated at 40, 55, 80, 100 km/h or 25, 34, 50, 62 mph, respectively). Of the 14 autopsies performed, five were illustrated by a skull diagram. Fracture patterns were noted (Fig. 6). Two cases had radiology reports available.
