## The Remains of Dr. Carl Austin Weiss: Anthropological Analysis

**REFERENCE:** Ubelaker, D. H., "The Remains of Dr. Carl Austin Weiss: Anthropological Analysis." *Journal of Forensic Sciences*, JFSCA, Vol. 41, No. 1, January 1996, pp. 60-79.

**ABSTRACT:** Anthropological analysis of the remains of Dr. Carl Austin Weiss revealed biological information consistent with his known characteristics. Postmortem changes included decomposition of amalgam dental restorations, likely releasing mercury that stained the anterior dentition, deposition of sulphur compounds on much of the skeleton, and the formation of numerous small bone fractures. Analysis revealed extensive perimortem trauma, indicating multiple gunshot wounds to the upper body. Trajectory analysis of the bony trauma suggested that at least 20 projectiles penetrated Dr. Weiss's body. They originated from many different directions, but mostly from the posterior. No bony changes associated with perimortem trauma of the hands were noted.

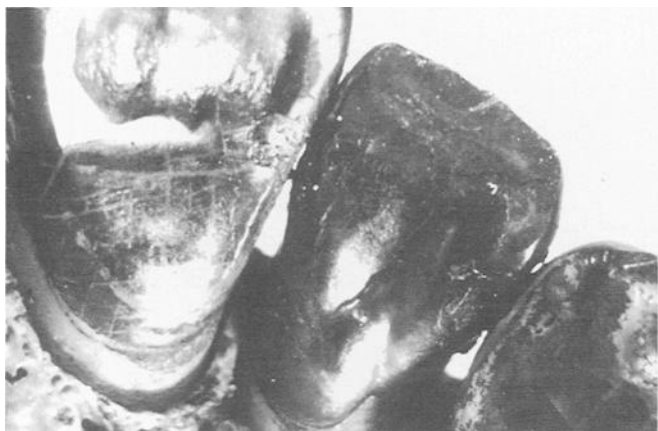
FIG. 4—Black metallic stain (mercury) on the lingual surfaces of the maxillary anterior teeth.

An unusual feature of the dentition of this individual was a metallic black stain on the anterior teeth. The stain occurred on the incisal one-third of the buccal surfaces of the following maxillary teeth: central incisors, left lateral incisor, and left canine. The

stain occurred on the lingual aspects of the crowns of all maxillary (Fig. 4) and mandibular (Fig. 5) teeth and was visible on the occlusal surfaces of the all anterior teeth (first premolars, canines, and incisors). The stain also was visible on the anterior lingual mandibular surface to gonion, excluding the rami. Analysis of the content of this stain by electron induced X-ray spectroscopy on a scanning electron microscope revealed the presence of mercury. Mercury was present at four sample sites: the lingual surface of the right central mandibular incisor (Fig. 6), the occlusal surface of the right central mandibular incisor, the buccal surface of the right central mandibular incisor and the lingual surface of the mandibular left first molar. Analysis of the medial surface of the left mandibular alveolus below the first molar also revealed the presence of mercury, in addition to the expected components of bone (calcium and phosphorus).

The metallic black stain in the mouth area of the skeleton represented mercury, likely originating from the dental amalgam restorations. These restorations appeared to be deteriorating, even to the point that they resembled temporary restorations. Analysis confirmed them as being permanent amalgam restorations (see above). They represented the most likely source for the mercury deposits, since the mercury was confined to the oral cavity in the immediate vicinity of the deteriorating restorations.

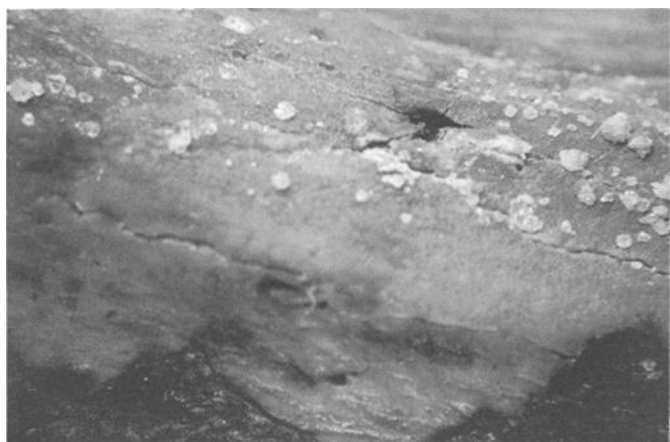
FIG. 11—Microscopic view of small white crystalline deposits on the diaphysis of the right second metacarpal.

The uniform distribution of these cracks and pits on the foot bones, as well as those from the hand, suggests that they all resulted from postmortem factors rather than perimortem trauma. The pits appear to correlate with the presence of small white crystalline deposits (Fig. 11) on the bone surface. When such a deposit was removed, usually a crater-like pit (Fig. 12) was present beneath the deposit in the bone surface. Electron induced X-ray spectroscopy using the scanning electron microscope suggested that the deposits were sulfuric in origin. Analysis of such a deposit from the distal articular surface of a right second metacarpal (Fig. 13) indicated a predominantly sulfuric composition, in addition to the normal bone calcium and phosphorus component. The material likely represents a calcium sulphate or calcium sulphite formed

through the long-term postmortem interaction of sulphur with the bone. Such deposits were noted on many bones of the skeleton.

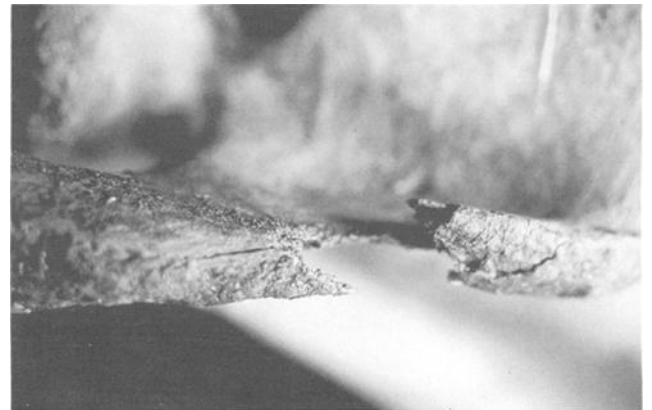
FIG. 20—Fracture of acromial process of left scapula, showing superior dislocation of fragment.

A perforation measuring about 8 mm × 19 mm was located on the left acromial process about 51 mm from the medial surface (Fig. 20). Associated fractures extended medially about 15 mm and anteriorly about 14 mm. Bone displacement was superior, indicating direction was from inferior to superior.

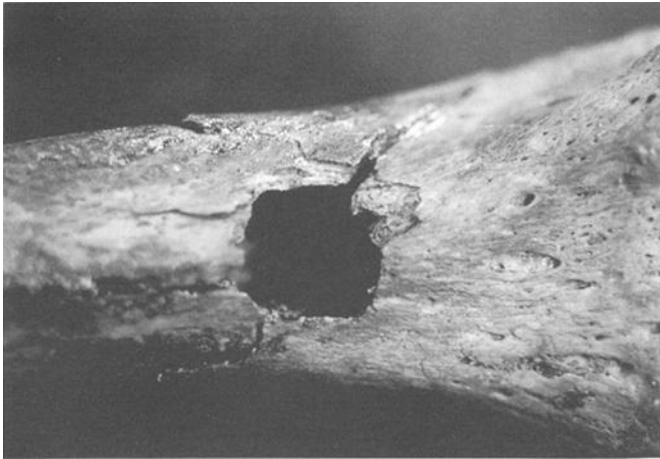
FIG. 22—Perforation in anterior medial surface of right humerus.

Extensive reconstruction revealed a large circular perforation, approximately 14 mm in diameter located on the anterior-medial surface about 60 mm distal from the humeral head (Fig. 22). Associated fragmentation caused separation of the humeral head. Copper staining was present on the external surface of the fragment on the lateral side. An additional radiating fracture extended distally on the posterior surface to a point 150 mm from the proximal end. Fragmentation primarily was concentrated on the anterior lateral surface. Smaller radiating fractures extended distally on the medial surface 12 mm and 20 mm. Some external bevelling was present on the lateral side of the perforation on the posterior side of the bone. Direction was from the anterior.

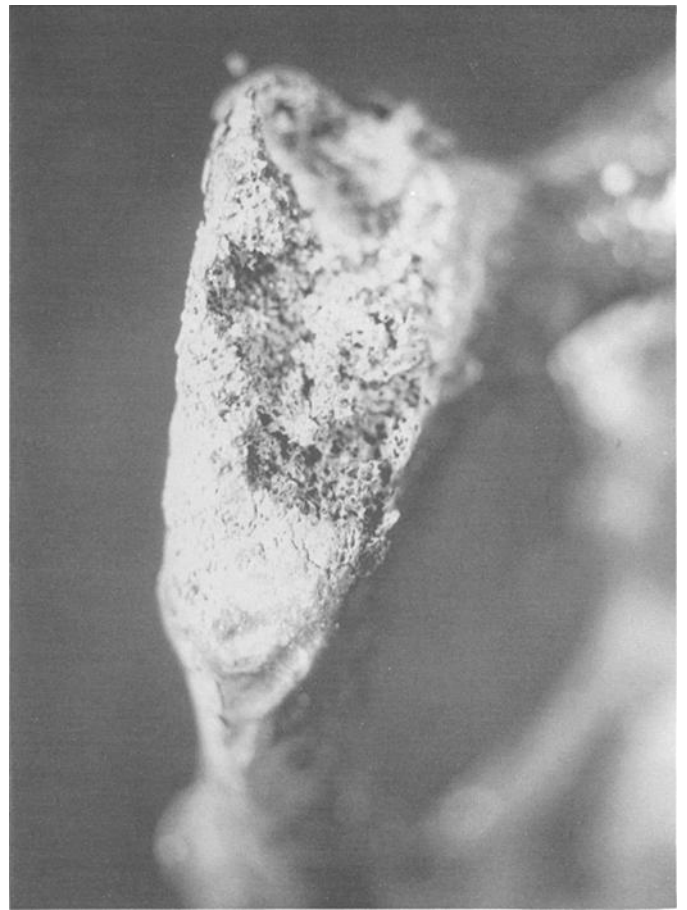
FIG. 26—Fracture of symphyseal face of right pubis.

An irregular fractured area was present on the superior two-thirds and dorsal side of the pubic symphysis (Fig. 26). No radiating fractures were present, but a projectile was found lodged in the bone. Considerable copper staining was present on adjacent areas. The area affected measured 35 mm × 22 mm. The projectile was lodged in the superior dorsal aspect of the pubic symphyseal area. The depression made by the projectile (Fig. 27) measured 15 mm × 17 mm.

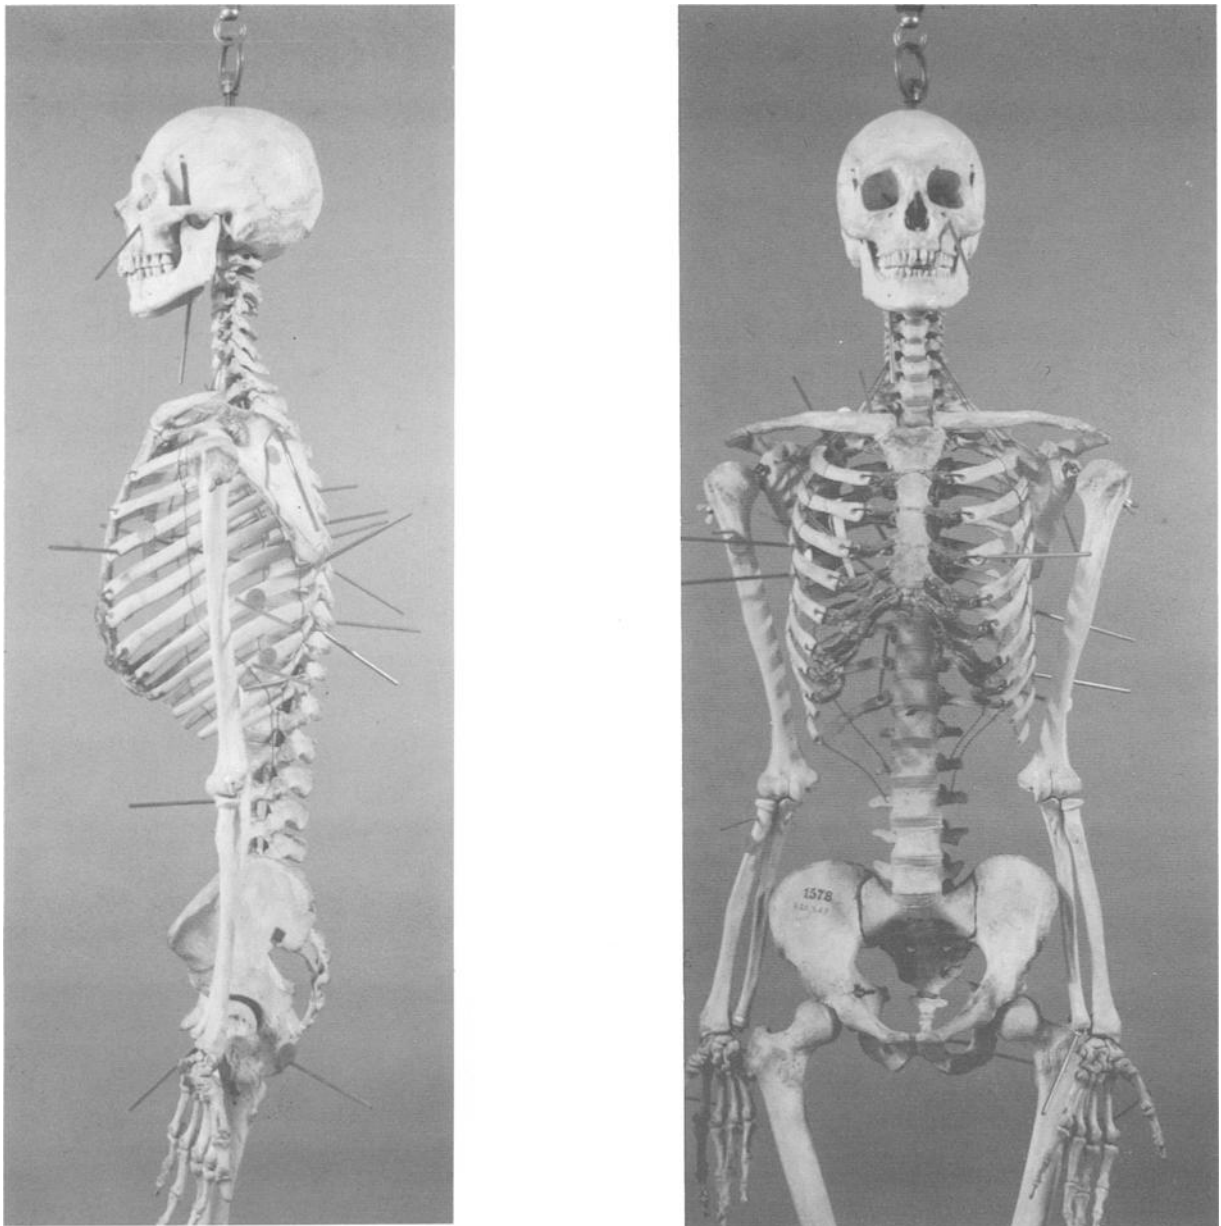
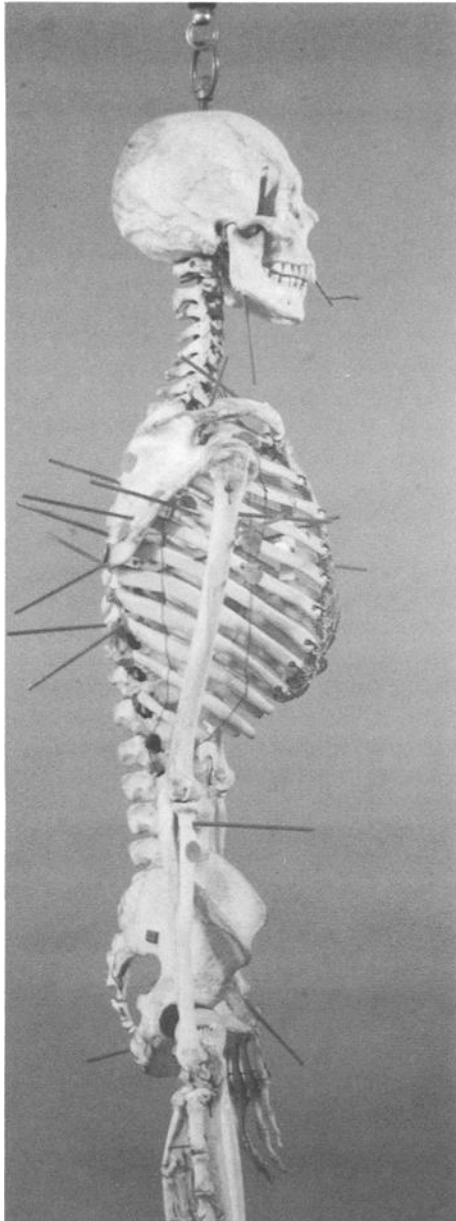
FIG. 30—Four views of markers placed on laboratory skeleton to indicate trajectory entrance sites: this page left: left lateral; this page right: anterior; next page left: right lateral; next page right: posterior.

Although 23 or 24 distinct trajectories can be established from the skeletal trauma (Fig. 30), it is possible that three trajectories on the arms can be linked to others on the chest and head. For example, the projectile involved in trajectory 3 (left wrist) could also have produced the trauma in trajectory 1, if the left arm was raised and tightly flexed with the left wrist in the area of the left face. Trajectories established for the anterior left wrist (3), left humerus (5), and the right lateral upper forearm (12) could link with any of the anterior trajectories and possibly even some of the posterior trajectories if the arms were twisted behind the back.

The evidence described above suggests that a minimum of 20 projectiles were involved. The number increases to 23 if those striking the arms did not strike other areas of the body as well.

Twenty-four projectiles are indicated if the trauma related to trajectory 24 (right lower back area) represents a distinct trajectory and not trauma associated with trajectories 21 or 22.
