## CASE REPORT

# Decipherment of an Obliterated Vehicle Identification Number

**REFERENCE:** Srinivasan, G. J. and Thirunavukkarasu, G., "Decipherment of an Obliterated Vehicle Identification Number," *Journal of Forensic Sciences*, JFSCA, Vol. 41, No. 1, January 1996, pp. 163–165.

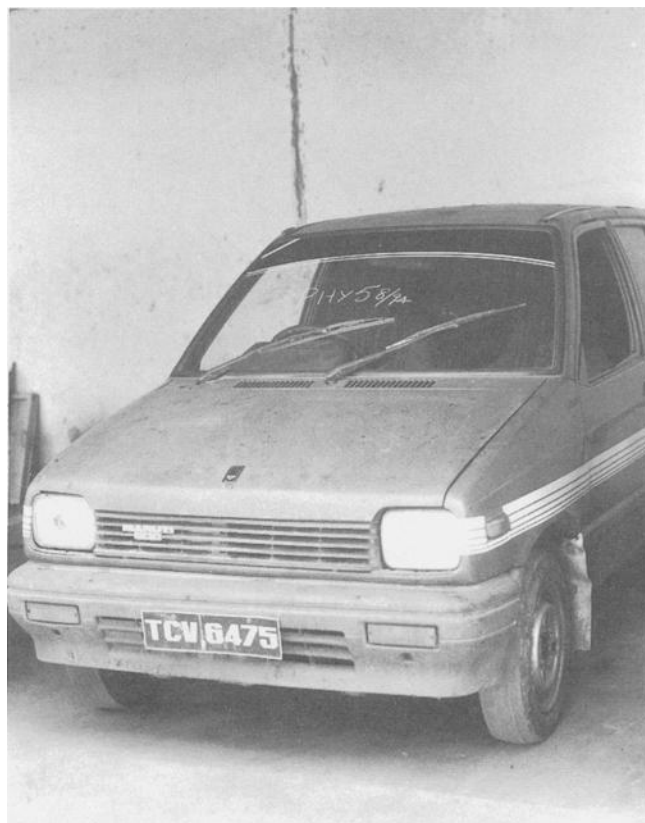
FIG. 1—Suspected stolen vehicle.

The suspected theft vehicle, was a Maruti car (Fig. 1). At the outset, any alteration/tampering of identification numbers on this vehicle could not be visualized since the registration certificate bore the same identification numbers that were found on the vehicle. However, the vehicle was subjected to forensic examination to discover/establish the authenticity of the identification numbers.

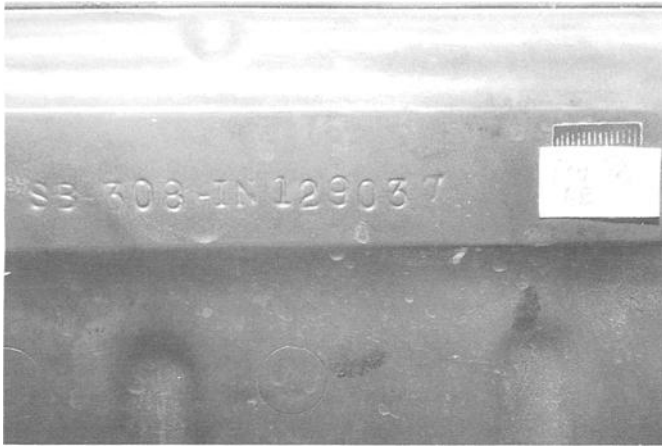
The surface bearing the chassis number (Fig. 2) was cleaned with acetone to remove dirt and paint and it revealed that a tailor-made iron metal piece bearing the number "SB-308-IN 129037" was fixed simply with tinkering paste (an adhesive) over the chassis. Application of trifluoroethanol through the sides of the metal piece softened the tinkering paste, and the metal piece was separated with ease from the chassis (Fig. 3). Removal of the remaining traces of the tinkering paste beneath the metal piece separated from the chassis revealed the punched number "SB 308 IN 128037" (Fig. 4).

FIG. 2—The present chassis number on the chassis.

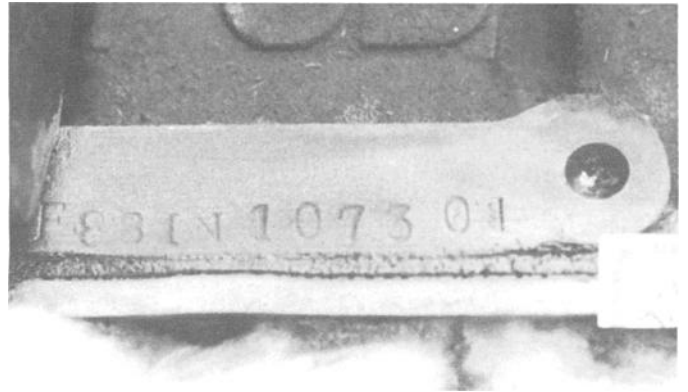
FIG. 5—Surface bearing the punched (Engine) number on the cylinder head.

The surface bearing the punched (engine) number “F8B IN 107301” on the cylinder head (Fig. 5) was devoid of the usual milling pattern indicating deep filing (Fig. 6) and hence no number other than this number was observed.

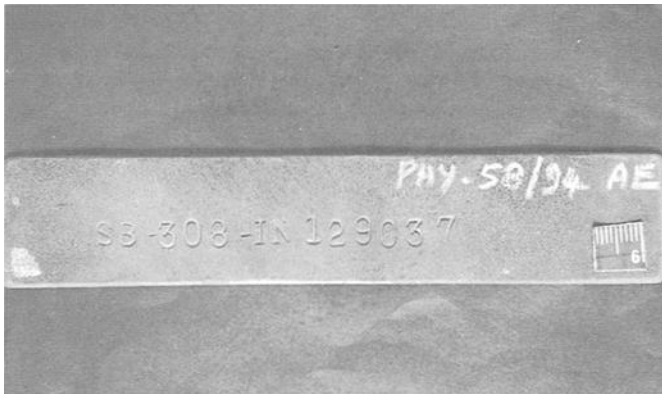
FIG. 3—The tailor-made iron metal piece bearing the present number “SB 308 IN 128037” separated from the chassis.

Lately, it has been the practice of criminals to remove by cutting the portion where the chassis number was punched and substitute for it by welding in a tailor-made metal piece with the number of their choice. In this case, the criminal affixed a small metal piece, after punching the numbers (Fig. 3), exactly over the chassis portion where the chassis number had already been punched (Fig. 4) to conceal any detection of his conspicuous tampering of the original chassis number.

If the examination had been constrained only to the punched surface of the chassis, viz., punched numbers (Fig. 3), the task of unraveling the tampering (Fig. 4) of the original chassis number would not have been possible. Even though the chemical etching did not reveal any of the erased numbers on the chassis, conclusive proof of tampering was established by the evidence of deep filing and differences noticed between the numbers “128037” and the preceding numbers “SB 308 IN” as far as their size, clarity and depth is concerned (Fig. 4). Absence of the usual milling pattern, but the presence of deep filing marks on the surface (Fig. 6) where the engine number had been punched also indicated tampering with the engine number by filing.

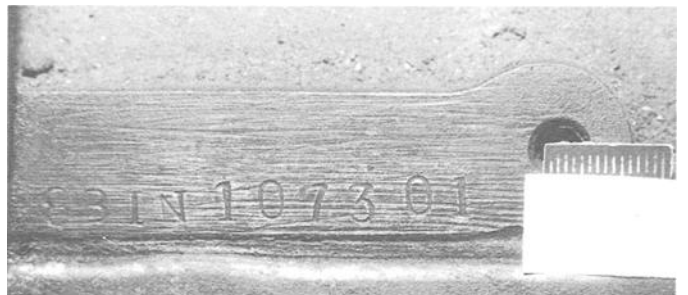
FIG. 6—Cylinder head showing the engine number and deep filing marks.

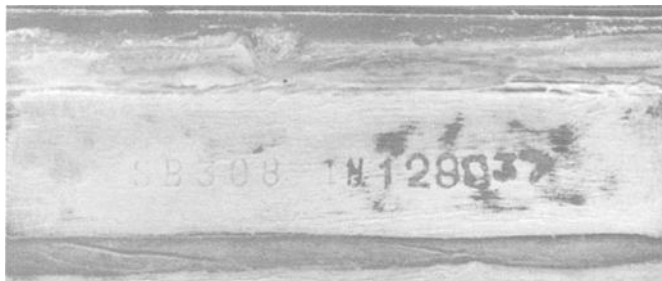
The area bearing the digits "128037" was found deeply filed in relation to the area bearing the other preceding numbers/letters

FIG. 4—Punched numbers on the chassis beneath the metal piece (Fig. 3) separated from the chassis.

“SB 308 IN,” and these two show differences with respect to size, clarity and depth. Due to deep filing no number was deciphered on the chassis.

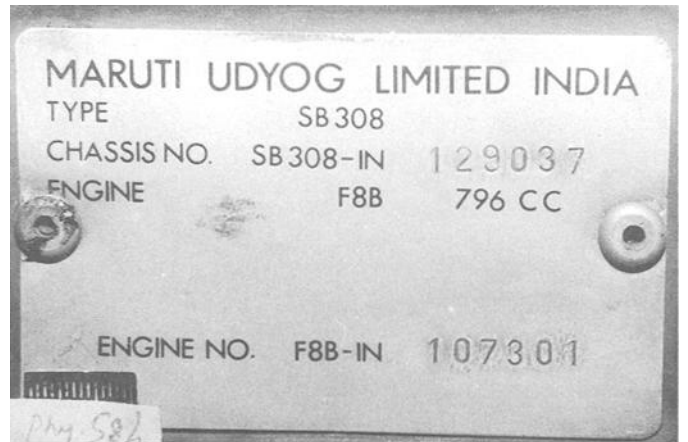
FIG. 7—Aluminum plate bearing identification numbers.

The aluminum chassis identification plate rivetted to the chassis (Fig. 7) was examined with 10X hand magnifier and the portion bearing the punched numbers “29037” and “07301” revealed conspicuous evidence of superficial erasure. Such evidence of erasure

Microscopical examination of this rivetted chassis identification plate under oblique light revealed the erased numbers as “02238” (Fig. 8) and “29463” (Fig. 9) under the presently punched numbers “29037” (Figs. 7 and 8) and “107301” (Figs. 7 and 9) respectively.

The preliminary microscopical study alone of the erased chassis and engine numbers of the chassis identification plate (Fig. 7) under proper illumination paved the way to easily deciphering the erased numbers (Figs. 8 and 9) and in establishing the true identity of the vehicle.

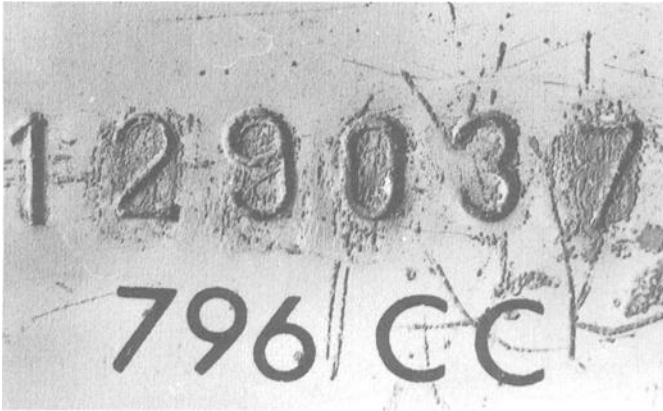
was absent on the metal surface corresponding to the sixth digit “1” (Figs. 8 and 9).

Examination of the backside of the metal plate revealed even projections corresponding to the presently punched numbers only and not the deciphered numbers. Further, the dimension of the presently punched and deciphered numbers was similar. Absence of erasure in and around the surface of the sixth digit “1” (Figs.

FIG. 8—Photograph showing the superficial erasure and the erased chassis number (see Fig. 7).

8 and 9) in both of the chassis and engine serial numbers and absence of projections on the reverse side of the plate corresponding to deciphered numbers and similarity in dimension of the deciphered and present numbers led to the conclusion that the sixth digit “1” could either be an additional punch made along with the already existing numbers or an over punch made exactly over the previous number, “1.”

Thus, it can be deduced that the original chassis and engine serial numbers could either be 02238 or 102238, and “29463” or “129463,” respectively.

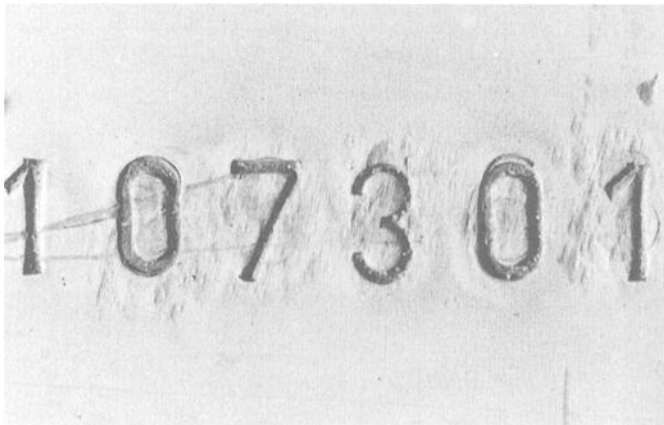
FIG. 9—Photograph showing the superficial erasure and the erased engine number (see Fig. 7).
