## CASE REPORT

# Visualization of a Restored Serial Number Using Scanning Electron Microscopy (SEM)

**REFERENCE:** Mongan AL. Visualization of a restored serial number using scanning electron microscopy (SEM). *J Forensic Sci* 1996;41(6):1074–1076.

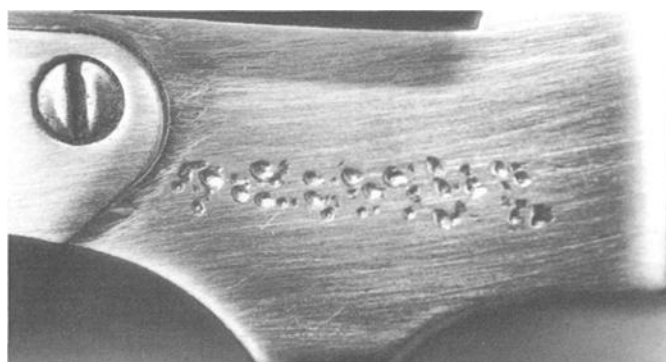
FIG. 1—Photograph showing area of obliterated serial number prior to restoration.

The firearm submitted to our laboratory was a Rossi .38 Special that had a severely obliterated serial number. The serial number had been obliterated by a means of a grinding and punching process resulting in deep "pock" marks. The pock marks appeared as depressions in the metal frame approximately 1 to 2 mm deep. See Fig. 1.

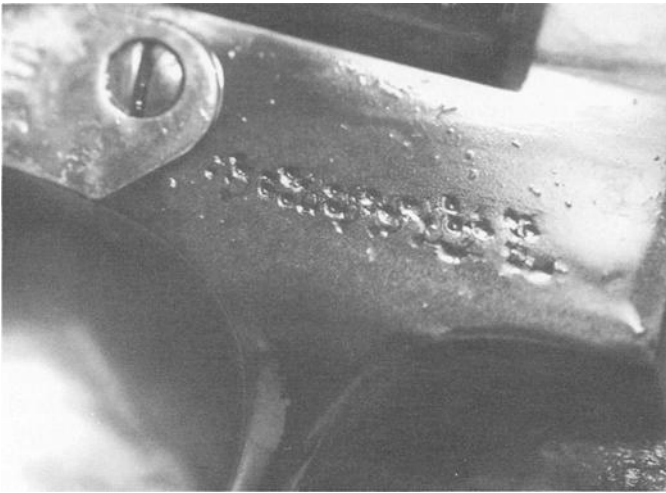
FIG. 2—Photograph showing area of obliterated serial number following restoration with Fry's etchant.

nylon fiber filament wheel impregnated with silicon carbide grain. Fry's etchant was prepared as described in the NASA report (1). (9 g of  $\text{CuCl}_2$ , 10 mL of water with 12 mL of HCl). The Fry's etchant was applied and the area was swabbed alternately with 10% nitric acid and water when the reaction was close to completion. The development of the serial number occurred relatively rapidly (within 5 min), however, the deep pock marks made the interpretation very difficult. See Fig. 2.

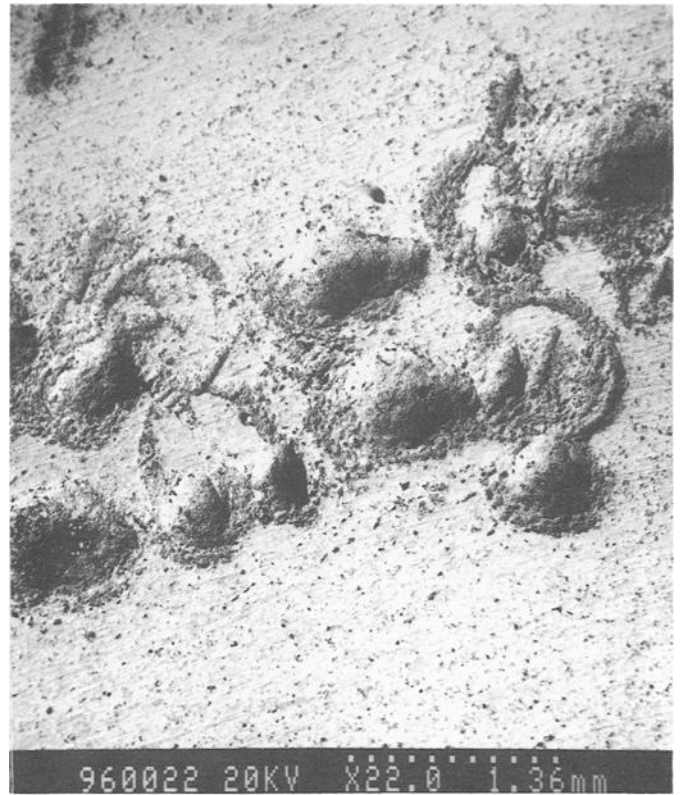
FIG. 4—SEM photomicrograph showing second and third digit of restored serial number.

of the restored serial number. Figure 3 shows the region that represents the first digit and the full space. The first digit was reported as being a "D" and the space or lack of alpha-numeric digit is clearly represented adjacent to it. Figure 4 shows the next two digits that are clearly represented as "8", "8." The following two digits are displayed in Fig. 5. The first of the two digits was assigned the candidates "0" and "9", whereas the second digit was defined as a "0." Figure 6 shows the remaining two digits, the first clearly visible as a "2" and the last digit having the candidates "3", "5", and "6."

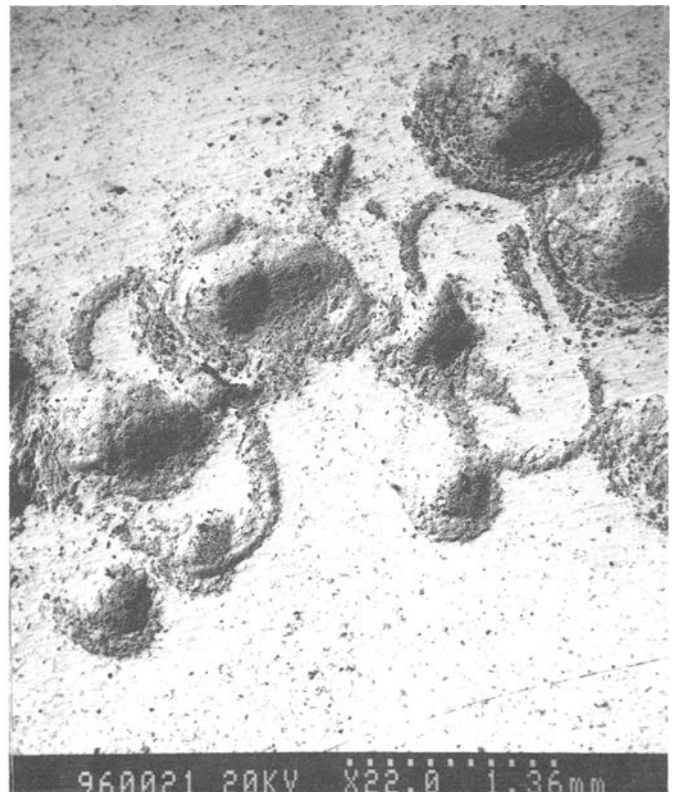
FIG. 5—SEM photomicrograph showing fourth and fifth digit of restored serial number.
