## The Entomological Evidence

**REFERENCE:** Rozen JG, Jr, Eickwort GC. The entomological evidence. *J Forensic Sci* 1997;42(3):394–397.

**ABSTRACT:** The primary task was to investigate and explain the source of blockage in an elbow (B2) and in other parts of the fuel supply unit recovered from the wreckage of a private airplane. A small clump of pollen associated with a disc-shaped gummy mass of plant fibers suggested that bees belonging to the family Megachilidae might have been responsible for accumulating these plant materials. Examination of other parts of the fuel control unit revealed three dead adult bees identified as *Osmia gaudiosa* Cockerell (Megachilidae) and a single dead individual of the genus *Ashmeadiella* (Megachilidae). A survey of the tubing of a heater that had been stored showed that 69% of its tubings and fittings contained nest material and other arthropod debris including those of *Ashmeadiella meliloti* (Cockerell) and *Anthidium* sp. (Megachilidae). Through SEM examination, a single branched hair partly embedded in the clump of pollen was matched with the postgenal hairs of an adult *Ashmeadiella*. These facts left no doubt that the B2 elbow mass was

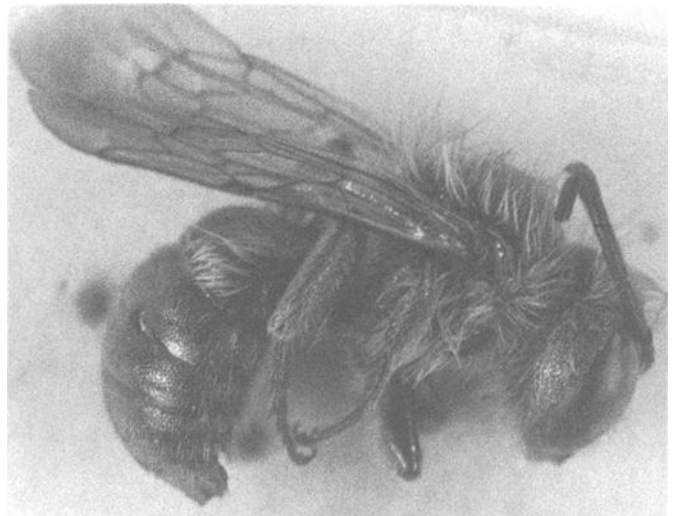
FIG. 2—A dead male of *Osmia gaudiosa*, removed from one of the cocoons from the fuel control unit, length about 9 mm.

Other parts of the fuel control unit taken from the wreckage. In the discovery session with the plaintiffs' lawyers and their expert witnesses (none trained in entomology) in constant presence, Eickwort and I recovered from four bores, three dead bees belonging to the megachilid genus *Osmia* in their cocoons (Fig(s). 1, 2) (later identified as *O. gaudiosa* Cockerell by Eickwort) and one dead bee of the megachilid genus *Ashmeadiella* (Fig(s). 3, 4) surrounded by its cell and cocoon. These bees had died before they had a chance to emerge.

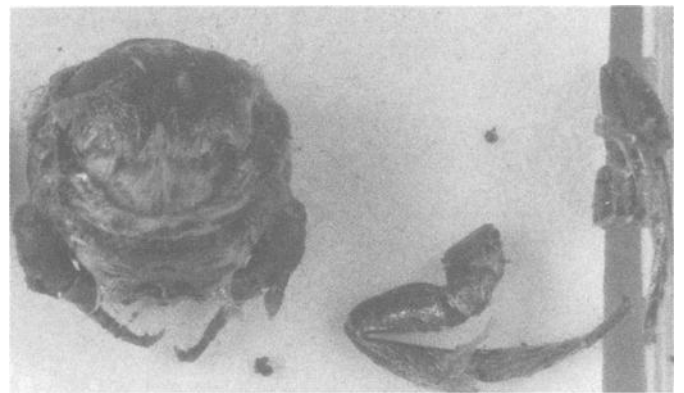
FIG. 3—Thorax and legs of *Ashmeadiella* sp., from the fuel control unit of the airplane wreckage.

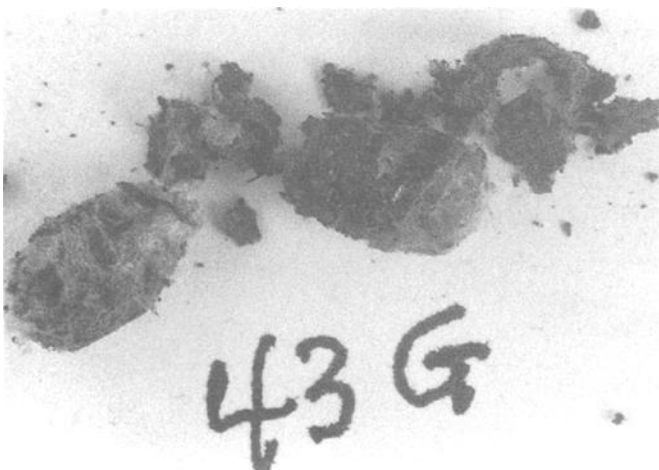
FIG. 1—Two cocoons and other nest debris of *Osmia gaudiosa* extracted from the fuel control unit of the airplane wreckage. Cocoon length approximately 10 mm.

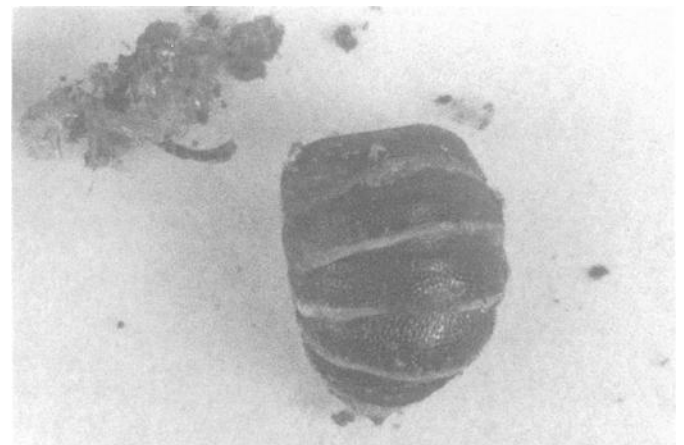
FIG. 4—Metasoma ("abdomen") of same.

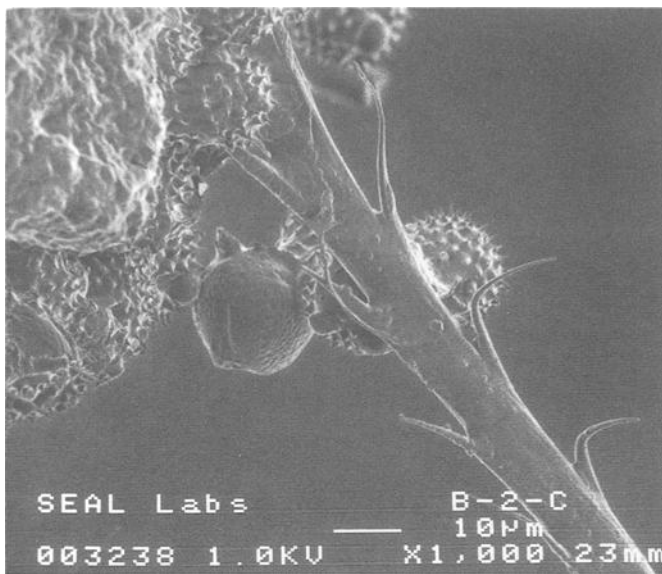
FIG. 5—Scanning electron micrograph of branched hair attached to clump of pollen from B2 elbow. For explanation, see text.

The mysterious single branched hair (Fig. 5) in the pollen mass. One of the diagnostic characteristics of adult bees permitting them to be distinguished from wasps is the fact that bees have branched or feathery hairs on some parts of their body whereas wasps have only simple body hairs. Although the single branched hair emerging from the pollen clump of the B2 elbow looked suspiciously like that of a bee, so many plant hairs were involved in the B2 mass (Bates et al., this series) that we were uncertain as to whether this single hair was of plant or bee origin at first. Eickwort solved the mystery in late May 1992 by conducting an SEM study of the hairs of *Ashmeadiella* and found an exact match of that single hair with the postgenal hairs (Fig. 6) from the lower part of the head. As adult bees get older, their hairs tend to break off. The hair in the pollen mass had accidentally been lost by the female as she was unloading the pollen from her foraging trip.

Each of these data by itself supported our hypothesis that megachilid bees had nested in the wreckage, and together they were virtual proof of megachilid involvement. The presence of the branched hair in the pollen clump left no doubt that the blockage in the B2 elbow was indeed the remnants of a nest of *Ashmeadiella*. We could further conclude that the nest had never been completed by the female making it because the pollen had not yet been eaten and there was no indication that the cell had been closed.

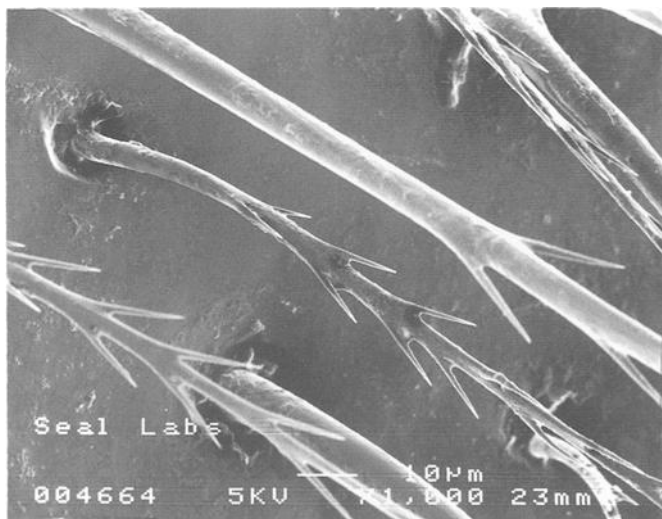
FIG. 6—Scanning electron micrograph of hairs from postgenal area of head of *Ashmeadiella* showing branching that matched that of hair in pollen clump found in B2 elbow.
