# Blunt Pancreatic Trauma by a Wheelchair User Restraint System During a Traffic Accident

**REFERENCE:** Bunai Y, Nagai A, Nakamura I, Ohya I. Blunt pancreatic trauma by a wheelchair user restraint system during a traffic accident. *J Forensic Sci* 2001;46(4):965–968.

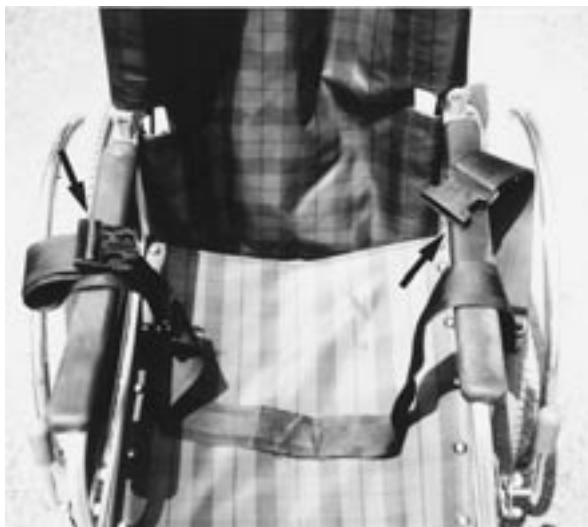
FIG. 1—Wheelchair user restraint system. The center of the belt was stitched to the seat, but some of the threads have been broken. The arrows indicate the location of the buckle that is fastened behind the back of the chair.

A police inspection after the man's death revealed that the right arm of the wheelchair had been deformed during the accident (Fig. 2). Some of the threads that had fastened the belt to the seat of the chair had been snapped, and the remaining threads were on the verge of breaking (Fig. 1). When the belt was fastened in place, the belt passed over the both sides of the user's abdominal wall nearly at the level of the umbilicus (Fig. 3).

sequently, poorly designed but cheap safety devices are sometimes installed and used (9). However, wheelchair users are often moved more violently than standard seatbelt users during traffic accidents, and inadequate safety devices like the present safety belt can be harmful, if not lethal. To prevent the injury of wheelchair users during traffic accidents, adequate designs and the appropriate use of safety devices are necessary.

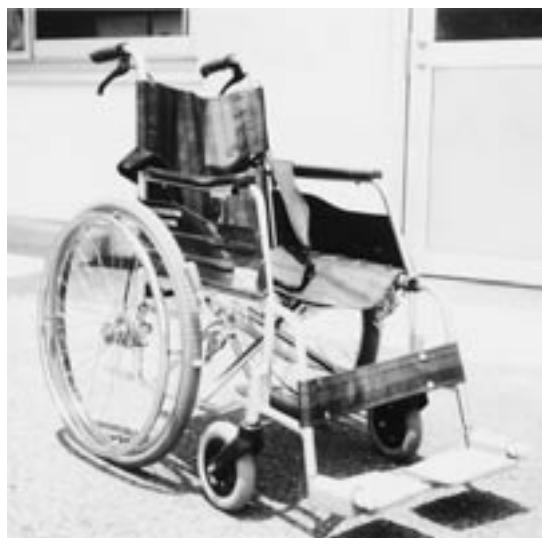
FIG. 2—The right arm of the wheelchair is deformed.

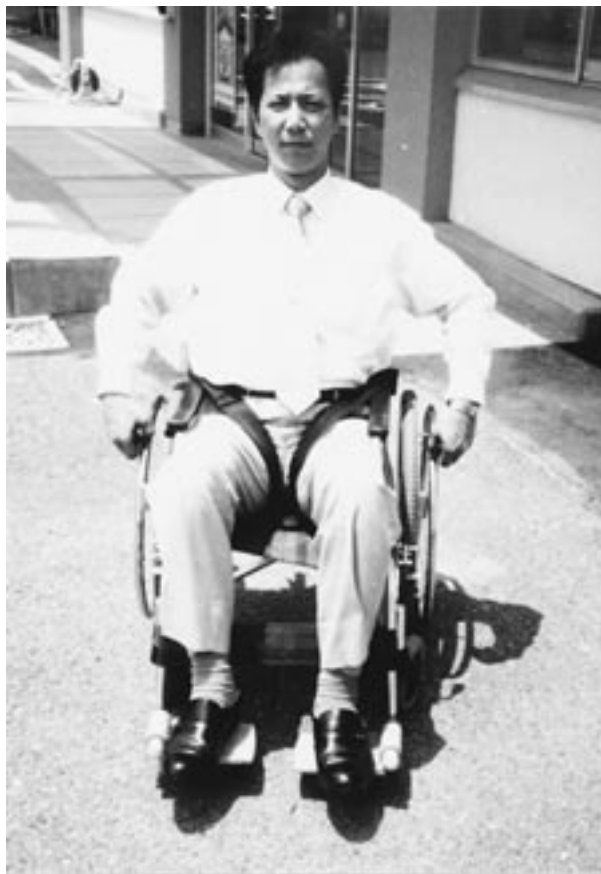
FIG. 3—When the belt is fastened, the belt passes over both sides of the user's abdominal wall nearly at the level of the umbilicus.

Considerable personal protection is afforded by seatbelts (11,12). A comparable level of protection is also necessary for wheelchair users during transportation. If safety restraints for wheelchairs are not installed, the drivers of vehicles containing wheelchair users may try to compensate by driving and braking more carefully. However, an emergency stop while traveling at a speed of even 7.5 km/h will create chaos for the wheelchair users if the users have no mean of bracing themselves (5). Wheelchair and wheelchair user restraint systems have been developed to protect wheelchair users during sudden impacts (5–10). In the present case, the wheelchair restraint system was supposed to hold the chair in position while the belt was intended to prevent the user from being ejected from the chair. Nevertheless, the victim's body was jerked abruptly during the accident. The threads that had fastened the belt to the seat of the chair were nearly or completely severed, and the right arm of the chair was deformed. The victim most likely knocked his upper left abdominal wall against the belt and then his right side against the right arm and back prop of the chair. The pancreatic and duodenojejunal injuries probably occurred during the former impact. The man's wife stated that the safety belt had been tightly fastened. However, no injuries were found on the victim's thighs where the belt should have been placed. Moreover, when the belt was passed over the arms of the chair and fastened behind the back of the chair, the belt passed over both sides of the abdominal wall. These findings suggested that the belt had been fastened loosely and that a large force was applied to the upper left abdominal wall via the belt at the time of the accident. Safety belts must be tightly fastened and pass over certain areas of the body in order to be effective. Shoulder belts should pass over the sternum, while lap belts should pass over the pelvic bone. Otherwise, the abdominal organs can be seriously damaged during a sudden impact. Loosening and/or inappropriate positioning of seatbelts can be harmful, even lethal (11,13). Recently, a lap belt has been developed for wheelchair users. The belt is anchored to the floor of the vehicle or to a bracket fastened to the back props of the chair. The belt passes over the pelvic bone of the wheelchair user when properly placed (5,6,8–10).
