Restoration of Obliterated Painted Registration Number on Vehicle

REFERENCE: Thirunavukkarasu G, Hemalatha M, Kuppuswamy R. Restoration of obliterated painted registration number on vehicle. *J Forensic Sci* 2002;47(2):374–376.

ABSTRACT: A simple technique employed for the restoration of the obliterated painted registration number on a motor vehicle involved in a case of murder is described.

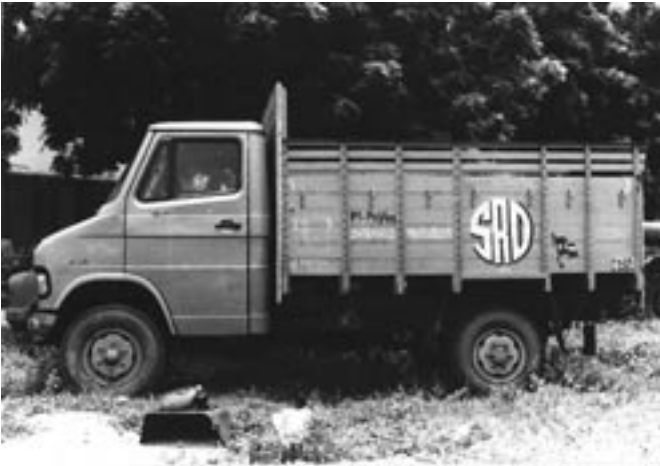
FIG. 1—The lorry involved in the murder case.

In a case of murder, the assailants hired a gray color Tata mini lorry with registration number “TN-02-C-5758”, during night hours, under the pretext of transporting cattles from their field. In the mid way, the driver and the cleaner were dragged out of the lorry and attacked with knives by the assailants. Then the assailants escaped successfully along with the lorry under the cover of total darkness presuming that both of them had died on the spot. While the cleaner died, the driver survived despite having received deep cut injuries in his throat and reported the incident to the police. During the investigation, one blue color Tata mini lorry with registration number “TN-23-A-2664” (Fig. 1) was seized and referred for forensic examination to ascertain its true identity.

The lorry (Fig. 1) was examined to find out its original registration, chassis, and engine numbers. The registration number on the

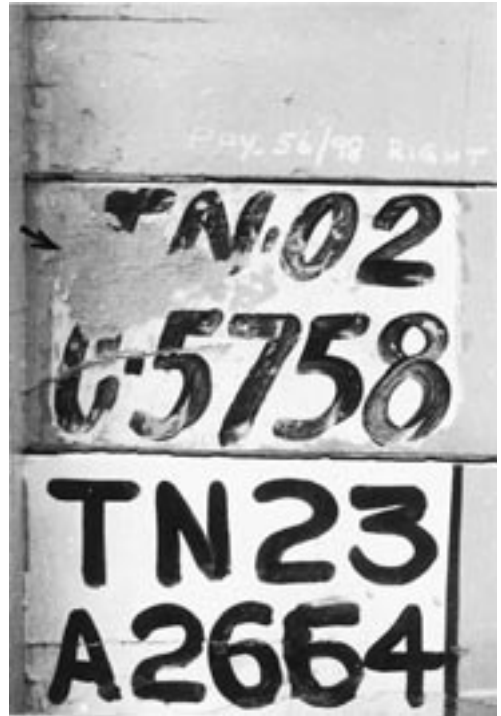
FIG. 4—The restored registration number “TN-02-C-5758” just above the existing registration number on the right rear of the lorry (see Fig. 2) (arrow mark indicates the area of erasure).

The rear sides of the vehicle, where the registration number was suspected to have been obliterated by painting, were cleaned with water to remove dirt; then it was treated with MIBK using cotton swab, for about a minute, until the top layer just swelled or softened. Care was taken to avoid excess application of the solvent, as it might affect the layer underneath the top layer. The swelled or softened top layer was removed by gentle and careful squeezing of the surface uniformly with a small, handy and densely rolled ball of dry cotton. When the top paint layer was thus removed, the original identification number hidden underneath the top layer, on both the right and left rear sides of the lorry, appeared (Figs. 4 and 5). Significantly, the presence of brush marks in the letters and numerals and of the localized erasure of the original number made by the culprits during obliteration (indicated by an arrow in Figs. 4 and 5) were also revealed. Thus the technique had the capability of removing the top layer only. After the restoration, the surface was washed thoroughly with excess of water to protect from the effects of remnant solvent adhering to it, if any.

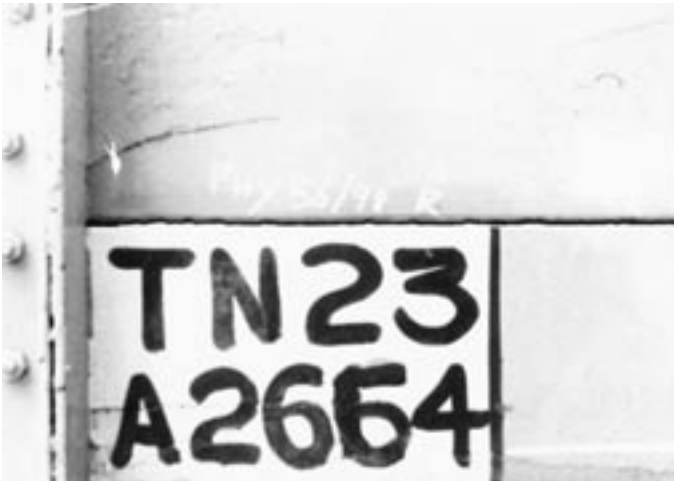
FIG. 2—The existing registration number on the right rear of the lorry.

plates fixed to the front and back of the lorry, when examined, had shown no change in them, and remained unaltered. These registration numbers were also painted on the right and left rear of the body of the lorry (Figs. 2 and 3). When the latter numbers were examined under specular illumination, no new marks or numbers were found underneath the surface. However, the paint flakes collected from different locations of the body of the lorry revealed three layers and the sequence from the top was blue, gray and black, black being the base paint. Localized etching of the present blue paint coating at the rear sides of the body, around the existing number at different locations to an extent of about 1 mm², showed some black paint sparsely underneath the top layer; Methyl Iso Butyl Ketone (MIBK), a common paint solvent, was selected for the above purpose after few trials. This suggested the possibility of some hidden number underneath the top blue layer. To restore this hidden number the conventional method suggested in the literature, viz., washing away of the top paint layer with suitable solvents (1) was not adopted because such washing away always has the danger of removing the crucial underlying layer also, while the top layer is removed in the process. Therefore, a modified technique, as described below, was employed.

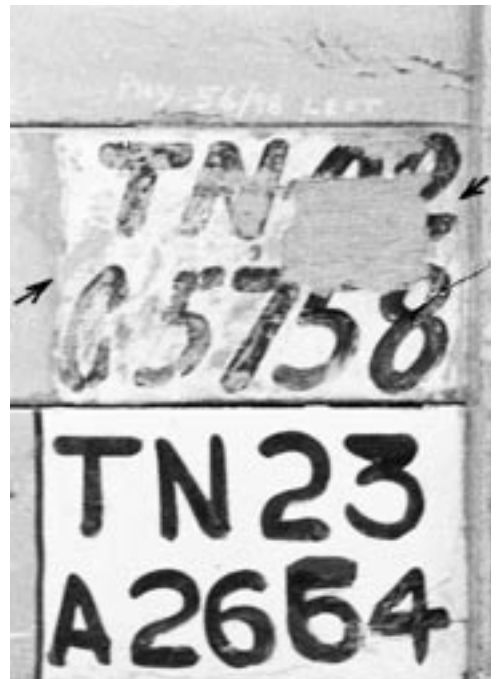
FIG. 5—The restored registration number “TN-02-C-5758” just above the existing registration number on the left rear of the lorry (see Fig. 3) (arrow marks indicate the area of erasure).

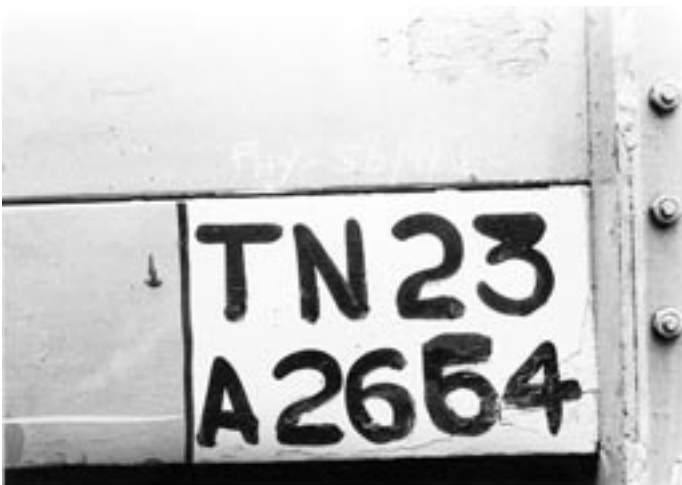
FIG. 3—The existing registration number on the left rear of the lorry.
