## CASE REPORT

# Neck Injuries Caused by Automatic Two-point Seat Belts: An Analysis of Four Cases

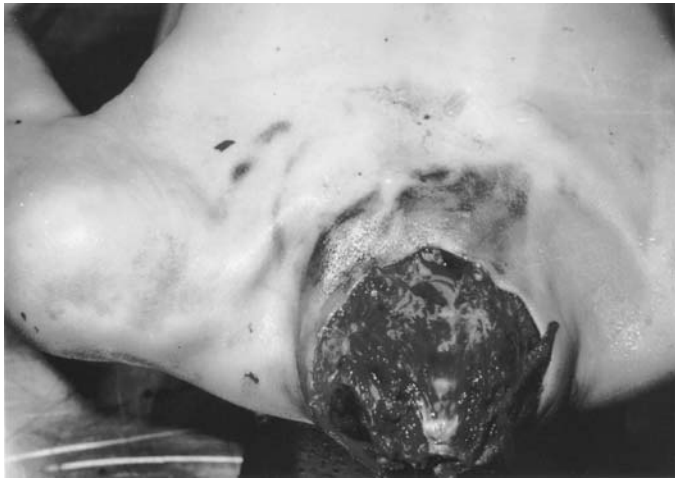
FIG. 1—Decapitation site with adjacent abrasion.

Injuries to the decedent included decapitation at the level of the third cervical intervertebral disc. The line of decapitation was oblique with an upward angle of approximately 45°. The strap muscles, trachea, esophagus, right and left common carotid arteries and the jugular veins were transected with clean edges as if incised. The neck skin immediately inferior to the decapitation site had a patterned injury consisting of a sharply demarcated abrasion and traumatic overstretching injuries indicating that the skin was stretched before the strap lacerated the skin (Fig. 1). Within the abrasion was a 1-cm area of non-abraded, intact skin that resulted from overlapping of the skin as it was pulled and stretched by the strap. Small coarse black fibers matching the material of the seat belt were recovered from the soft tissues at the decapitation site. The right arm and axilla had abrasions consistent with being caused by the shoulder restraint as it rubbed under the decedent's arm before being ejected from the car. The chest and abdominal organs were without injuries.

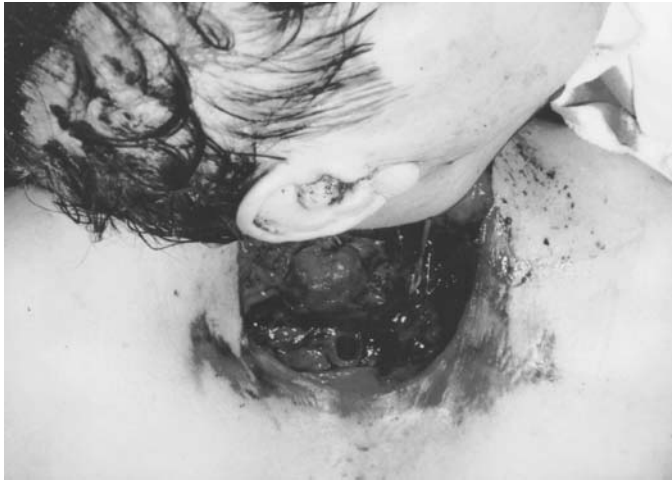
The near complete decapitation was associated with lacerations of the anterior neck muscles and transection of the trachea, esophagus, right and left common carotid arteries, jugular veins, cervical spine at the atlanto-axial membrane and cervical spinal cord. The skin at the back of the neck was intact and served to keep the head attached to the body. The angle of injury was upward at approximately 45°. Patterned injuries consisting of a broad abrasion and traumatic overstretching injuries were on the skin adjacent to the decapitation site (Fig. 2). The abrasion was confined to the front and left side of the neck.

FIG. 2—Near decapitation with adjacent abrasion and overstretching injuries.

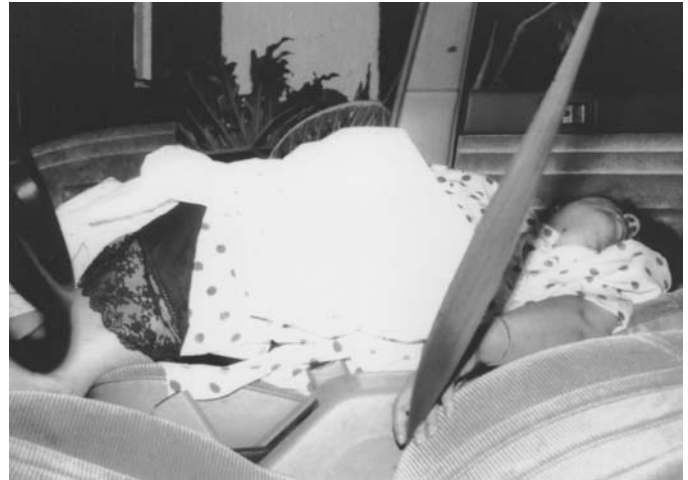
FIG. 3—Right front seat occupant “submarine” beneath the dashboard.

Based on the on-scene investigation, it was apparent that the driver had applied the brakes prior to impacting the tree. This pre-impact braking caused the right front occupant to move forward in response to the vehicle's deceleration. As her chest loaded the shoulder restraint it became anchored, however, without a lap belt her pelvis and lower extremities continued to move forward. The victim's knees impacted the glove compartment and with continued forward movement, her right tibia and fibula fractured; this allowed her torso to “submarine” beneath the right side of the dashboard. The decedent was pronounced dead at the scene found slumped partially beneath the dashboard (Fig. 3). Upon arrival of rescue personnel, the driver of the vehicle was in stable condition.

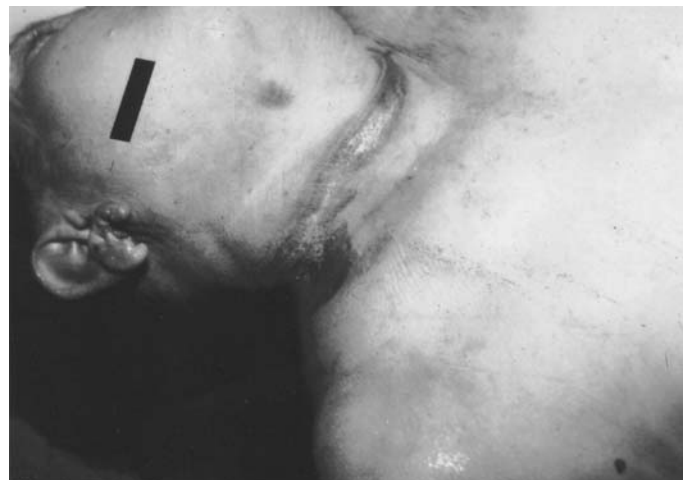
At autopsy, the decedent had dashboard injuries on both knees and the right tibia and fibula had compound fractures. An abrasion was on the neck starting beneath the right ear and extending 3 cm left of the midline (Fig. 4). The trachea was transected through the cricoid cartilage and the second cervical vertebra had a dislocated fracture through the vertebral body at the base of the odontoid process. The carotid arteries and jugular veins were intact. The spleen and right lobe of the liver had superficial capsular lacerations.

FIG. 4—Abrasion band on the neck caused by the shoulder harness of a two-point automatic seat belt.
