## TECHNICAL NOTE

# Forensic Value of Pattern and Particle Transfers From Deployed Automotive Airbag Contact\*

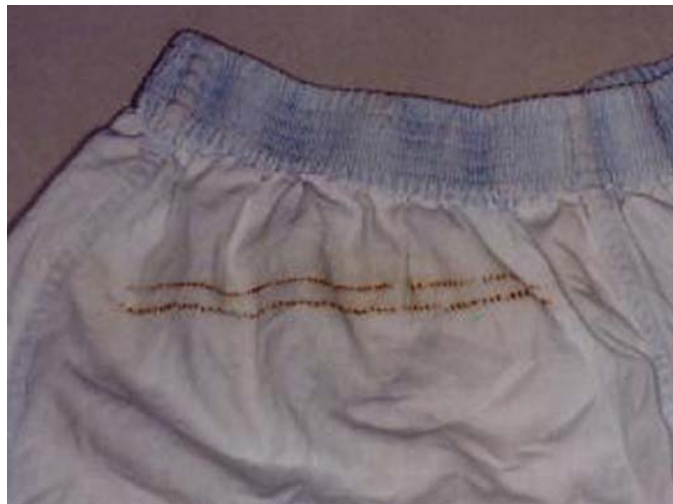
FIG. 1—Singe pattern on shorts from driver of 1991 Lincoln Continental after airbags deployed.

The gas discharged from the driver side airbag inflator can be as hot as 600°C and as hot as 700°C from the passenger side inflator (Airbag manufacturer, name withheld by request. Personal communication). The gas starts to cool immediately, but is still hot when it reaches the surface of the airbag. Since the airbags are designed to be inflated for only a short time, they are not airtight. The hot gas escapes through the vent holes in the back, as designed, but it can also be forced through the small holes from the stitching seams in the front of the airbag, which tends to be a weak point. If clothing from the occupants comes into contact with the airbag when it is at or near maximum inflation, the hot gas can cause singe patterns on the front of the clothing, characteristic of the seam patterns. This pattern appears as a series of small black dots or smears, 2–3 mm apart, in a single line or multiple parallel lines (Fig. 1), depending on the number of seam rows.

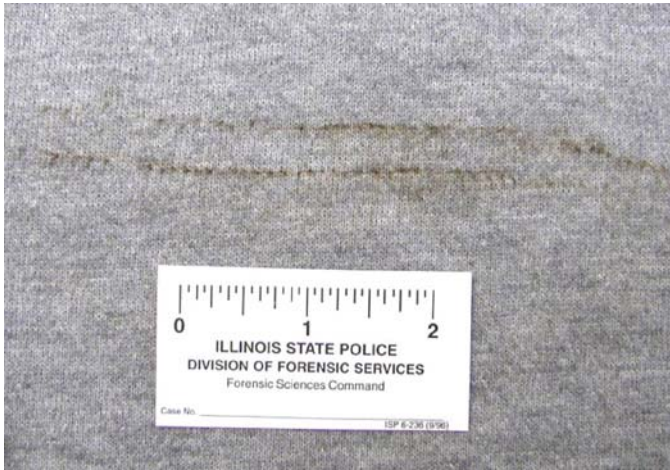
FIG. 2—Double row singe pattern on lower abdominal area of sweatshirt from the suspected driver of crashed 1996 Dodge Ram pick-up truck.

dots or smears, 2–3 mm apart. The manufacturer of the airbag was contacted and they stated that the hot gas that inflates the airbag can leak through the seams and produce singe patterns on the occupant's clothing (Airbag manufacturer, name withheld by request. Personal communication). With this information, the singe patterns on the sweatshirt were compared to the seams of the airbag. Some of the seam threads appeared to be charred and slightly melted. Two parallel singe lines observed on the abdominal area (Fig. 2) and left sleeve of the sweatshirt corresponded to the two outer seams of the airbag (Fig. 3). This also indicated that the driver was not likely wearing the lapbelt. Singe patterns observed on the upper left quadrant of the sweatshirt (Fig. 4) corresponded to the smaller single central seam on the airbag (Fig. 5), which attaches the inner tethers. This also indicated that the driver was not likely wearing the shoulder restraint. The 3/8 in. oblong singe pattern observed on the inside left sleeve of the sweatshirt (Fig. 6) corresponded to the single vent hole located on the back of the airbag (Fig. 7). This indicated that the driver was still holding the steering wheel when the airbags deployed.

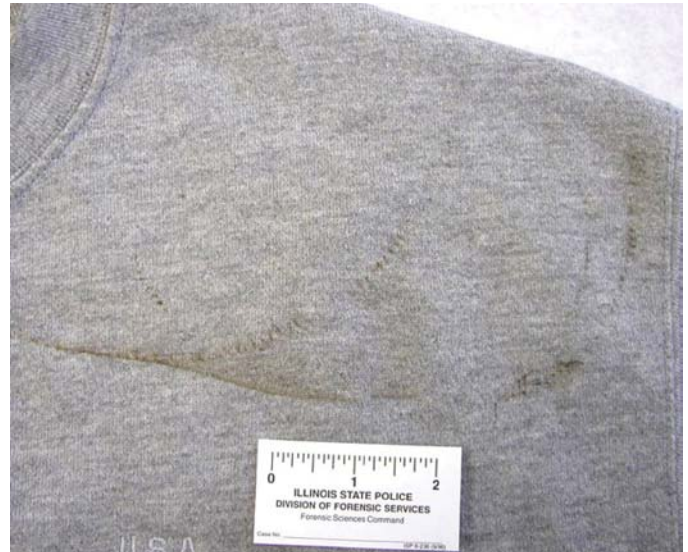
FIG. 4—Single row singe patterns on front upper left quadrant of sweatshirt from suspected driver of crashed 1996 Dodge Ram pick-up truck.

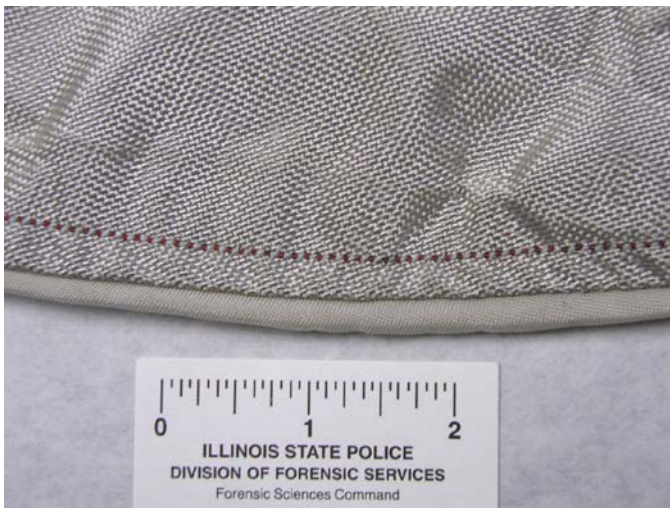
FIG. 3—Double outer seam area of the deployed driver side airbag from 1996 Dodge Ram pick-up truck. Some of the top seam threads are charred and slightly melted.

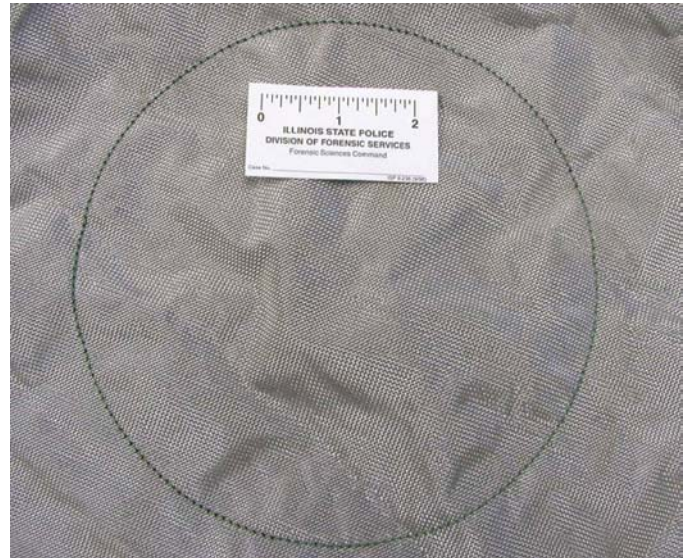
FIG. 5—Single central seam area of deployed driver side airbag from 1996 Dodge Ram pick-up truck.

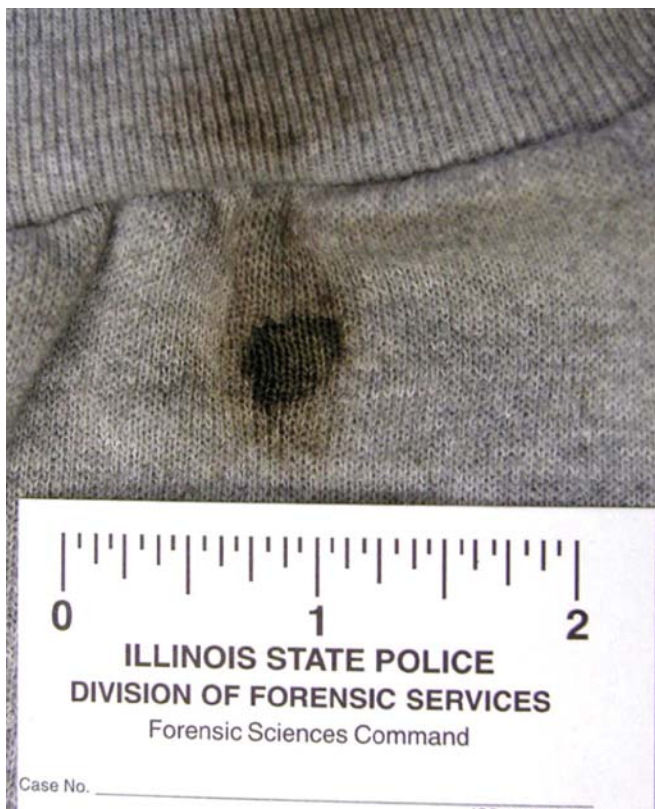
FIG. 6—Singe pattern on lower left sleeve of sweatshirt from suspected driver of crashed 1996 Dodge Ram pick-up truck.

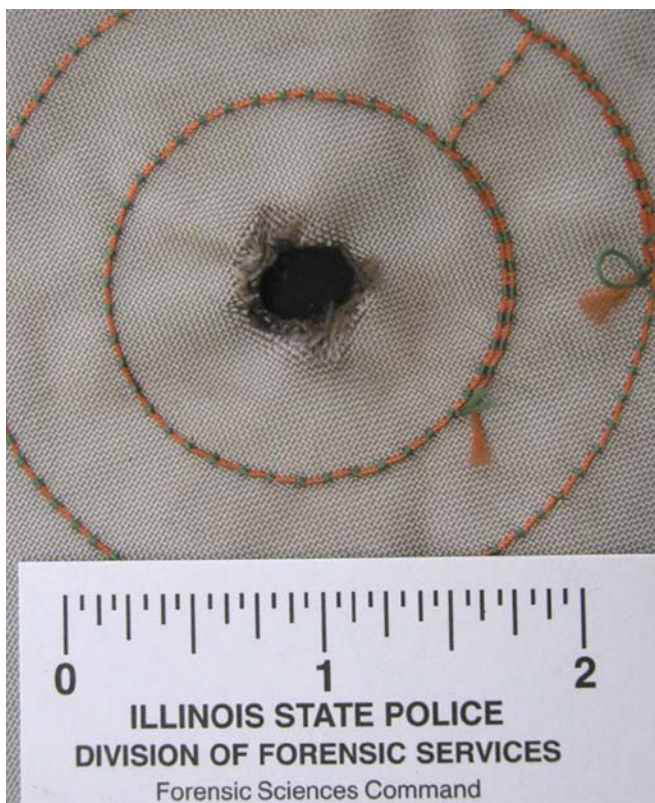
FIG. 7—Single vent hole on back of the deployed driver side airbag from 1996 Dodge Ram pick-up truck.

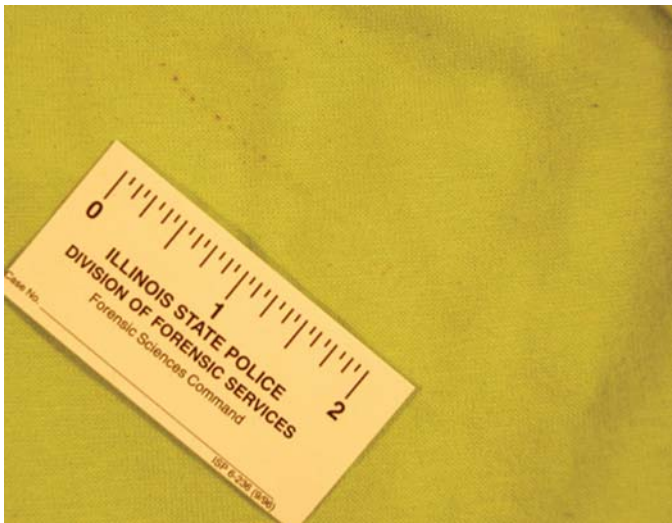
FIG. 9—Straight single row singe pattern on upper left chest area of shirt worn by suspected passenger of crashed 1996 Kia Sephia.

The shirt and the airbags were first taped with clear book tape, in separate examination rooms, to remove any trace debris. Upon a more detailed examination, a diagonal singe pattern of small dots in a straight line about 2 in. long was observed on the upper left chest area of the female's shirt (Fig. 9). Under UV light (366 nm), this row of dots and smears appeared to be about  $3\frac{3}{4}$  in. long (Fig. 10). The driver side airbag had a double outer seam in a large arc shape and a double central seam in a tighter arc pattern. This was not consistent with the pattern on the shirt, so the driver side airbag was eliminated as a source of the singe pattern. The passenger side airbag seams were all in straight lines with many single and some double rows. Further comparison showed that the passenger airbag could not be eliminated as the source of the singe pattern (Fig. 11).

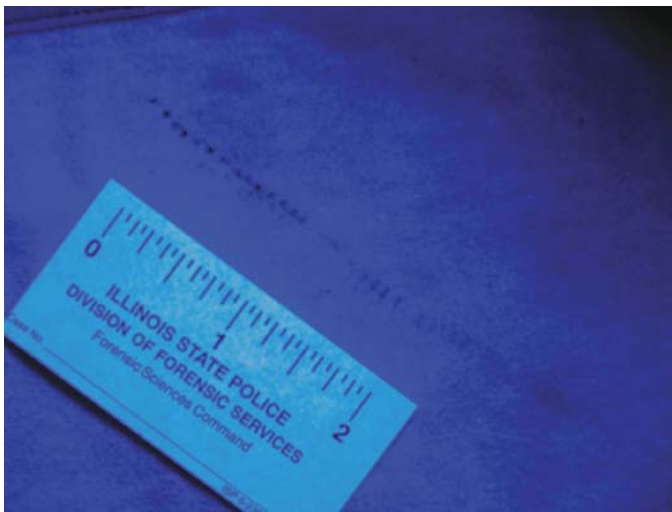
FIG. 10—Same area as in Fig. 9 viewed under 366 nm UV light.

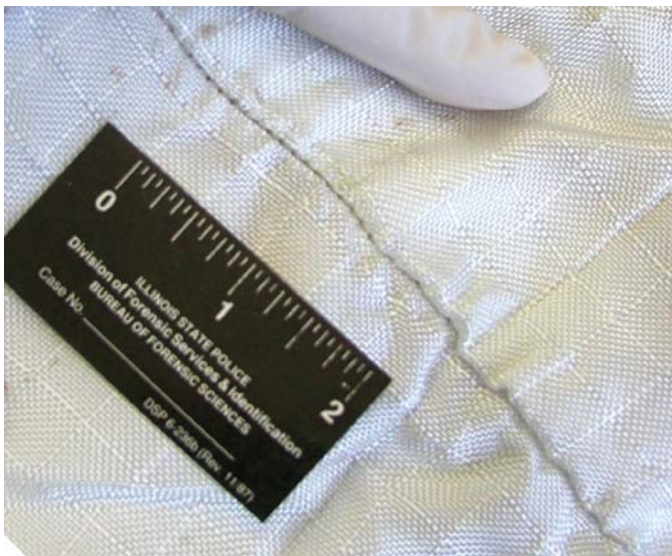
FIG. 11—Straight single seam area on deployed passenger side airbag from 1996 Kia Sephia.
