CASE REPORT

Throat-Cutting of Accidental Origin

ABSTRACT: Incised wounds of the neck can be accidental, homicidal, or suicidal. In this paper, a death case has been presented where a spinning circular saw of a cutting machine in a workshop came off its place and cut the throat of a 30-year-old male who was operating the machine. There was an incision (15 cm × 5 cm) that began in the middle of the neck down the thyroid cartilage, extended horizontally to the left of the neck and ended on the outer part of the neck in the outer left side of m. trapezius. Death occurred because of exsanguination caused by the cutting of carotis artery and jugular vein. In the case we presented, although the cut in the neck initially suggested homicide, it was found to have occurred as a result of an accident after the autopsy and death scene investigation.

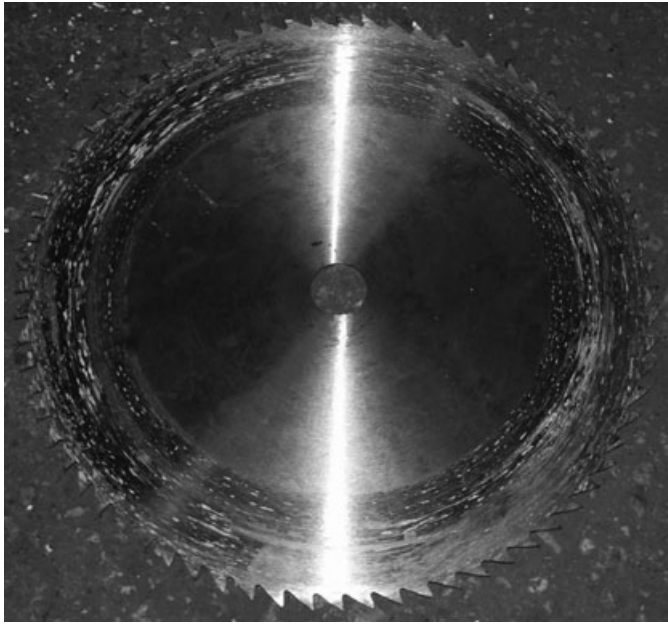
In the investigation made at the site of the accident, the circular saw of the PVC cutting machine was found 2 m away from the machine, with its surface covered in blood (Fig. 1). The circular saw was 27 cm in diameter and 0.2 cm in thickness. The teeth of the saw were 0.5 cm in height, and the separation of the teeth was 1 cm in width. It was observed that the nut holding the circular saw in place came off its proper place and fell on the machine and that there were abrasions on the surface of the nut (Fig. 2). Blood spots were observed starting from the front part of the machine where the accident took place and they continued as far as the blood pond and the deceased 4 m from the machine (Fig. 3). The workers in the same workshop who witnessed the accident reported that the accident took place when the victim was cutting PVC (Fig. 4).

FIG. 1—Circular saw that cut the neck.

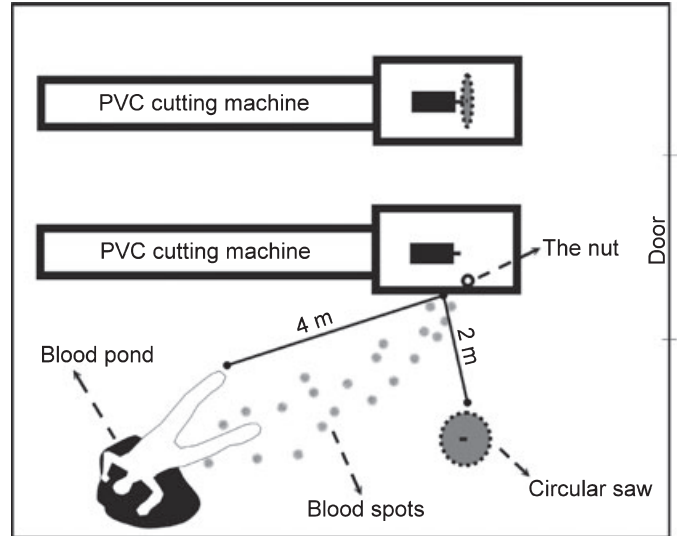
FIG. 3—A schematic of the accident scene where the victim was cutting polyvinyl chloride.

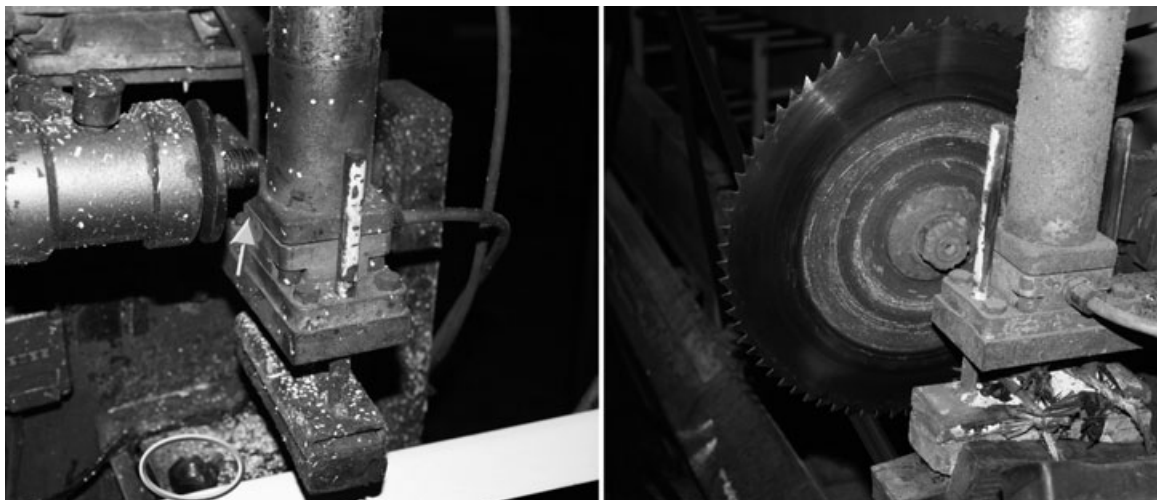
FIG. 2—It is seen that the nut that held in place the circular saw of the machine on the left where the accident took place came off its place. The arrow points toward the spindle on which the blade was mounted and a circle has been drawn around the nut that fell off the spindle releasing the saw blade. On the right side is another machine at the same workshop which is functional.

accident after the autopsy and death scene investigation. This circumstance emphasizes the importance of the examination of incident scene and autopsy in determining the origin. Moreover, we believe that to prevent injuries and death such as this, it would be useful to install a saw-protective lid on the parts other than those parts of the spinning saw that will do the cutting and offer education on the use of the machine.

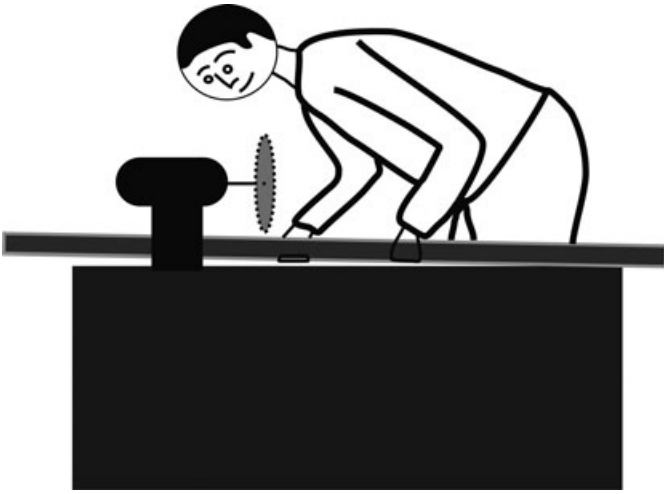
FIG. 4—A schematic of the position of the victim according to the declarations of the workers who witnessed the accident.

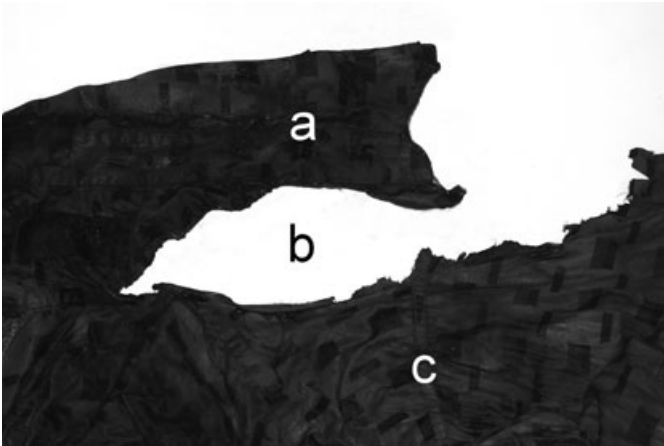
On the left collar of the shirt and flannel of the corpse, there was an incision that corresponded to the recesses and projections on the surface of the saw (Fig. 5). In the external examination, an incision (15 × 5 cm) was observed that began in the middle of the neck down the thyroid cartilage, extended horizontally to the left of the neck and ended on the outer part of the neck in the outer left side of m. trapezius. Although the incision seemed straight-edged initially (Fig. 6), on closer inspection, recesses and projections were observed in the skin especially where it ended (Fig. 7). The beginning of the

FIG. 5—Incision of the shirt of the victim. (a) Collar of the shirt, (b) defect that corresponded to the recesses and projections on the surface of the saw, (c) left shoulder of the shirt.

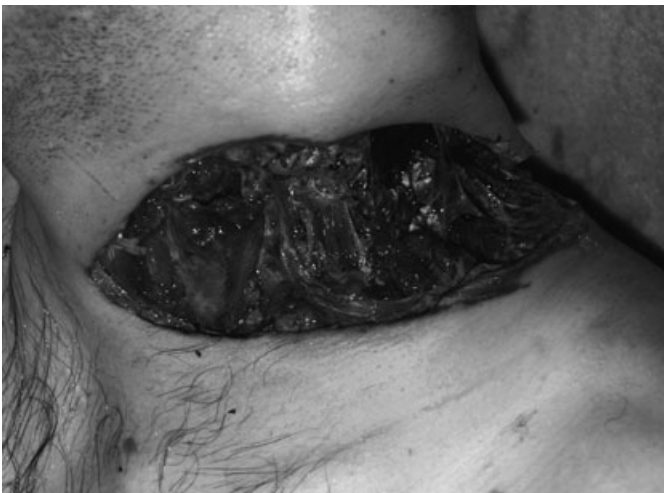
wound on the left side of the middle of the neck occurred as a result of the circular saw contacting the neck at a right angle. The spinning saw moved backward, and on the outer left side of m. trapezius the angle between the neck's skin and the circular saw narrowed. The teeth of the circular saw spinning on this region contacted the skin at an acute angle, so there were recesses and projections in the skin that corresponded to the teeth of the circular saw. It was thought that partial marginal abrasions occurred on the lips of the wound, with the edges of the circular saw contacting the skin.

FIG. 6—Incision on the left side of the neck vertical to the axis of the neck.

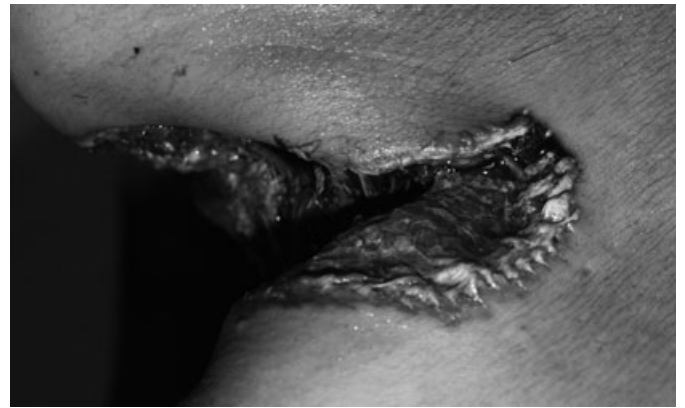
FIG. 7—More intensive recesses and projections on the lips of the wound where the incision ended.
