Karolyn L. Tontarski,<sup>1</sup> M.S.; Kyle A. Hoskins,<sup>2</sup> B.S.; Tani G. Watkins,<sup>2</sup> B.A.; Leanora Brun-Conti,<sup>3</sup> B.S.; and Amy L. Michaud,<sup>3</sup> B.S.

## Chemical Enhancement Techniques of Bloodstain Patterns and DNA Recovery After Fire Exposure\*

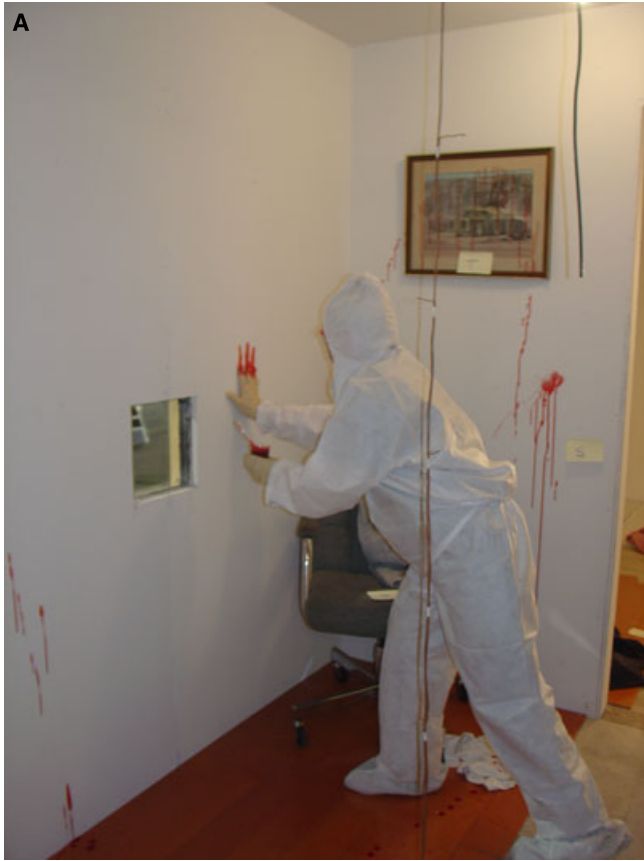
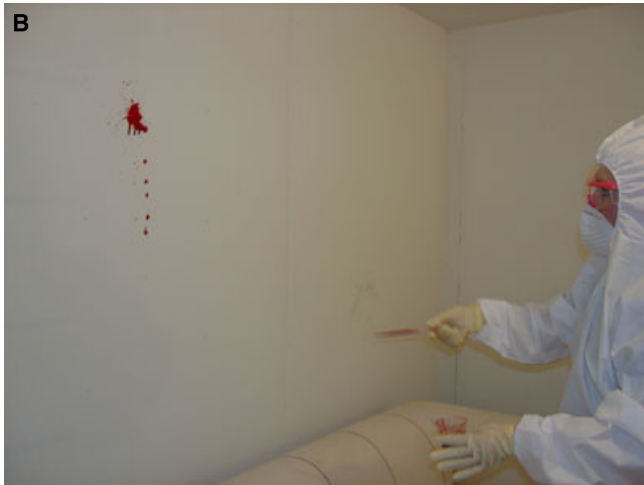
FIG. 3—(A) Creation of transfer stain pattern in living room. (B) Creation of projected blood pattern in living room.

A pint of human blood was provided by the Michigan Community Blood Centers (Grand Rapids, MI). The blood was placed on surfaces and substrates within the structure (Figs. 3A and 3F) in typical bloodstain patterns normally observed at a crime scene (11). The patterns were documented and allowed to dry overnight. Prior to the burning of the structure, all of the stains appeared to be dry with the exception of a pooled bloodstain pattern in the bedroom. The created patterns included: impact stains, castoff, transfer, dripping patterns, projected blood, and blood pools.

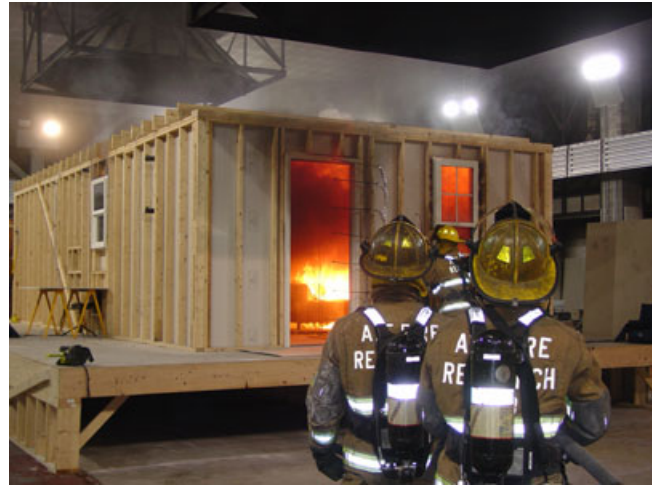
FIG. 4—The structure approaching flashover.

The structure was exposed to a simulated “accidental” sofa fire. The sofa was positioned in the living room directly across from the shut window and door of the living room. The initiating fire source in this scenario was a natural gas sand burner that was positioned adjacent to the armrest of the sofa. Direct flames from the burner were applied for 300 sec to ignite the sofa. After the initial 300 sec, the gas was shut off and the fire was allowed to develop naturally, for c. 45 min, until flashover conditions were reached

(Fig. 4). The fire was then put out by firefighters using water. The maximum and minimum temperatures of each room at the ceiling and floor levels were recorded (Table 1). After the structure cooled, the structure was documented for changes in the previously applied bloodstain patterns, chemical enhancement techniques were utilized to better visualize any patterns, and samples were collected for DNA analysis.

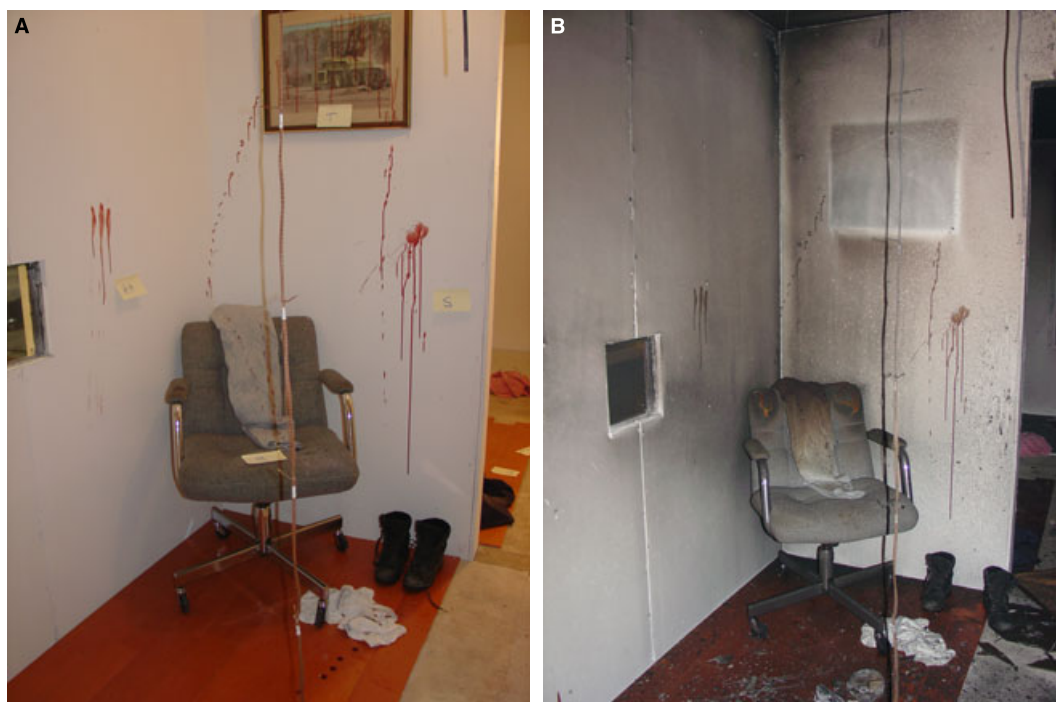
FIG. 7—(A) Dining room before burn. (B) Dining room after burn.

The remainder of the structure (dining area, kitchen, and bedroom) had similar effects to the less burned areas of the living room, having received a lesser degree of heat and smoke damage (Figs. 7A and 7B). All of the bloodstain patterns, including the footwear impressions created in the bedroom and kitchen on the wood flooring product and the vinyl, could be visualized utilizing a bright light. All of the chemical enhancement products utilized gave positive results. The lowest temperature recorded in the

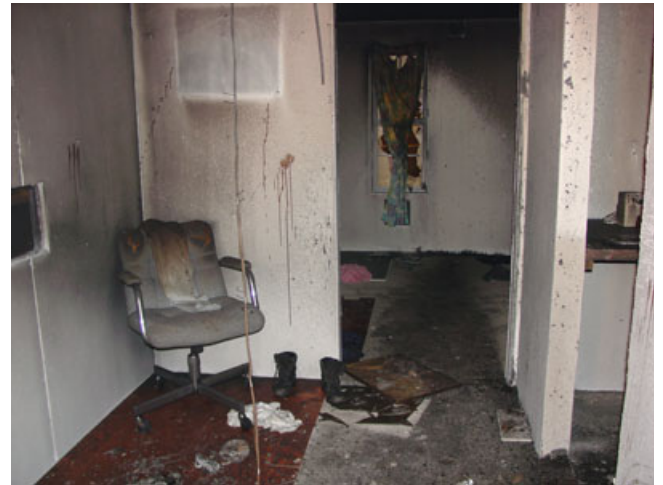
FIG. 8—View depicting locations saturated with water when the fire was extinguished, with “halo” effect evident against the back wall.

A series of samples directly in the “line of fire” from the water hose used to extinguish the blaze yielded somewhat unexpected results. Primarily, these bloodstains were recovered from the north walls in the dining room and bedroom and objects near the walls. Of the nine samples recovered from this area, six did not yield a DNA profile, two yielded a partial DNA profile, and one yielded a full DNA profile, albeit with a classic degradation pattern (Table 5). Figure 8 depicts the areas in the structure on which the water was concentrated during the effort to put the fire out. The “halo” where less soot is noted defines this area. Because many other samples yielded full DNA profiles when the temperatures to which they were exposed were even higher than these areas, it is unlikely that temperature alone is responsible. In addition, these samples tended to have less soot deposits given the force of the water directed on them. It is not likely that the soot was an interfering factor as many other samples from which full DNA profiles were obtained had heavier soot deposits. Based on these findings, further testing was performed to determine if there was something unusual about the water used by the ATF FRL that may have interfered with the ability to obtain DNA testing results. Our subsequent testing on a sample of water obtained from the Laboratory did not show any affect of this water on the ability to isolate or amplify DNA. It is important to note, however, that this sample of water was obtained months after our structure fire was extinguished and may have had different properties than the water that was actually used. It is surmised by the process of elimination, therefore, that either the force of the water as it was expelled from the fire hose may be in some way responsible for this observed phenomenon or something in the composition of the water.
