Evaluation of the debris throw from the 1992 explosion in the Steingletscher installation in Switzerland¹

Peter O. Kummer *

Bienz, Kummer and Partner Ltd., Langgüertenstrasse 6, CH-8125 Zollikerberg, Switzerland

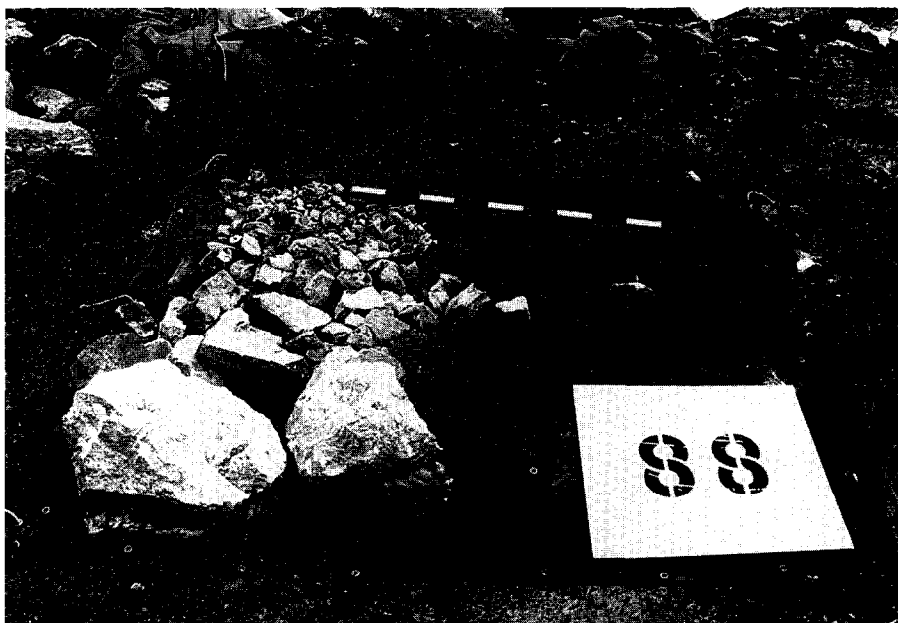
Fig. 10. Debris from a 'collection area'.

(3) At last, all debris were collected, sorted out for different materials (rock, concrete, metal parts, etc.) and according to their size. Fig. 10 shows an example. The debris were counted and weighed. Back in the office, for each debris field a data sheet showing all details was elaborated and, as a first step of the evaluation, the debris mass density in kg m^{-2} was defined (Fig. 11). Fig. 12 gives an overview of the data of all debris fields.

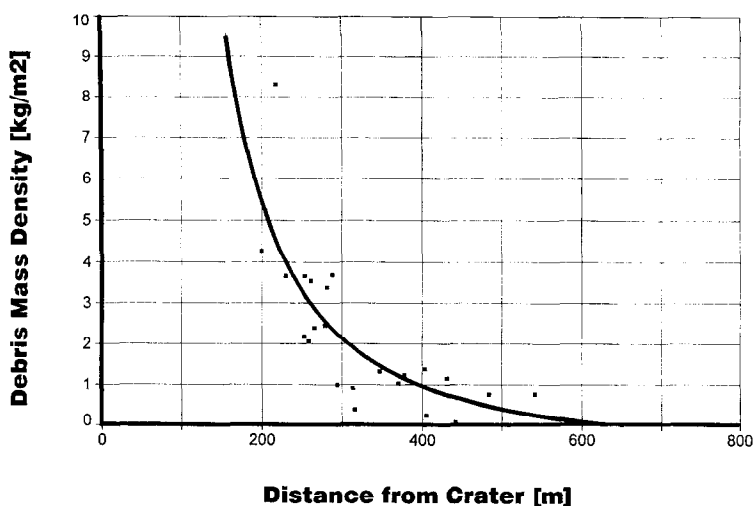
Fig. 13. Debris mass density versus distance from centre of crater.

coming from an access tunnel. For further evaluation of the debris throw from the crater, only the debris fields Nos. 81 to 95 and 109 to 116, (a total of 23) were used. Together with the fact that the maximum crater debris throw distance was on the order of 600 to 700 m, the graph in Fig. 13 was developed. Although the data scattering was not as small as we would have liked it, the debris mass density versus distance curve represents the physical facts, in our view, reasonably well. Based on this curve the debris mass density contour lines in Fig. 14 could be drawn as a final result.

With the values from the initial evaluation, and according to the NATO safety principles, it is easy to calculate the ‘safety distance’ based on the criterion of one hazardous debris per 600 ft^2 or 55.7 m^2 , respectively. According to Fig. 13 you would

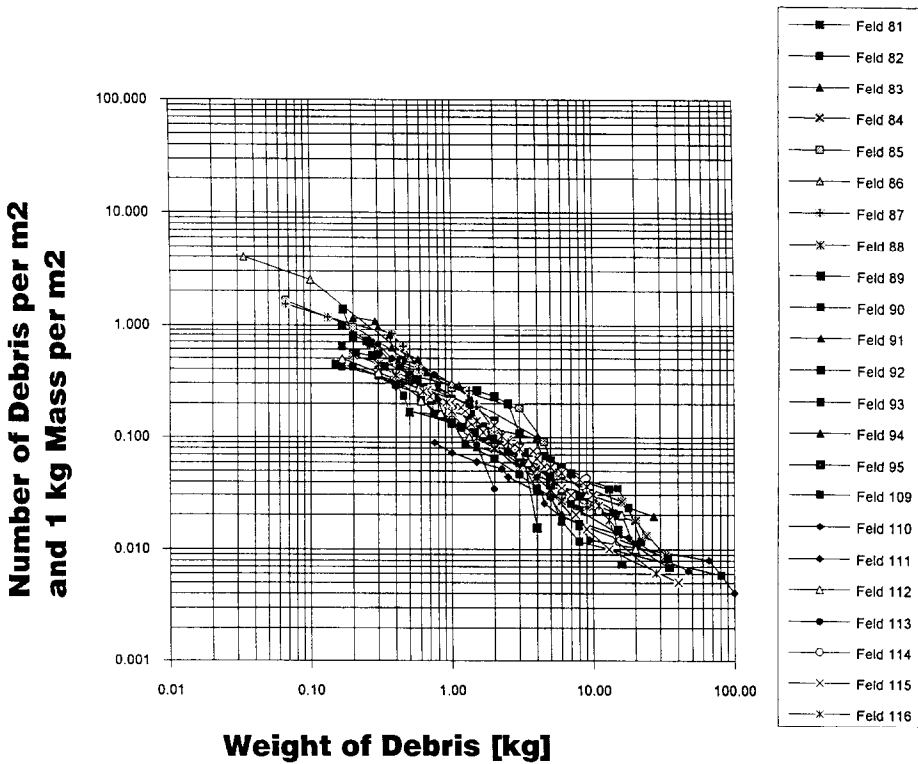
Fig. 15. Summary of debris size distribution of all debris fields.

Thus, the next step in our evaluation was to establish the relationship between the number of hazardous debris and the debris mass density. Based on the data sheets of the debris fields (Fig. 11) a debris size summation curve was developed for each field. A summary of the curves of all 23 fields is shown in Fig. 15. A regression with these data points was made (Fig. 16) and a final average distribution of the debris size (mass) versus number of debris, standardized for an area of one m^2 and a debris density of 1 kg m^{-2} , was the result. The data was evaluated to see if the debris size distribution was dependent on the distance from the crater or the angle from the tunnel axis, but neither were determined to be of important influence.

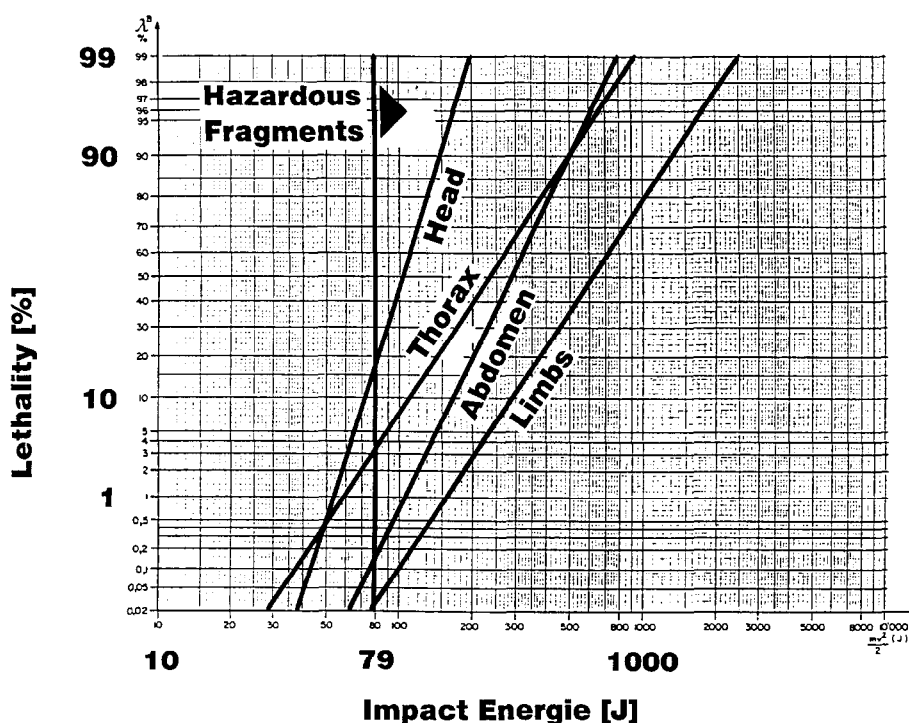
Fig. 18. Lethality versus impact energy.

How would we judge this situation according to the Swiss Safety Regulations? We do not have safety distances, but calculate the risk quantitatively [8,9]. This approach gives a much better picture of what really happens. Thus, the technical models such as lethality as a function of physical effects have to be more extensive and detailed than in a quantity-distance approach. Therefore, several years ago the lethality of persons due to debris throw coming from a crater was studied in-depth [5,7]. Taken into account were, for example, the impact angle of debris and the different susceptibility of different parts of the body. Fig. 18 shows that the impact of a debris with an energy of 79 J results in a considerable lethality rate only in case the head is hit. Other parts of the body are less sensitive to debris impact with respect to lethality. Based on that model and for the debris density measured at the Steingletscher site, taking into account the distribution of the debris size according to Fig. 16, the lethality was calculated. Coming up with a lethality of less than 10% at point A (Fig. 19), we are confident that this situation is more realistic than the NATO criteria.
