## Incident analysis of Bucheon LPG filling station pool fire and BLEVE

An LPG filling station incident in Korea has been studied. The direct cause of the incident was concluded to be faulty joining of the couplings of the hoses during the butane unloading process from a tank lorry into an underground storage tank. The faulty connection of a hose to the tank lorry resulted in a massive leak of gas followed by catastrophic explosions. The leaking source was verified by calculating the amount of released LPG and by analyzing captured photos recorded by the television news service. Two BLEVEs were also studied.

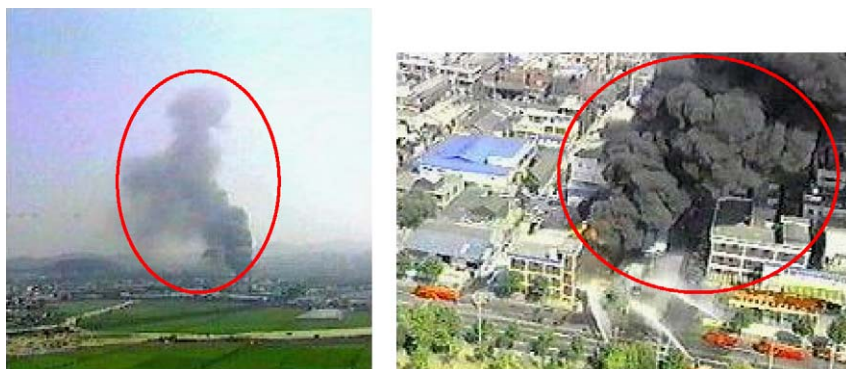
According to witnesses, gas leak was observed about 2:06 pm and fire was observed around the butane tank lorry about 2:10 pm. The fire was reported to a fire station at 2:11 pm. The television camera started recording the incident at 2:20 pm. As seen in Fig. 3, considerable amount of heavy smoke was observed, which may be attributed to liquid phase combustion of LPG, i.e., pool fire [5]. Soon after recording began, glass windows at nearby building were observed undamaged, which may indicate that VCE (vapor cloud explosion) had not occurred, in spite of delayed ignition. By about 2:22 pm, fire could not be seen at area G as seen in Fig. 4.

Fig. 3. Fire with heavy smoke at Bucheon LPG filling station.

The incidental chronology is very dynamic and rather complicated to be analyzed precisely. In this work, a brief analysis has been conducted on the initial release quantity and fireball phenomena. As seen in Fig. 3, the first part of the incident was the pool fire. The flame length for a tilted flame can be estimated

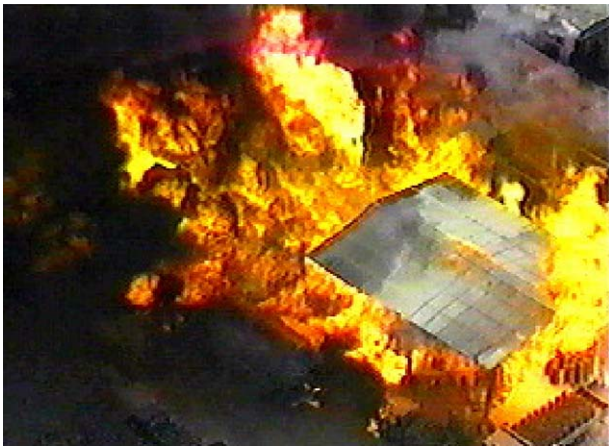
Photo captured at about 2:23 pm shows two kinds of LPG fire at the cylinder filling area as shown in Fig. 5. The one with heavy smoke (left side) is a pool fire of liquid phase LPG, and the other without smoke (right side) is combustion of gas phase LPG that leaked through the safety valve of the LPG cylinder heated by the nearby pool fire. The length of pool fire was estimated to be

Fig. 5. Pool fire captured from northeast of the LPG filling area after 13 min of fire.

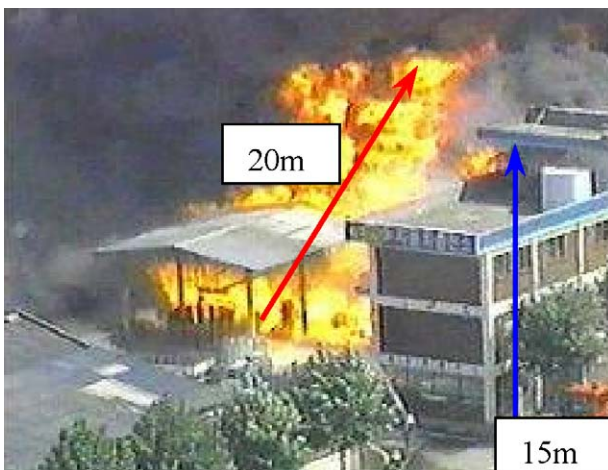
about 20 m by comparison with the nearby building as seen in Fig. 6.

Fig. 6. Average height of pool fire estimated from office building height.

The diameter of the pool fire was estimated by Fig. 6 and Eq. (1). With the flame length  $L=20$  m,  $\dot{m}_{\infty} = 0.078$  kg/m<sup>2</sup>s for butane,  $\rho_a = 1.3$  kg/m<sup>3</sup>,  $g = 9.81$  m/s<sup>2</sup>, the diameter of pool fire  $D$  is estimated as 7.8 m. Then the amount of LPG involved in the pool fire before BLEVE was estimated by Eq. (2) [7]:

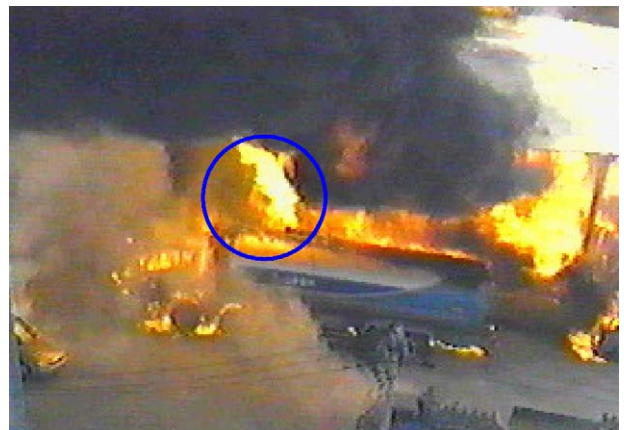
As shown in Fig. 7, a small flame was observed at the propane tank lorry, which was attributed to a flame of purged propane through the safety valve. At about 2:25 pm, the first BLEVE was observed at the propane tank lorry with duration of 9 s. Around 2:27 pm the second BLEVE was observed at the butane

Fig. 7. Flame surrounding butane tank lorry and small flame by purged butane through safety valve.

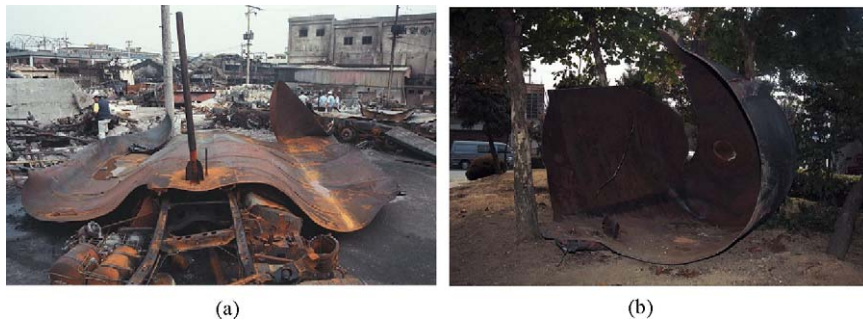
tank lorry with duration of 7 s as shown in Fig. 2. The BLEVE durations were decided from the video recorded by the television camera. As a result of the explosions, the body and rear parts of the propane tank was propelled 28.5 and 12.6 m, respectively, from the propane tank body that was deformed to a plate shape as in Fig. 8. The front part of the butane tank was propelled 67.4 m from the plate-shape deformed butane tank body as in Fig. 9.

Fig. 9. Butane tank lorry after explosion: (a) body and (b) front part of tank.
