# Investigative studies for the use of an inactive asbestos mine as a disposal site for asbestos wastes

Evangelos Gidarakos\*, Kalliopi Anastasiadou,  
Emmanuel Koumantakis, Stappas Nikolaos

*Laboratory of Toxic and Hazardous Waste Management, Department of Environmental Engineering,  
Technical University of Crete, Politechniopolis, Chania, P.C. 73100, Greece*

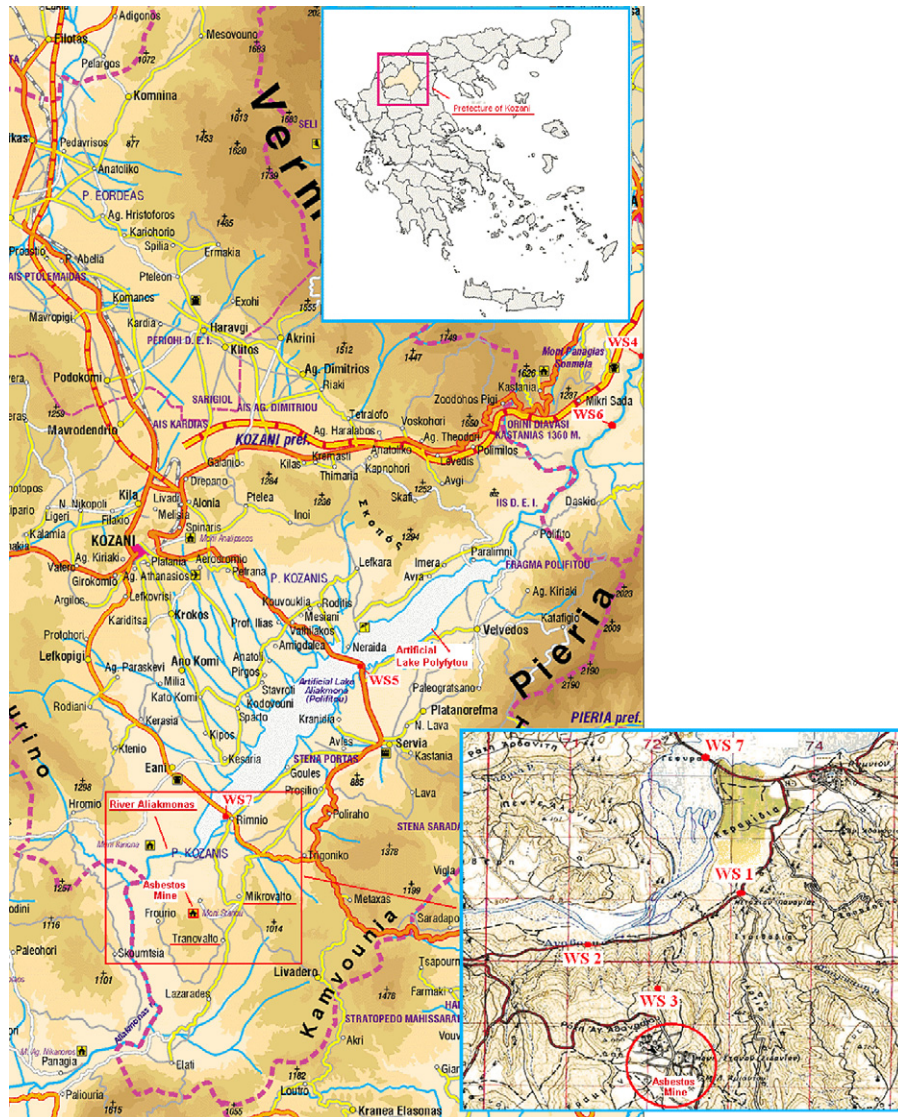
Fig. 1. Relative locations of the old mine of Zidani, the Aliakmonas River and the artificial lake Polyfytoy.

Fig. 1 shows the relative locations of asbestos mine, the Aliakmonas River and the artificial lake Polyfytou.

In the wider vicinity of the mine, at a distance of roughly 2.5 km W–SW, a small settlement named Mikrobalto is located, while at a distance of 3.5 km S–SW there is another settlement named Tranovalto.

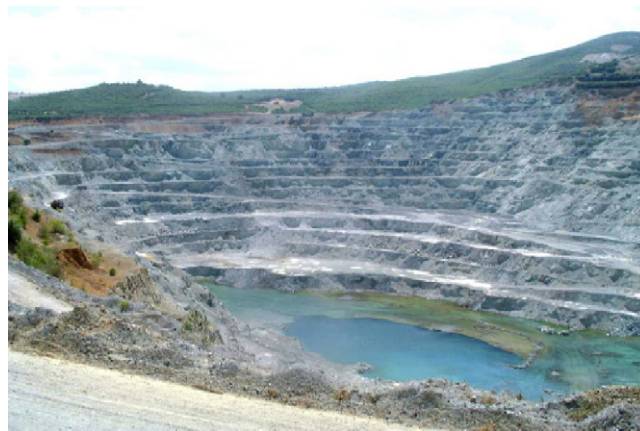
Fig. 3. Asbestos mine excavation using the open pit method.

In Fig. 3 a view of the lake of the open pit excavation is present.

After years of operation, the mining process created a funnel-shaped excavation, with a depth of 180 m, with rungs of 10 m high and a width of 5 m. The continuous excavation created a small lake at the bottom of mine (altitude +480 m).
