Estimating the TNT equivalence of a 15-ton single base powder explosion through damaged building profiles analyses

Back in 1964 President Vargas Works was the only place in the country which processed single base powder for the Brazilian Armed Forces. Then its industrial activity was quite strong and around 4:45 a.m. of 23rd September an intense decomposition of nearly 15 ton of that material took place in one of the production lines workshops. The consequences of this explosion were the destruction and extensive damage to the workshops around its epicenter. At that time pictures of all affected buildings were taken and their damages fully described. This led to the present work which consists in the evaluation of the TNT equivalent charge of the explosion using the concept of damage category developed by UK engineers based on the WWII damaging bombing data.

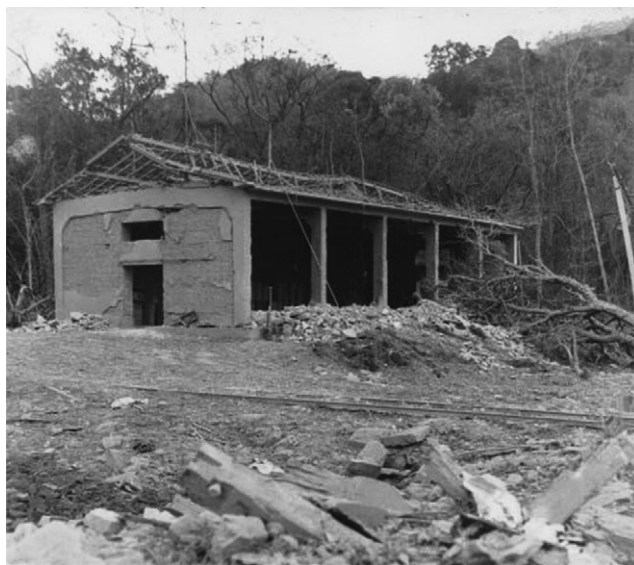
Fig. 1. Single base powder boxes storage depot. Picture taken 50 m from epicenter.

- Complete demolition*: At least one wall has crashed as shown in Figs. 1–4.
- Partial demolition*: At least one wall shows severe cracks and crashing is imminent of follow as displayed in Fig. 5.

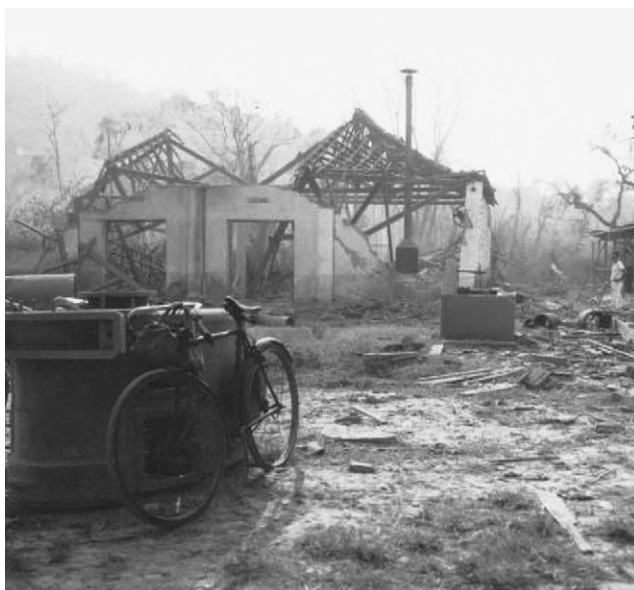
Fig. 2. Machine shop I. Picture taken 80 m from epicenter (obviously the bicycle belonged to the photographer).

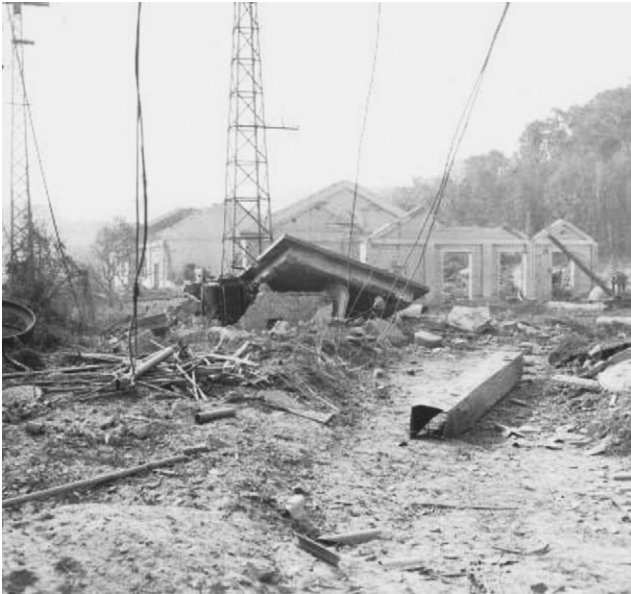
Fig. 3. Electric power room. Picture taken 80 m from epicenter.

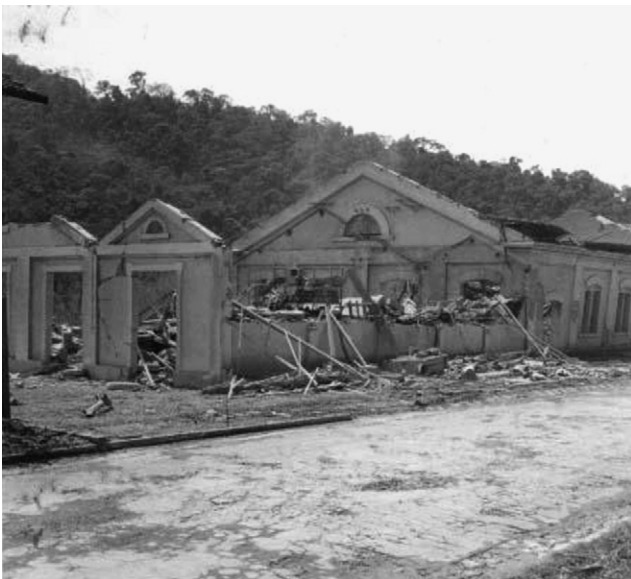
Fig. 4. Carpentry. Picture taken 110 m from epicenter.

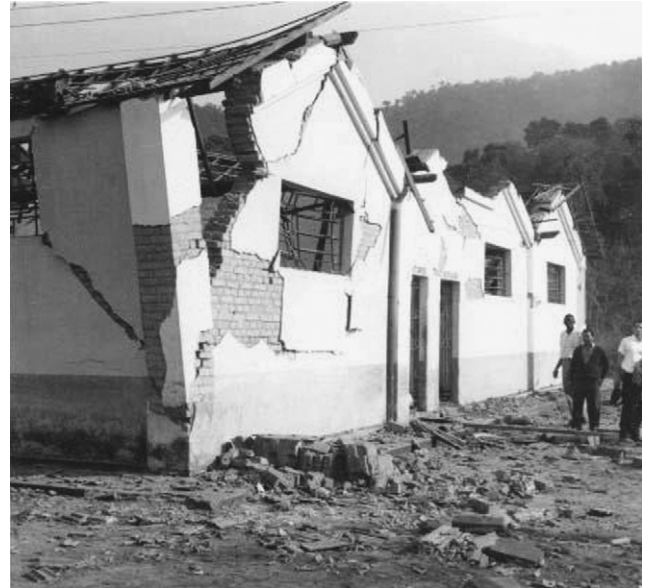
Fig. 5. Machine shop II. Picture taken 140 m from epicenter.

- (a) Total collapse (as shown in Figs. 5–7).
 (b) Partial collapse (as shown in Fig. 9).
 (c) *Tiles (ceramic) pulled out*: The roof structure remains but more than 70% of tiles are pulled out, as it can be seen in Fig. 10.
 (d) *Tiles (ceramic) displaced*: Less than 50% of tiles were pulled out, as shown in Fig. 12.
 (e) *Tiles (ceramic) with cracks*: Small pieces of tile were found inside the building, unfortunately there is no picture available.

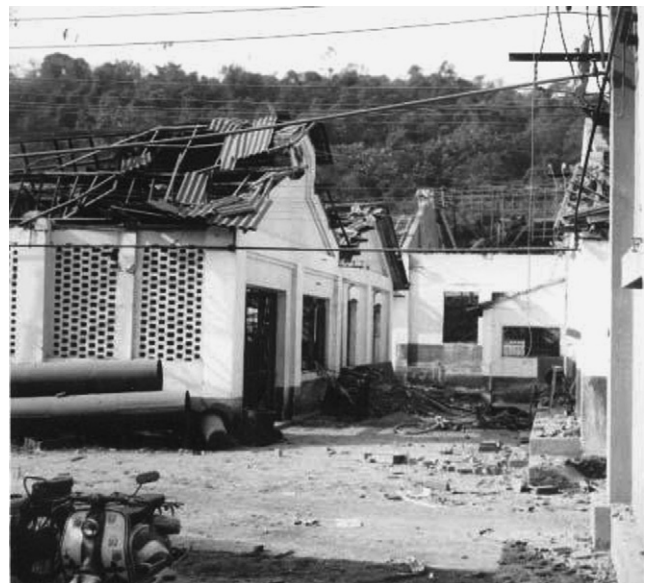
Fig. 6. Machine shop III. Picture taken 170 m from epicenter.

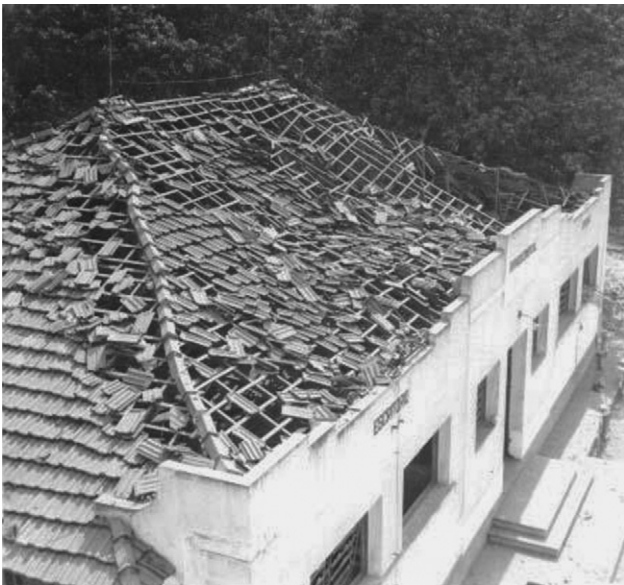
Fig. 9. Sales department building. Picture taken 190 m from epicenter.

- (c) *Gaping cracks*: At least one wall shows cracks not too severe to need demolition as shown in Figs. 8 and 9.

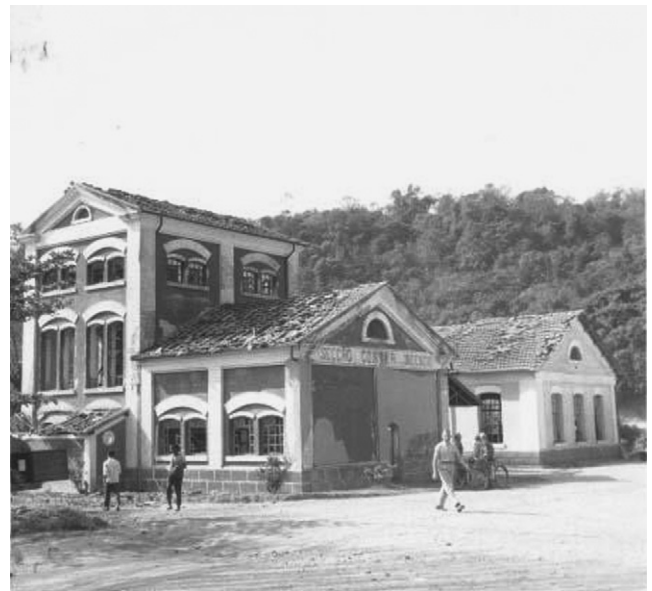
Fig. 10. Fire department building. Picture taken 240 m from epicenter.

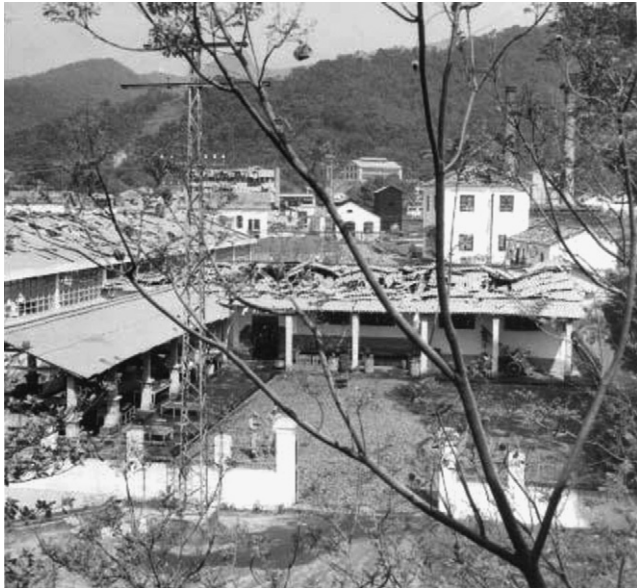
Fig. 11. Mess room. Picture taken 270 m from epicenter.

- (f) *Tiles (asbestos) displaced*: Asbestos tiles were displaced even when no damage were noticed in tiles (ceramic). Fig. 11, taken 240 m from the explosion epicenter shows this effect on the mess room roof. However, it is worth mentioning that displaced asbestos tiles were found as far as 740 m away from the explosion epicenter.

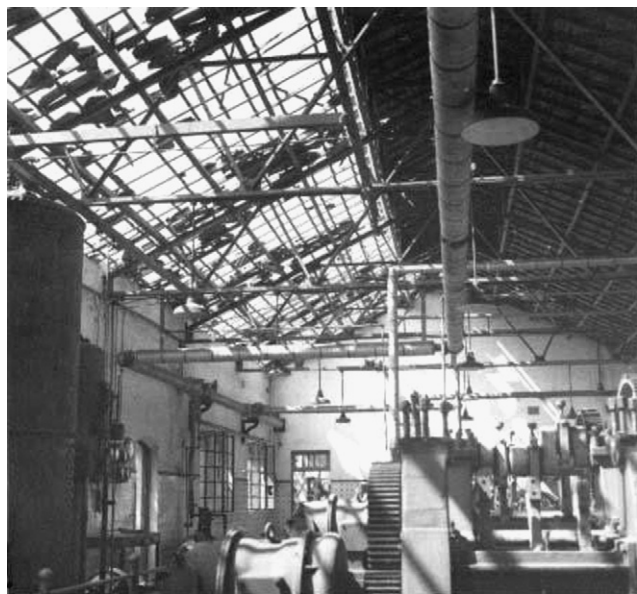
Fig. 12. Boiler room. Picture taken 340 m from epicenter.
