Post-Test Corrosion Analysis of High-Temperature Thermal Energy Storage Capsules

H. Fathollahnejad, B.-H. Tsao, R. Ponnappan, and D. Jacobson

Thermal energy storage capsules have been freeze-thaw cycled in vacuum at 1000 ± 100 K. The capsules were fabricated from Inconel 617[®] (Inco Alloys International, Inc.) and contained eutectic fluoride mixtures of sodium, magnesium, lithium, and potassium. Samples that were thermal cycled for 20,000 and 30,000 hr were analyzed for corrosion effects. Radiography indicated neither flaws nor inhomogeneities, and there were no significant microstructural changes in the container alloy. The microstructural damage penetrating the inside surface was as deep as 120 μ m and that penetrating the outside surface was approximately 150 μ m. Microprobe results on the containers revealed a concentration gradient of alloying elements. The aluminum concentration was reduced from 1.34% in the original matrix to 0.4% at 10 μ m from the inside surface, and chromium was reduced from a nominal value of 23% to 10% at the outer surface. The depletion of aluminum and chromium from the outer surface was due to vacuum vaporization at elevated temperature. X-ray diff

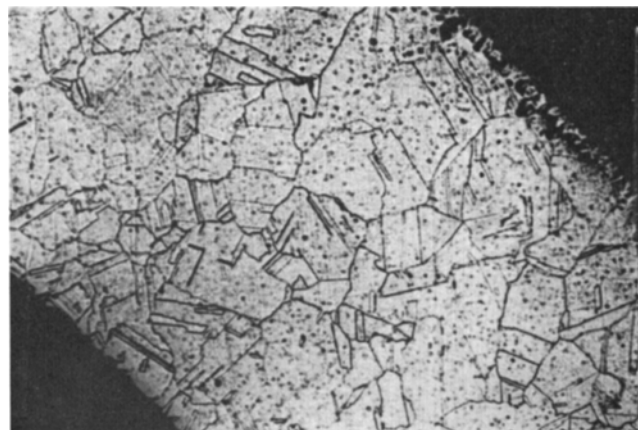
Fig. 4 Optical micrograph showing the tube wall (sample 16 tested for 20,000 hr, 50 \times).

The inner edge exhibited minimal visual damage, as shown in Fig. 4 for samples tested after 20,000 hr. At higher magnifications, small voids were observed near the inner edge. These voids are probably due to salt reactions.

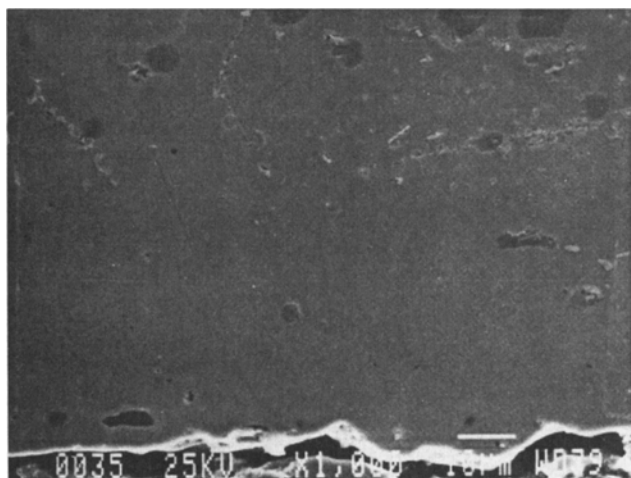
The inner edges of the cut specimens were examined by scanning electron microscopy (SEM). Figures 11 to 13 show the extent of the damage done to the inner edge by eutectic salts at high temperature. The images show that there are no precipitates at grain boundaries within 50 and 70 μm of the edge for

Fig. 11 SEM micrograph showing the inside edge (sample 12 tested for 30,000 hr).

Fig. 12 SEM image of inside edge (sample 16 tested for 20,000 hr, salt type C).

samples tested 20,000 and 30,000 hr, respectively. There were some voids in the precipitate-depleted region, which may be due to the polishing process or diffusion of alloying elements from the surfaces. These voids may have resulted from vacancies created by preferential diffusion of chromium and aluminum into the salts.

Fig. 13 SEM image of inside edge (sample 19 tested for 20,000 hr, salt type A).

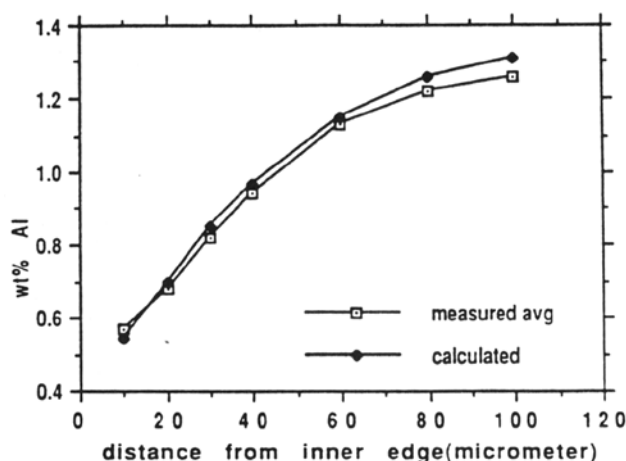
Concentrations of aluminum, chromium, and molybdenum were plotted as a function of position. The results are shown in Fig. 17 to 20. A decrease from the nominal composition is observed for aluminum and chromium near the edges. The composition then matches the nominal composition deeper into the wall. The molybdenum composition varies in a manner opposite to aluminum and chromium. The molybdenum composition is above the nominal value near the outside edge, drops below nominal, and then increases back to the nominal composition again. This behavior suggests that molybdenum diffuses from the matrix to the surface, but does not evaporate. The graphs for aluminum and chromium suggest that they both diffuse to the surface and then react with the salt on the interface. To verify this reaction, chemical analyses were performed for traces of aluminum and chromium in the salt. The quantitative

Fig. 17 Concentration profile of aluminum vs the distance from inside edge (salt type A). (a) Samples tested after 20,000 hr of cycling. (b) Samples tested after 30,000 hr.

Table 4 lists the measured averages from microprobe analysis and calculated values of C_x at various positions from the inner edge. Comparison of these values is shown in Fig. 17. Considering the possible errors in measurements, the measured values are in good agreement with the calculated values. Therefore, it might be concluded that corrosion of this form is a solid-state diffusion-dominated process.

As shown in Fig. 17 and 18, the corrosion process is not controlled by thermodynamic reactions on the salt-clad interface. Diffusion plays an important role in the development of the corrosion process.
