# Localized Corrosion Studies on Materials Proposed for A Safety-Grade Sodium-to-Air Decay-Heat Removal System for Fast Breeder Reactors

*U. Kamachi Mudali, H.S. Khatak, R.K. Dayal, and J.B. Gnanamoorthy*

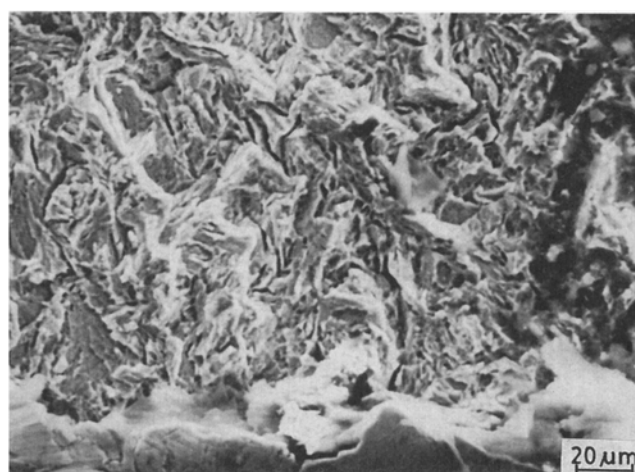
**Fig. 5** SEM micrographs of stress-corrosion cracking tested 9Cr-1Mo steel in the normalized condition. (a) Crack initiation by intergranular mode. (b) Final failure by transgranular mode in 0.05 M NaCl medium.

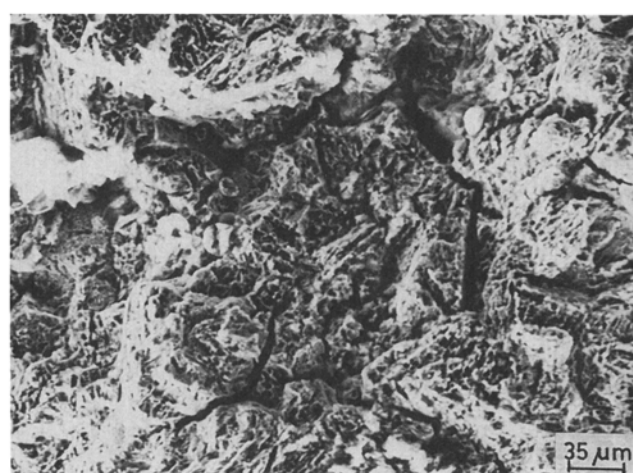
**Fig. 6** SEM micrographs of stress-corrosion cracking tested 9Cr-1Mo steel in the normalized condition. (a) Mixed (intergranular + transgranular) mode. (b) Transgranular mode with secondary cracking in 5 M NaCl medium.
