# An Investigation of Pore Cracking in Titanium Welds

T. Khaled

Two welded Ti-6Al-4V pressure vessels leaked prematurely in service. The leaks were caused by cracks emanating from weld porosity. The cracks originated during fabrication, with subsequent growth in service leading to the formation of the leak paths. Pore cracking is thought to be caused by a mechanism that involves both sustained-load and cyclic contributions, with the former being the more prominent. It is shown that the tendency for cracking is influenced by pore position and that pore size is not a deciding factor in that regard. The factors that govern pore cracking are discussed, and the possible role of interstitial embrittlement is assessed.

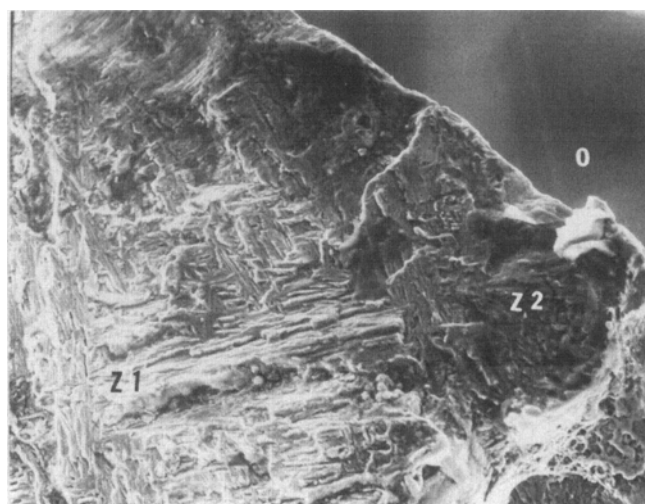
**Fig. 11** Zone 1 to zone 2 transition near the outside vessel surface. 266 $\times$ .

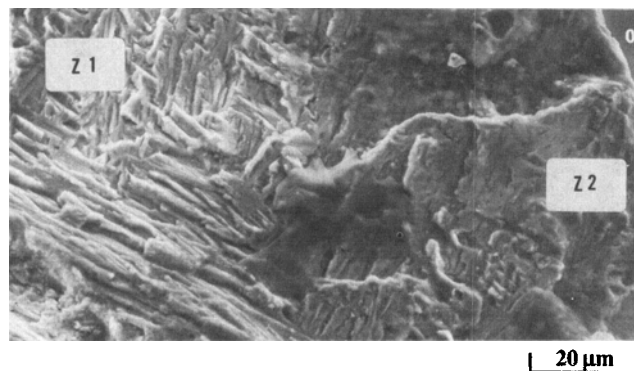
**Fig. 12** The transition of Fig. 11 at higher magnification. 550 $\times$ .

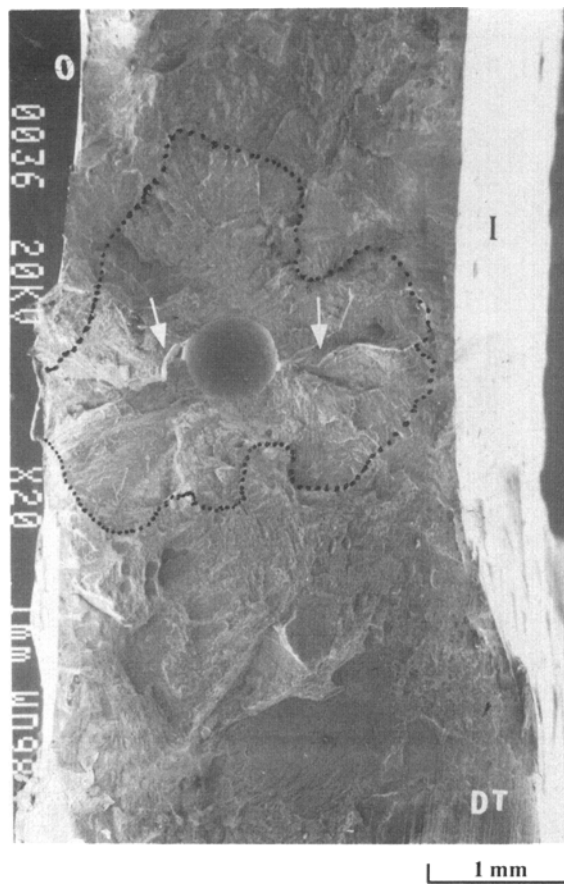
**Fig. 21** SEM micrographs of cracked pore fracture surfaces. (a) Pore diameter, 0.015 in. (0.38 mm). Unheat-tinted fracture. Zone 1 boundary outlined for clarity. 13 $\times$ . (b) Pore diameter, 0.025 in. (0.64 mm). Heat-tinted fracture (not evident in SEM). Zone 1 boundaries outlined for clarity. 20 $\times$ .

Of the 29 cracked pores, 19 had heat-tinted existing fractures, indicating that the cracks were linked to a free surface. By contrast, the remaining 10 sites had unheat-tinted existing fractures. Figures 20 and 21 show examples of the heat-tinted and unheat-tinted existing fractures; the characteristic tear ridges (arrows) are evident in Fig. 21. The fact that unheat-tinted existing fractures were observed indicates conclusively
